SECTION 19 FLOOD RISK INVESTIGATION
FLOOD RISK INVESTIGATION REPORT

PREPARED FOR LONDON BOROUGH OF REDBRIDGE

Authored by: Michael McCarthy
Reviewed by: Tom Whitworth
Approved by: Nicholas Metcalfe
Date: September 2022
Version: 2.1

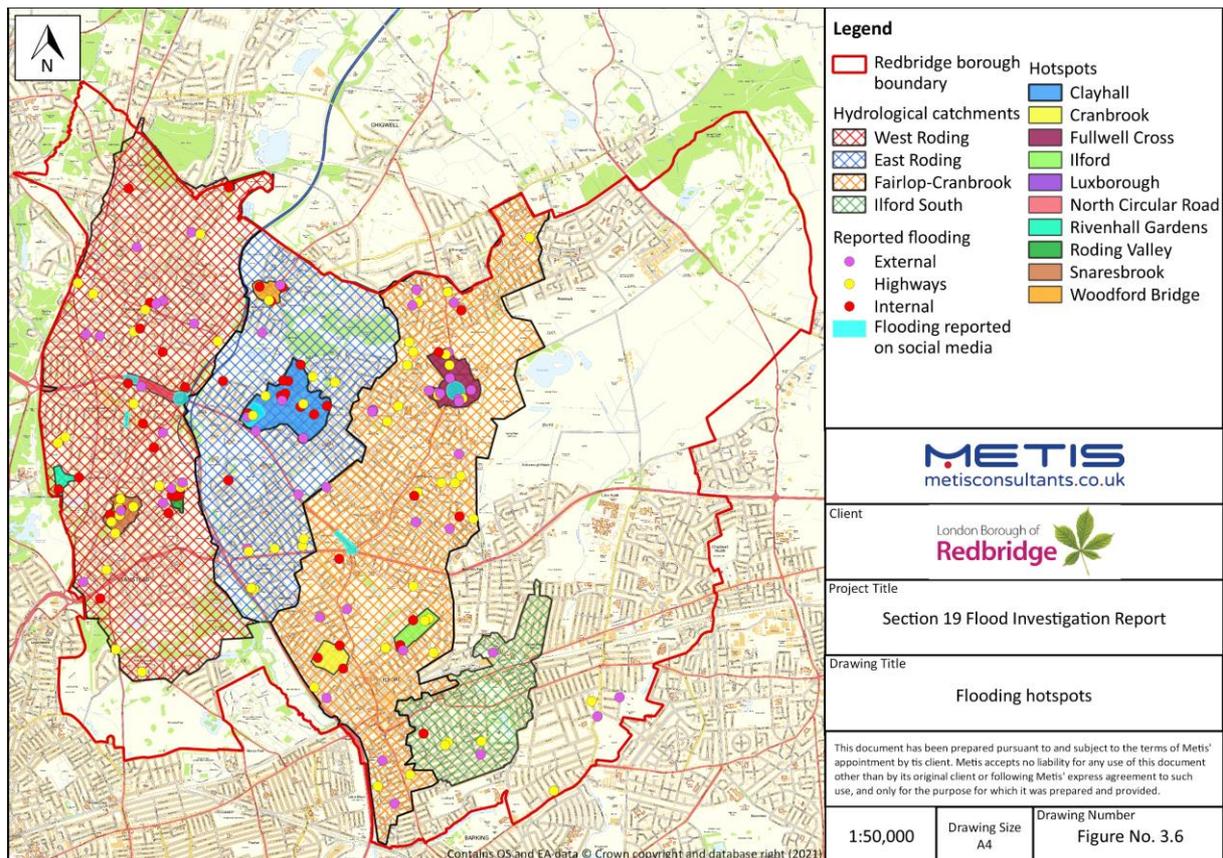
Figure A.1: Map showing the reported flooding, the hydrological catchments, and the hotspots

To carry out the investigation and due to the large number of flooded locations, four hydrological catchments were defined, and ten hotspots were identified (**Error! Reference source not found.**). The hotspots are small areas with clusters of flood incidents or of severe highway flooding, in line with Redbridge’s flood incident criteria. For each hotspot, the flooding mechanisms and various flood risks were assessed, the actions of RMAs before, during and after the flooding were recorded (where known), and recommendations were formulated.

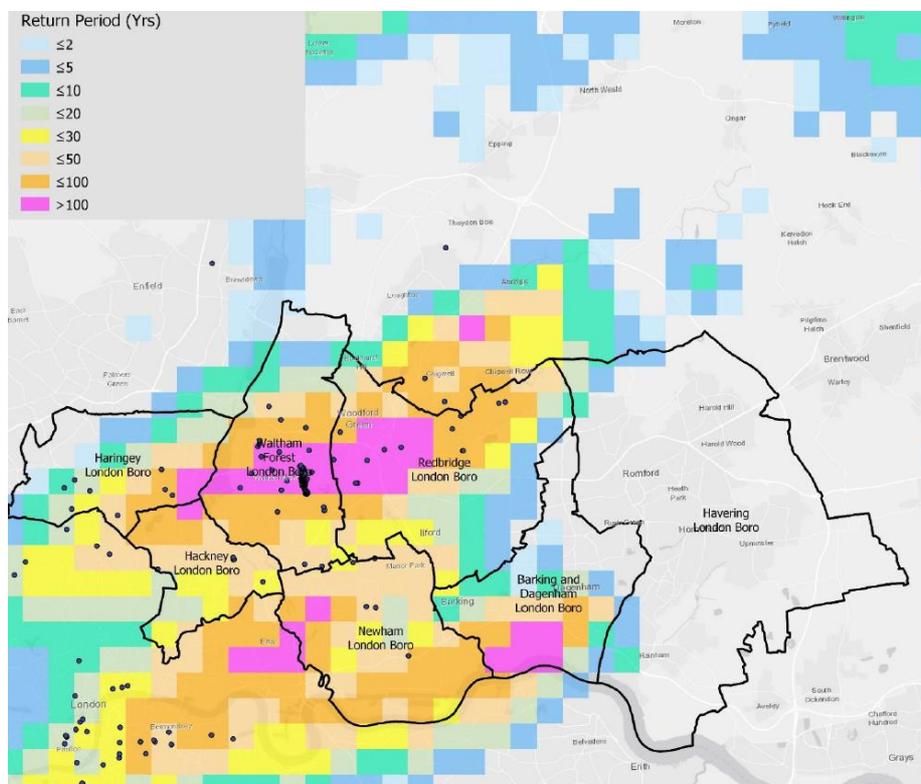
Figure 3.1: Rainfall return period and reported flooding incidents for the 25th July 2021 (RARA data using FEH 99) (Thames Water, 2021)

TWUL has produced some maps showing the return periods of the 25th July rainfall event using Met Office data as shown in *Figure 3.1*. From their analysis, a large area in the western part of Redbridge experienced rainfall with a return period of greater than 1 in 100 year. According to the Met Office and as reported by Thames Water in their Internal Review, the return period of the storm that occurred on the 25th July 2021 is 1 in 118 year, although it has not been specified for which area of London this figure is valid.

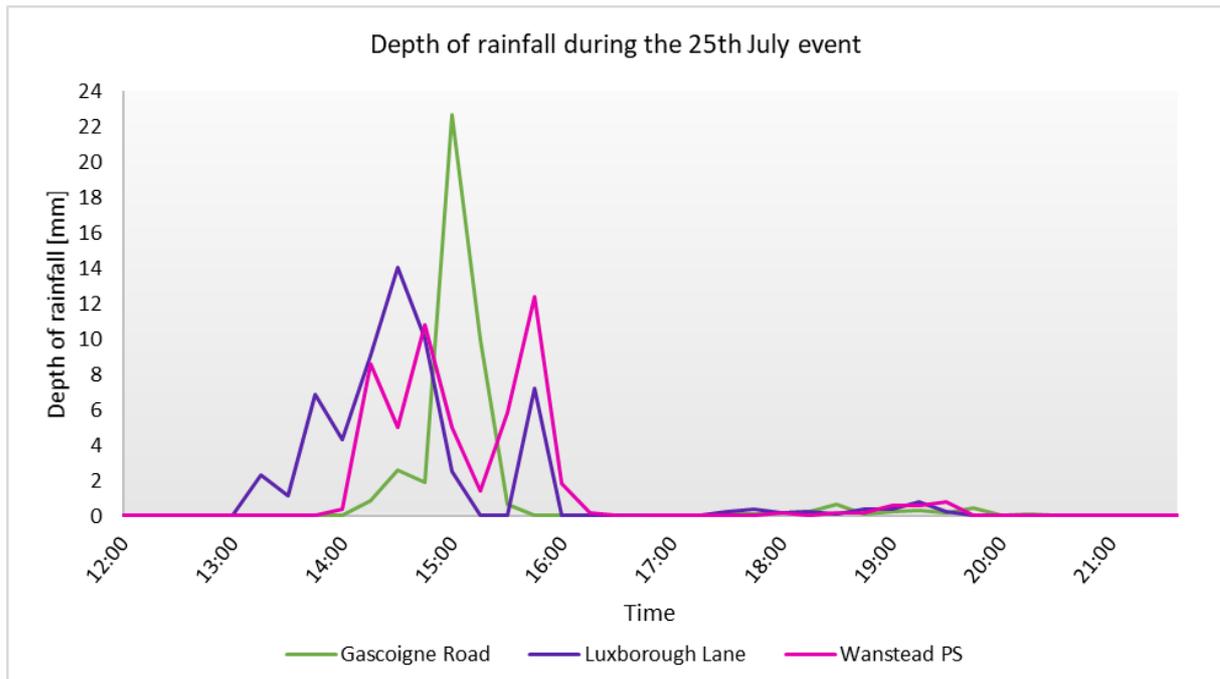
Figure 3.3: Depth of rainfall during the 25th July event

Rainfall started in the early afternoon on 25th July and peaked between 2:30pm and 4pm, with slight variations between the different rain gauges because of their location in relation to the Borough. The rain gauge data can be found in *Table A.1*. The total cumulative amount of rainfall recorded over two hours and fifteen minutes by the Wanstead PS rain gauge is 54.1mm.

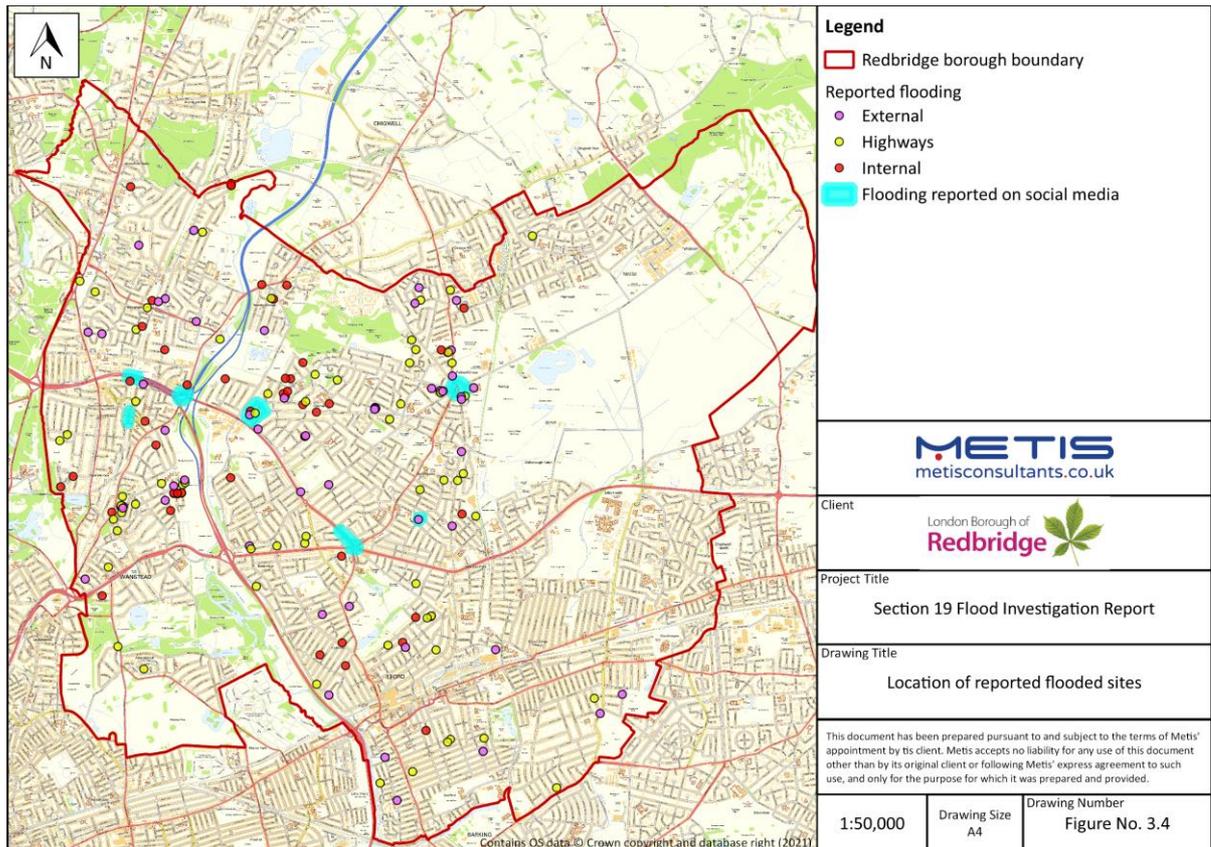
Figure 3.4: Location of reported flooded sites

Most of the flooding reported appeared to be associated with surcharging gullies, which occurs when there is insufficient capacity in the surface water sewer network to accommodate for the surface water runoff entering the network during a rainfall event.

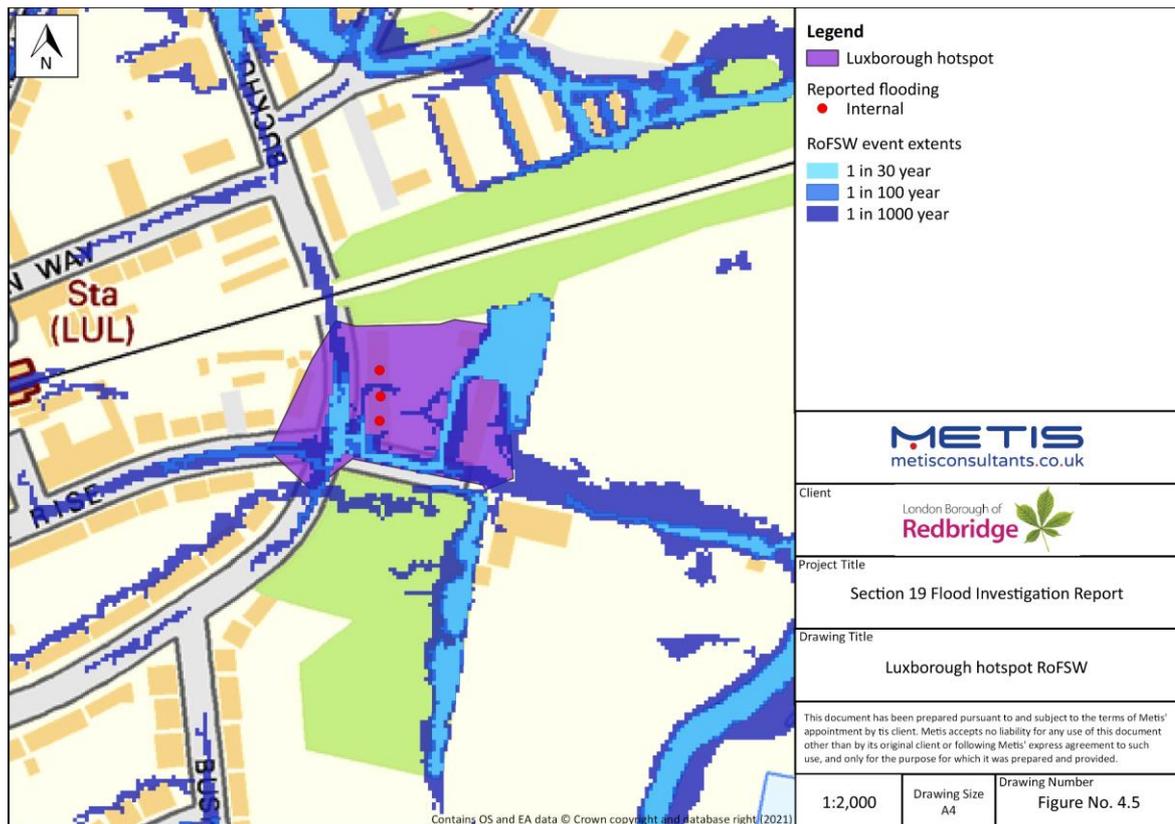
Figure 4.5: Luxborough hotspot RoFSW

A review of the EA's Risk of Flooding from Surface Water (RoFSW) data shows that the surface water is predicted to flow from adjacent roads towards the intersection between Buckhurst Road and Cherry Tree Rise. The mapping also shows that the intersection is at risk from the 1 in 30 year, 1 in 100 year and 1 in 1000 year events (see Figure 4.5) with flood depths ranging between 0.15m and 0.60m. The flooding extents of the 1 in 100 year and the 1 in 1000 year events encroach on the properties that have reported internal flooding. Overall, the Luxborough hotspot is at high risk of surface water flooding.

- Redbridge to investigate raising kerb levels in front of flooded properties in Buckhurst Road to guide surface water away from properties.
- Redbridge to investigate if the installation of new gullies in Buckhurst Way would be beneficial to prevent further flooding. It should be noted that adding new gullies will not prevent future flooding if the surface water sewer does not have sufficient capacity for the additional surface water entering the network.
- For TWUL actions, refer to Section 8.2.

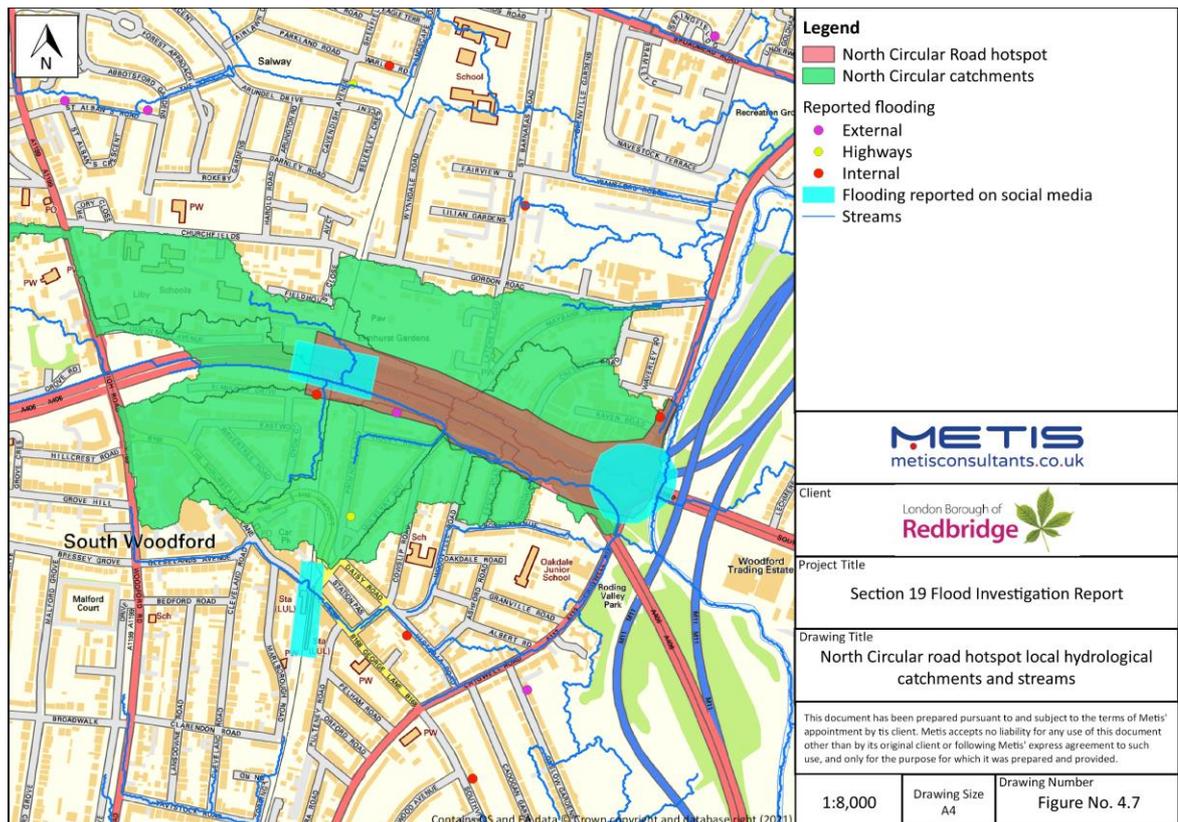
Figure 4.7: North Circular Road hotspot local hydrological catchments and streams

LiDAR data shows that the railway underpass lies on a topographical low point within the area. Surface water is therefore likely to flow towards the area. The primary flow paths of the sub-catchments that include the hotspots intersect near the underpass. Charlie Brown’s roundabout also borders a primary flow path. Furthermore, both locations having reported internal flooding are located on or in close proximity to the flow paths. The primary flow paths all connect to the River Roding which borders the hotspot to the east.

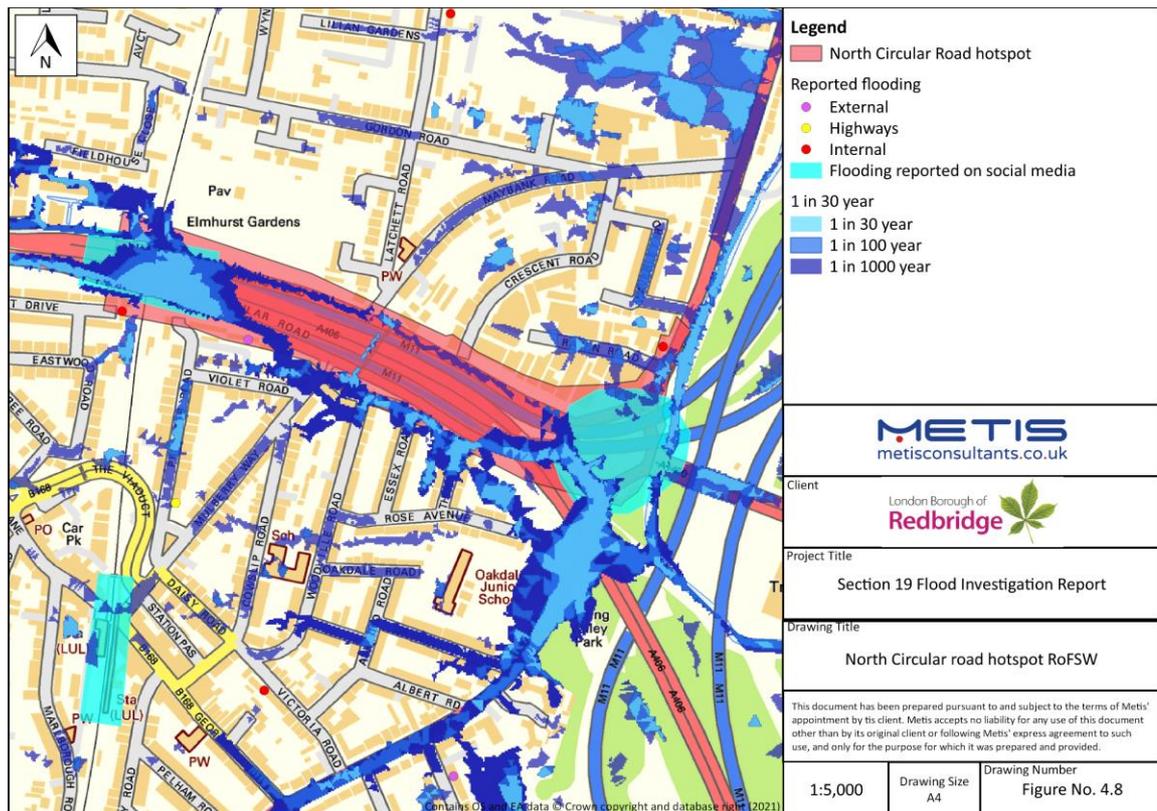
Figure 4.8: North Circular Road hotspot RoFSW

A review of the EA’s Risk of Flooding from Surface Water data shows that water is predicted to flow from the North Circular Road and neighbouring roads to the underpass (Figure 4.8). The mapping shows that the underpass is at risk of flooding from the 1 in 30 year, 1 in 100 year and 1 in 1000 year events with flood depths ranging between 0.15m to over 1.2m. The south-west section of Charlie Brown’s roundabout is also at risk of flooding from the 1 in 30 year, 1 in 100 year and 1 in 1000 year events with depths ranging between 0.15m and 0.90m. From the mapping, the properties on Chigwell Road and Elmhurst Drive are not explicitly at risk of flooding from surface water, they are however in close proximity to the predicted flooded areas. Overall, the railway underpass and Charlie Brown’s roundabout are at high risk of surface water flooding.

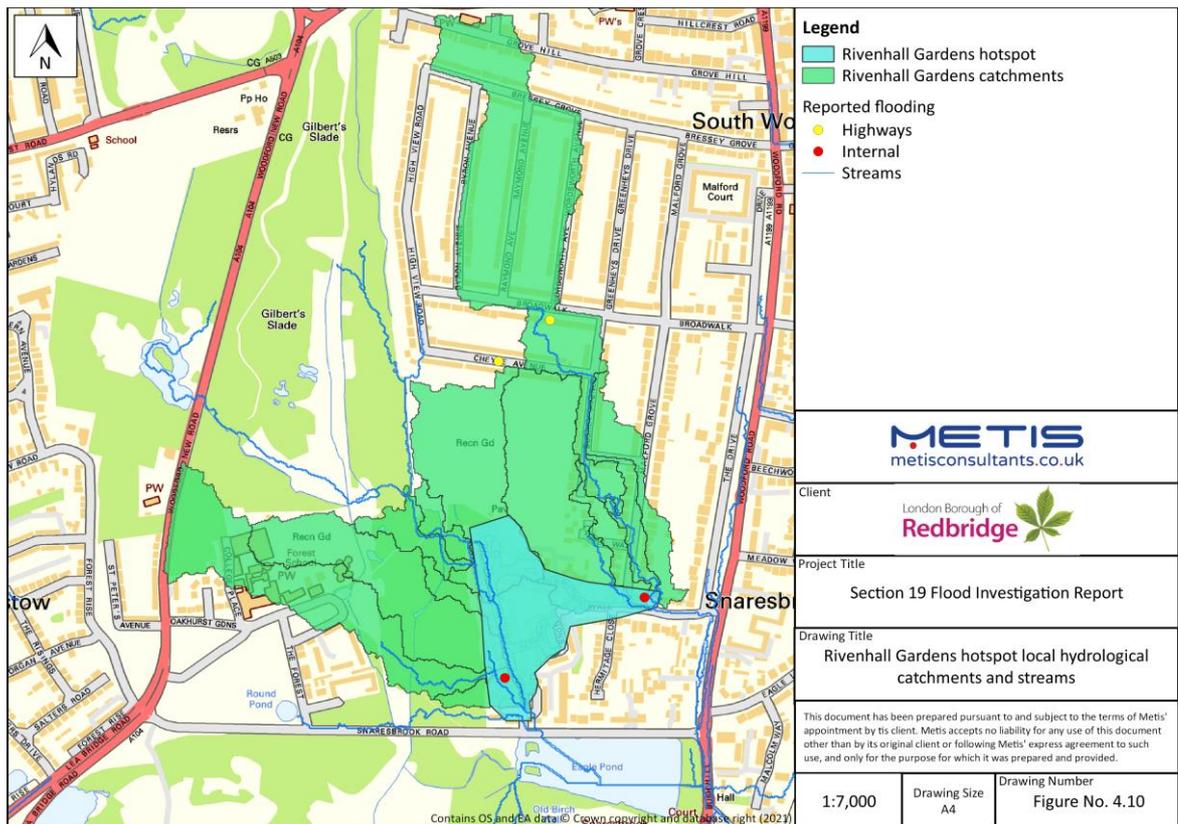
Figure 4.10: Rivenhall Gardens hotspot local hydrological catchment and stream

LIDAR data does not show that the flooded properties in Rivenhall Gardens and Hermitage Walk are in topographical low points within the area. The primary flow paths are the main overland flow route for surface water in the defined catchment. Both properties having reported internal flooding are located on or near the primary flow paths of the local sub-catchments.

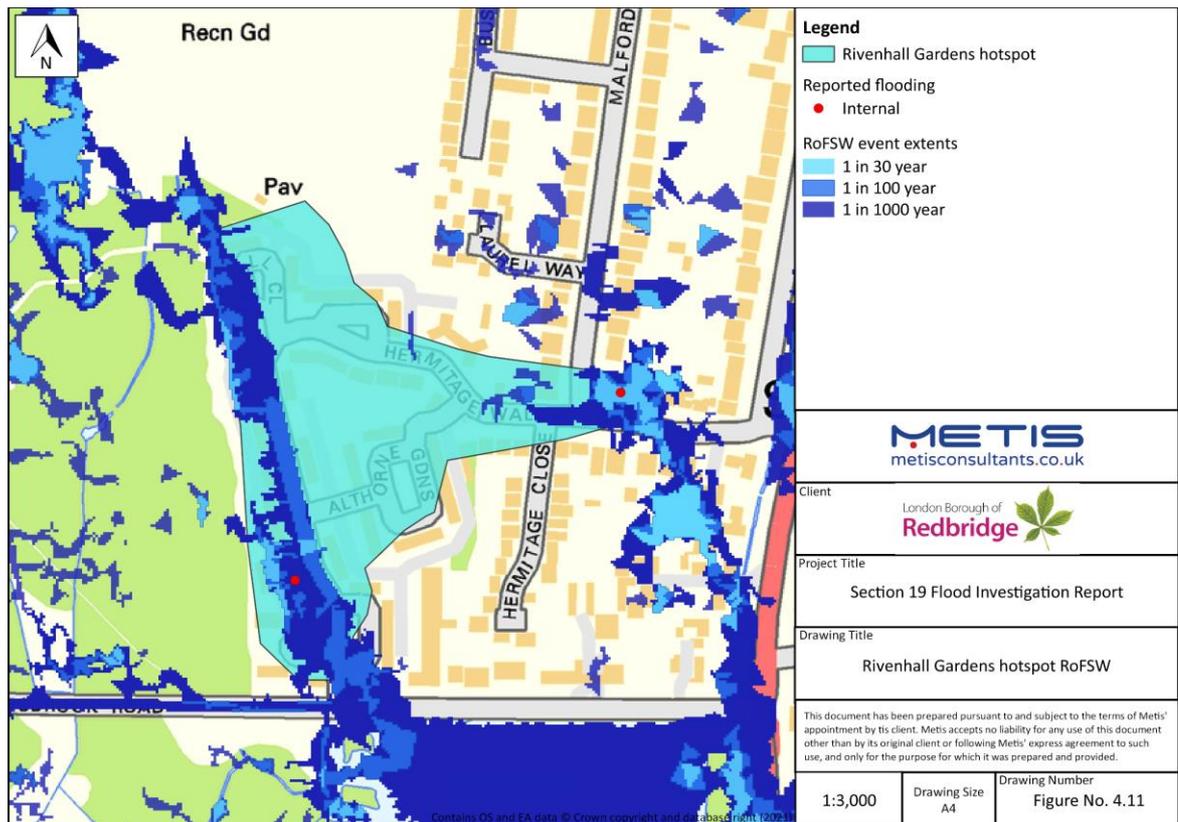
Figure 4.11: Rivenhall Gardens hotspot RoFSW

A review of the EA's RoFSW data (*Figure 4.11*) shows that both the property on Hermitage Walk and the property at the back of Rivenhall Gardens are at risk of flooding in the 1 in 30 year, 1 in 100 year and 1 in 1000 year rainfall events, with predicted depths ranging between 0.15m and 0.60m. Therefore, the Rivenhall Gardens hotspot is at high risk of surface water flooding.

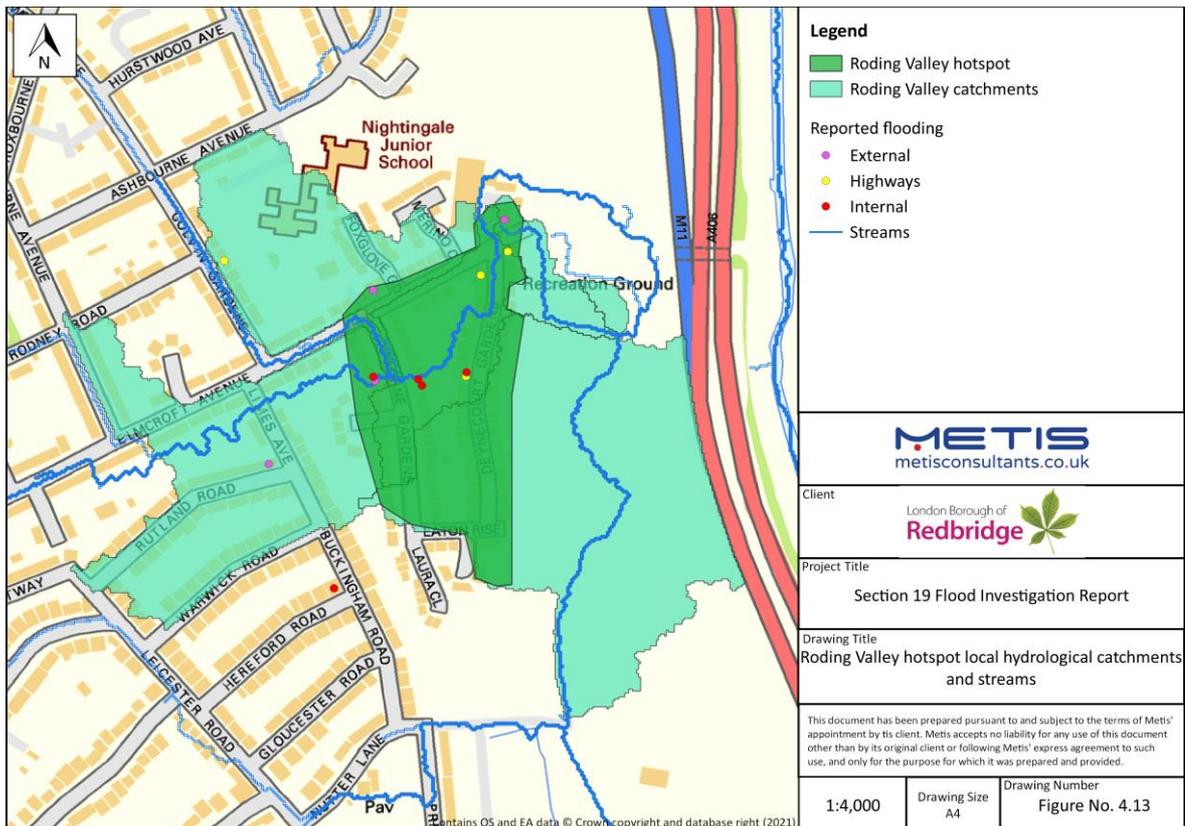
Figure 4.13: Roding Valley hotspot local hydrological catchment and stream

LiDAR data shows that the internally flooded properties reported in Lorne Gardens lie near in a topographical low point in the hotspot and surrounding area. The properties having reported internal flooding in Lorne Gardens are located on the overland flow path of the local sub-catchments. Surface water that falls within these catchments will naturally drain past these properties until reaching Deynecourt Gardens and flowing north until Elmcroft Avenue and flowing into the Recreation Ground. The locations of all the flooding reported in the hotspot lie in close proximity to the primary flow paths.

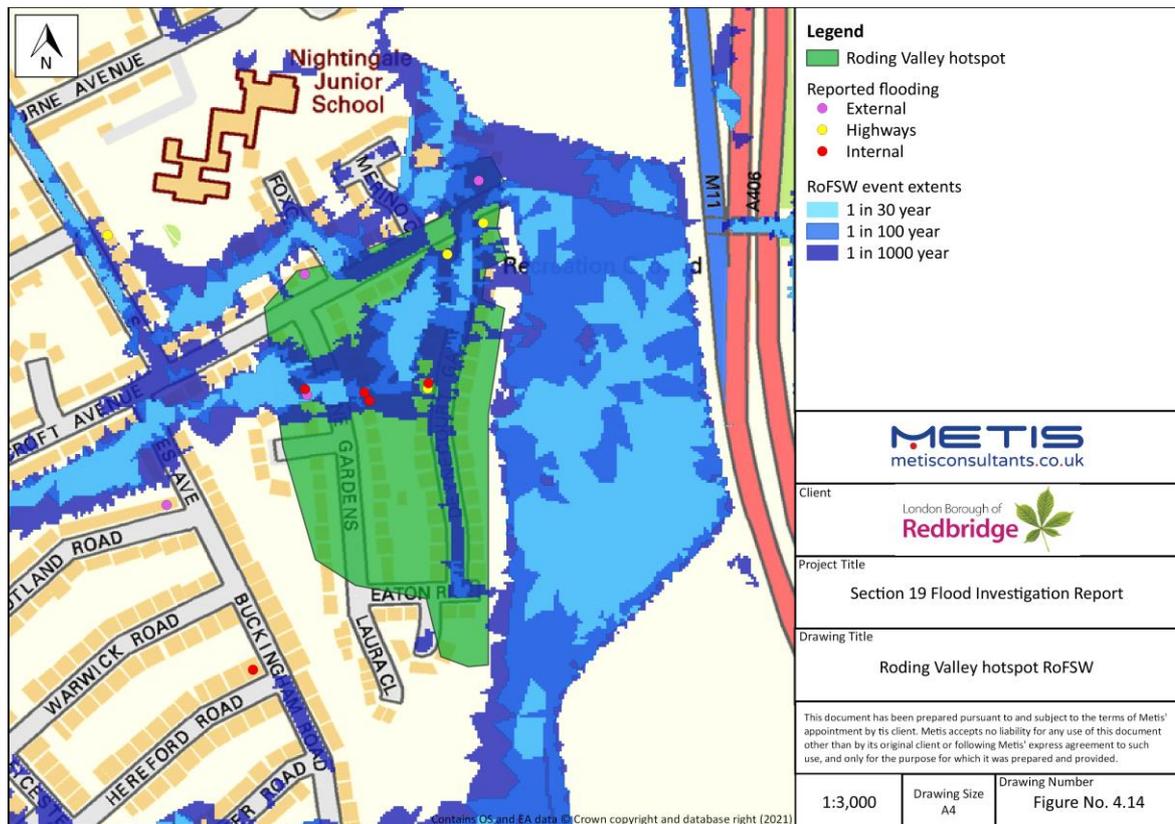
Figure 4.14: Roding Valley hotspot RoFSW

A review of the EA's RoFSW data (Figure 4.14) shows that surface water is predicted to flow in a north-easterly direction across Lorne Gardens and Deynecourt Gardens before reaching the Recreation Grounds and allotments. Surface water accumulates between the properties in Lorne Gardens and Deynecourt Gardens, at the intersection with Foxtan Gardens, and in the Recreation Grounds and allotments. The properties having reported flooding in Lorne Gardens are predicted to be at risk of flooding from the 1 in 30 year, 1 in 100 year and 1 in 1000 year, with predicted depths ranging between 0.15m and 1.2m. Deynecourt Gardens is predicted to be at risk of flooding from the 1 in 1000 year event, with some section predicted to be at risk of flooding from the 1 in 30 year and 1 in 100 year event, with predicted depths ranging between 0.15m and 1.2m. The largest depths are predicted in the gardens of the properties on Deynecourt Gardens. Therefore, the hotspot is at high risk of surface water flooding.

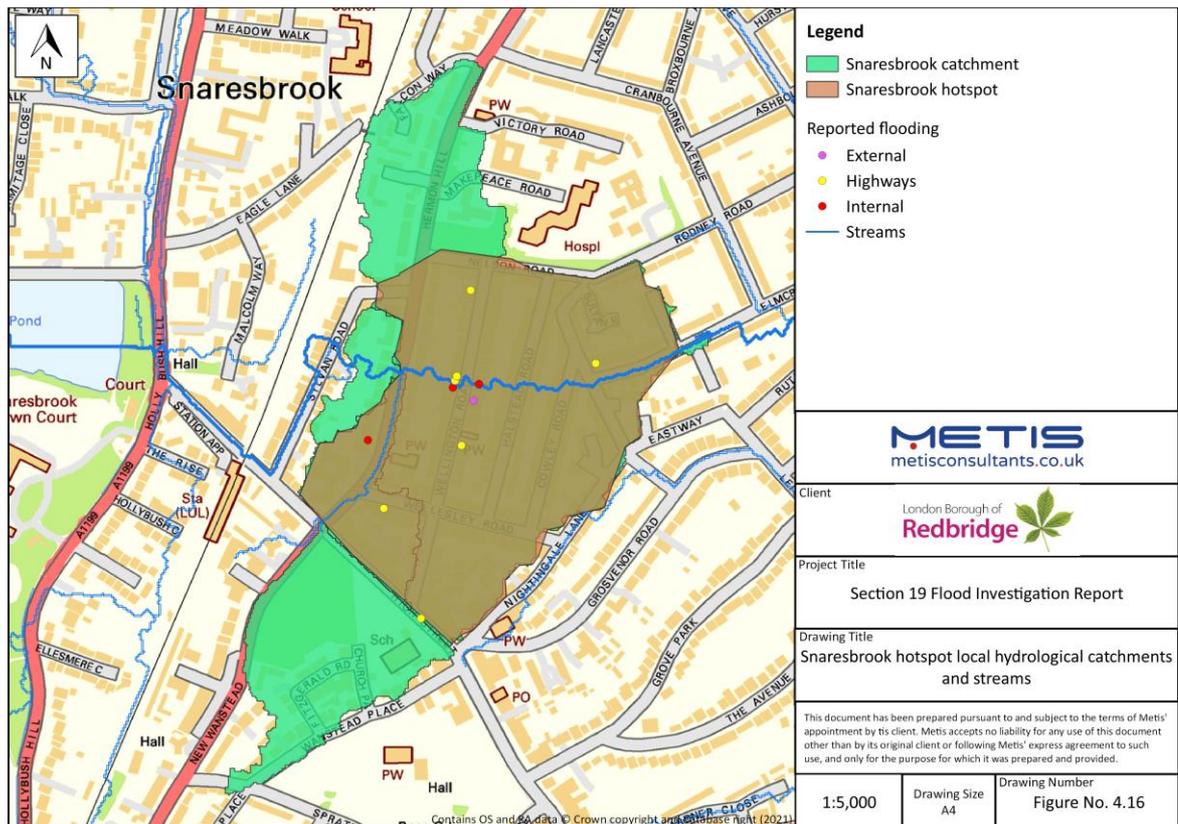
Figure 4.16: Snaresbrook hotspot local hydrological catchment and stream

A watershed analysis of the area using GIS provided several hydrological sub-catchments along with the primary flow paths (referred to as 'Streams' in Figure 4.16). The properties having reported internal flooding in Wellington Road are located on the primary flow path of the local sub-catchments. Surface water that falls within these catchments will naturally drain past these properties and flow in an easterly direction until reaching Elmcroft Avenue. The internal flooding reported in Hermon Hill also lies near a primary flow path.

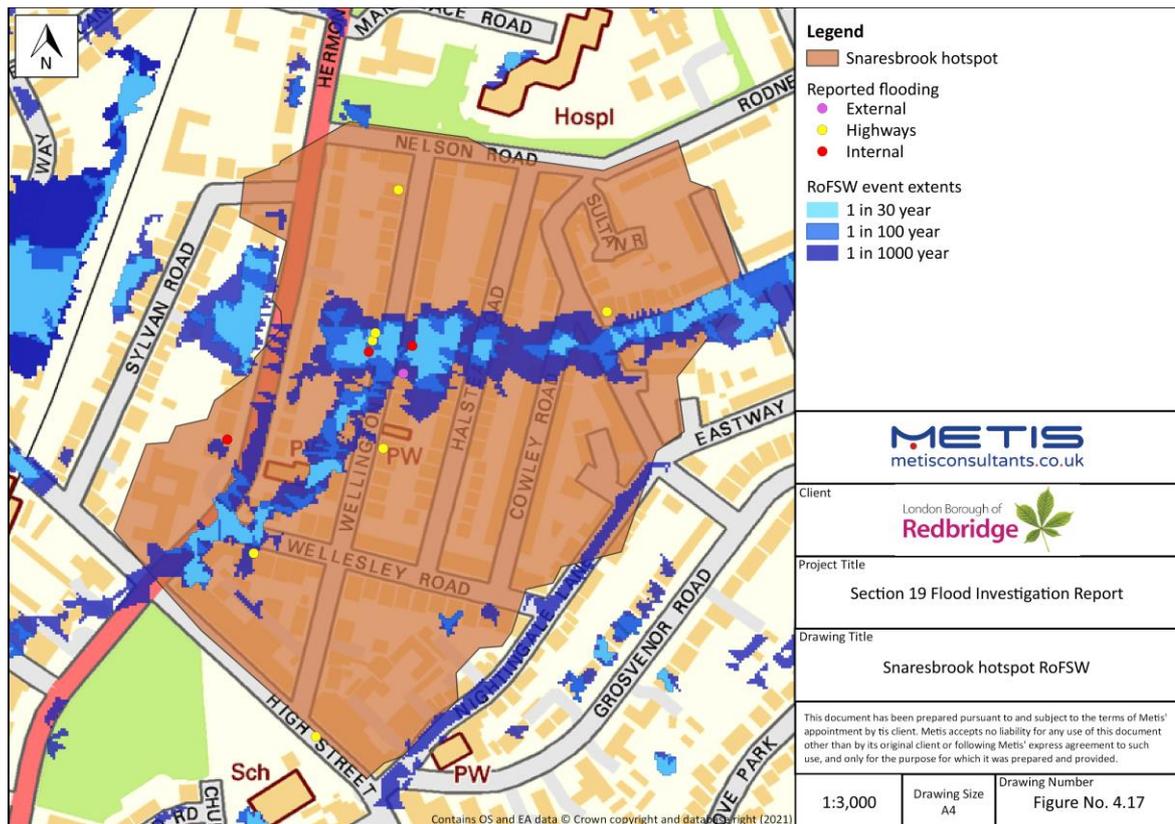
Figure 4.17: Snaresbrook hotspot RoFSW

A review of the EA's RoFSW data (*Figure 4.17*) shows that surface water is predicted to flow in an easterly direction across Wellington Road, Halstead Road, and Cowley Road. Surface water also accumulates at the junction between Hermon Hill and Wellesley Road. The properties that have reported flooding in Wellington Road are at a predicted risk of flooding from the 1 in 30 year, 1 in 100 year and 1 in 1000 year rainfall events, with predicted depths ranging between 0.15m and 0.6m. The property on Hermon Hill is at a predicted risk of flooding from the 1 in 1000 year rainfall event with predicted depths ranging between 0.3m and 0.9m. Therefore, the hotspot is at high risk of surface water flooding.

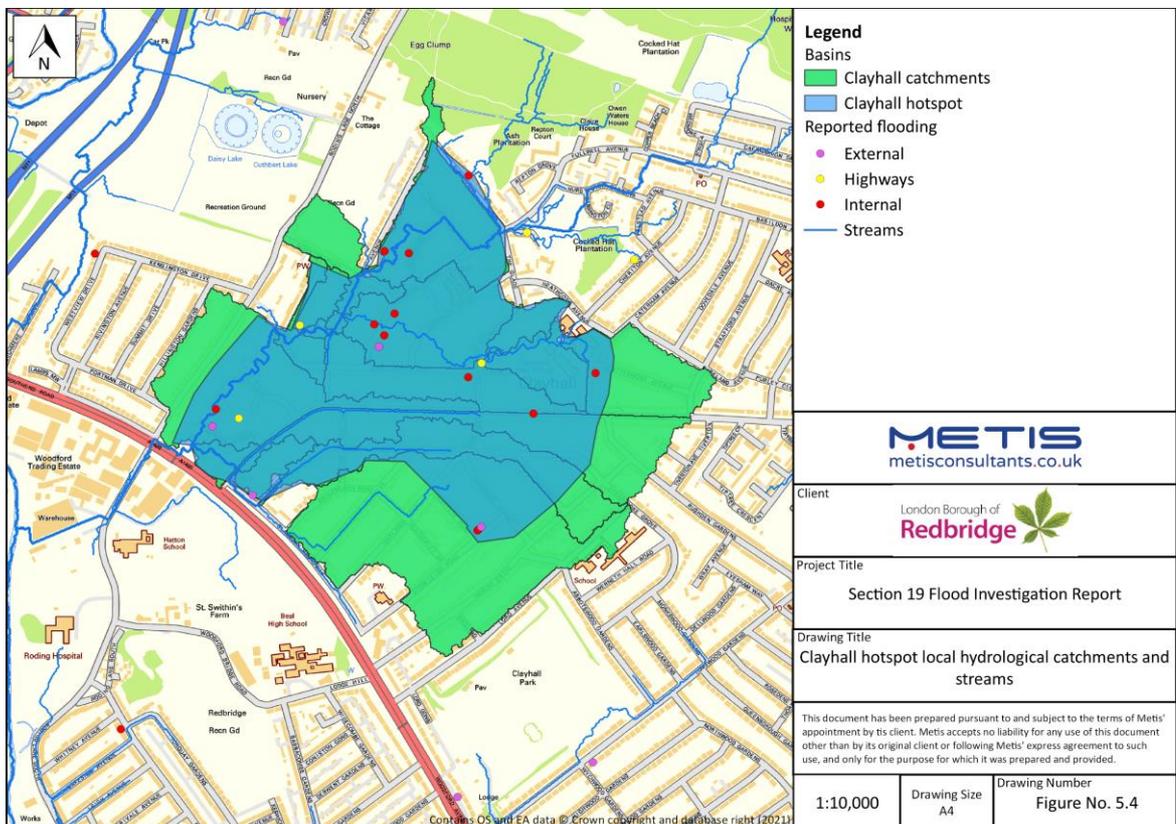
Figure 5.4: Clayhall hotspot local hydrological catchment and stream

All the reported properties with internal flooding within the hotspot lie on or in close proximity to the primary flow paths of the local sub-catchments. The flow paths from The Glade, Atherton Road and neighbouring roads merge before reaching Peel Place.

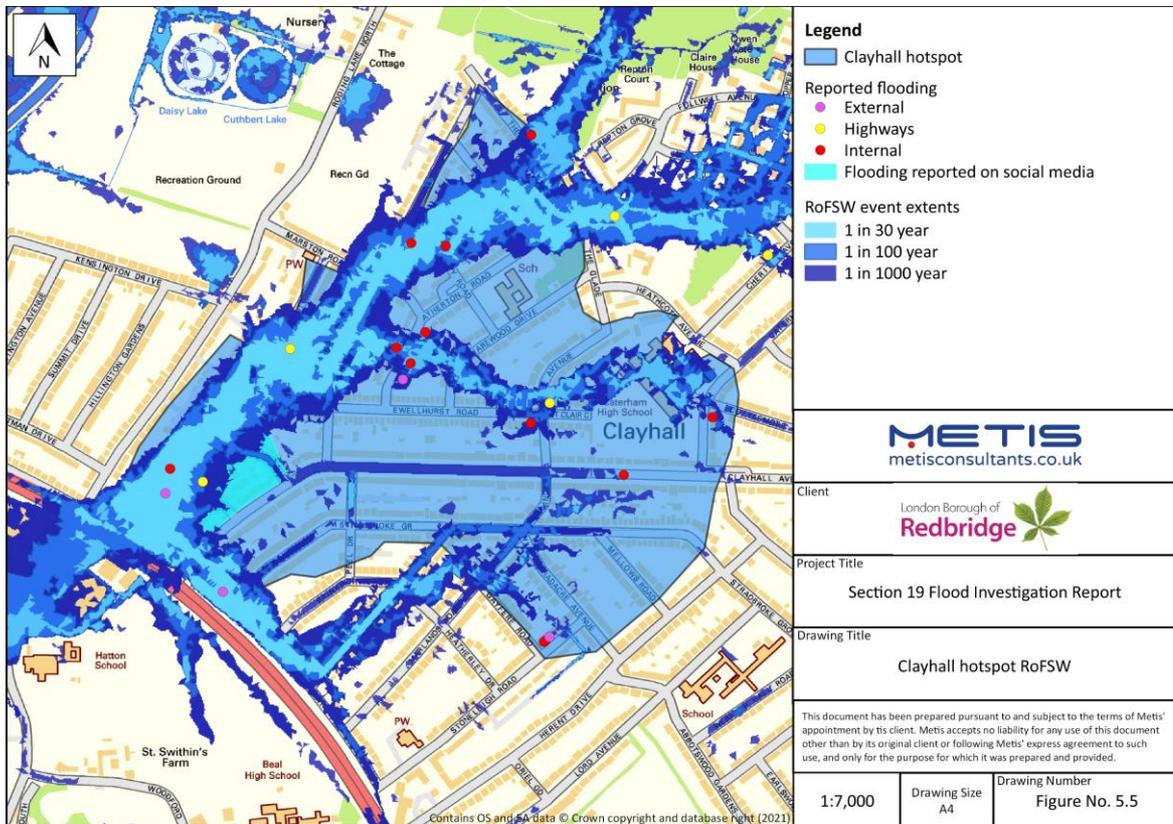
Figure 5.5: Clayhall hotspot RoFSW

depth of flooding ranges from 0.15m to 0.9m. Therefore, the Clayhall hotspot and surrounding area is at high risk of surface water flooding.

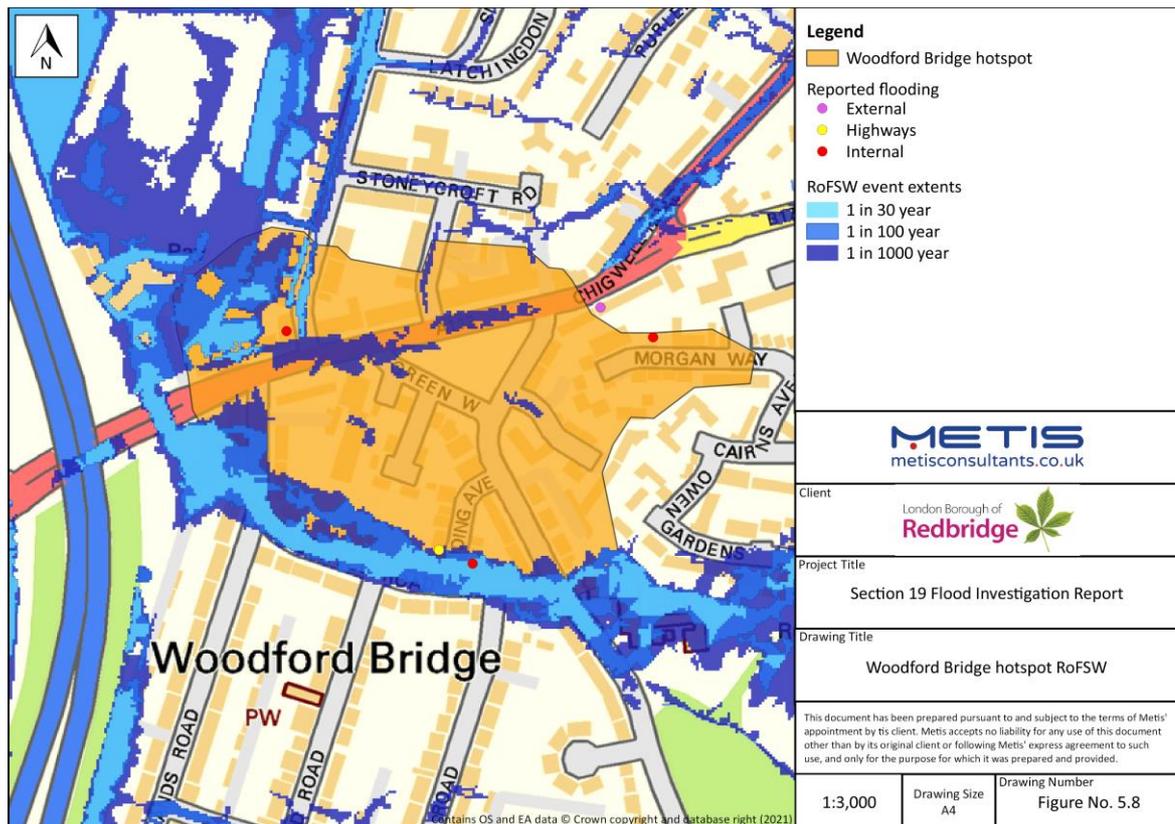
Figure 5.8: Woodford Bridge hotspot RoFSW

LiDAR data shows that the flooded properties in Waltham Road and Roding Avenue lie on topographical low points within the hotspot. This means that surface water within the defined catchment will naturally flow towards the area.

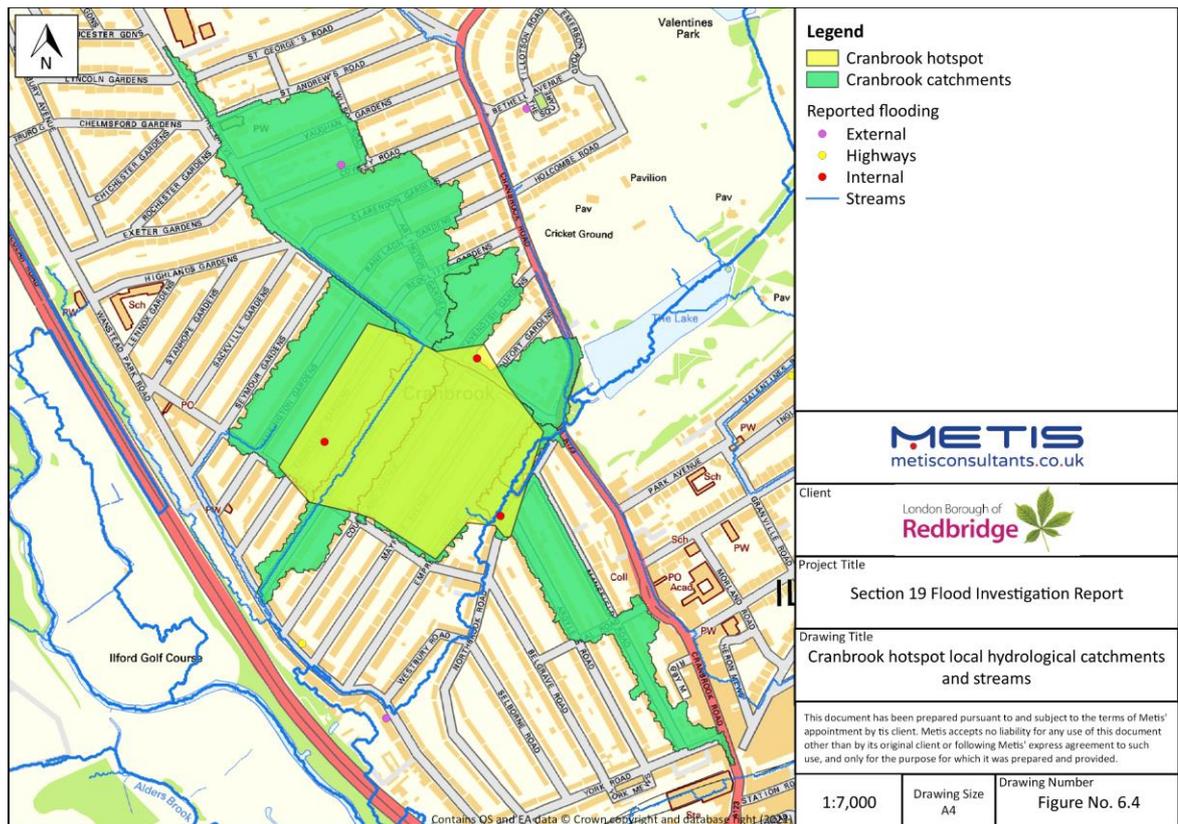
Figure 6.4: Cranbrook hotspot local hydrological catchment and stream

The property on Northbrook Road lies on the primary flow path of the local sub-catchment.

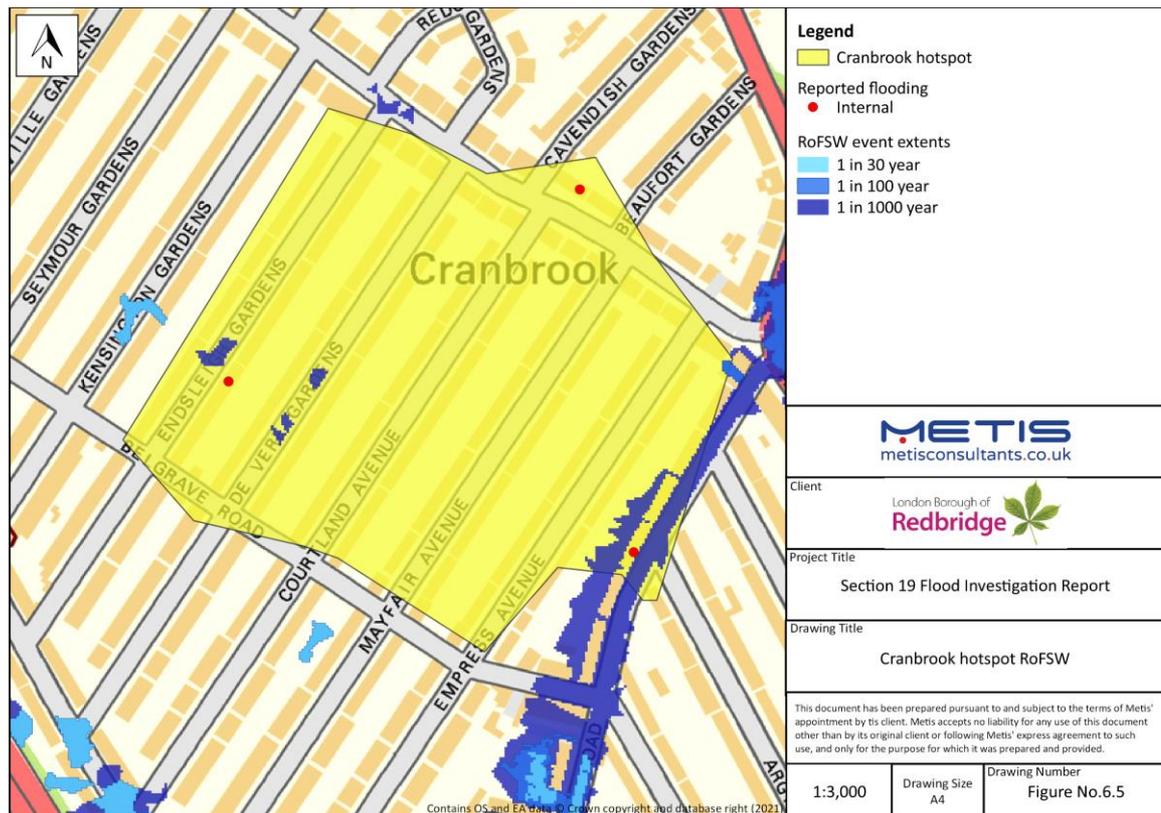
Figure 6.5: Cranbrook hotspot RoFSW

A review of the EA's RoFSW data (*Figure 6.5*) shows that the property in Northbrook Road falls within the flooding extent of the 1 in 1000 year rainfall event, with predicted depths ranging between 0.15m and 0.90m. The property in Endsleigh Gardens falls in close proximity to the 1 in 1000 year rainfall event flooding extent, with predicted depths ranging between 0.15m and 0.30m.

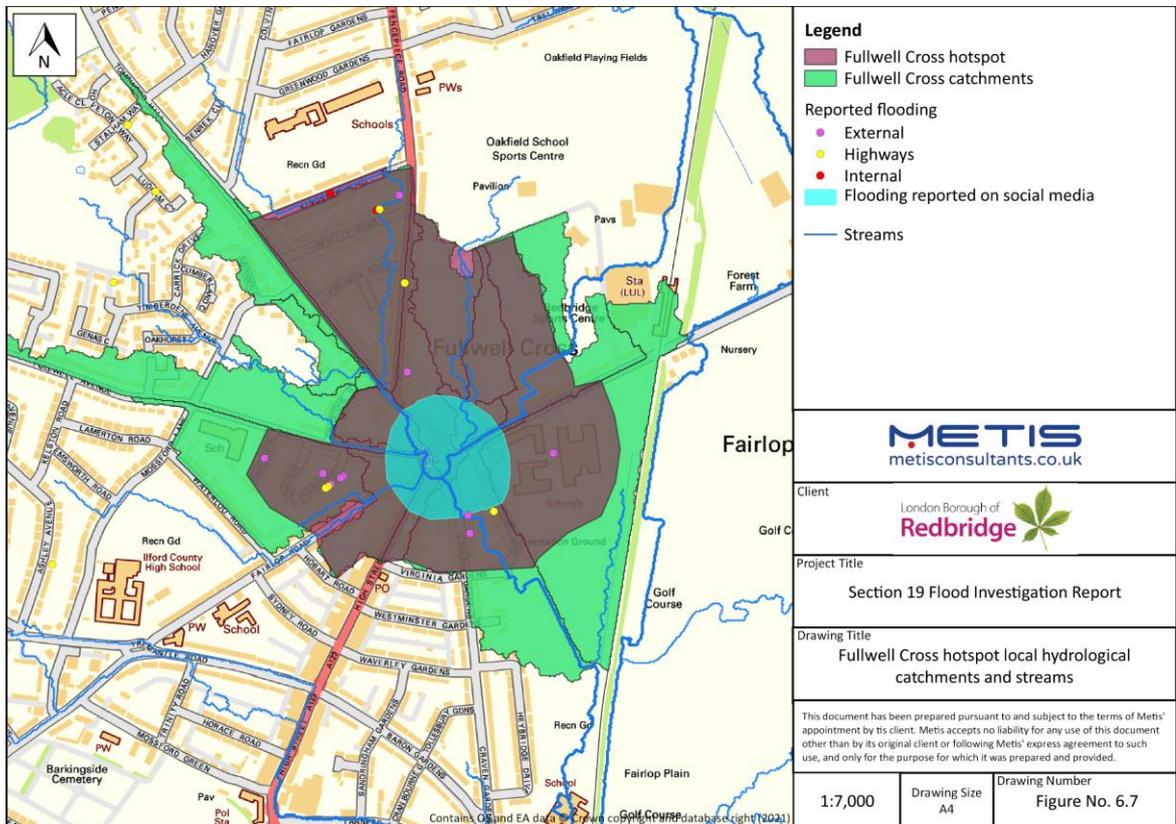
Figure 6.7: Fulwell Cross hotspot local hydrological catchment and stream

merging and flowing in a southerly direction. The properties in Kingsley Road and Neville Road are located on the overland flow paths of the local sub-catchments.

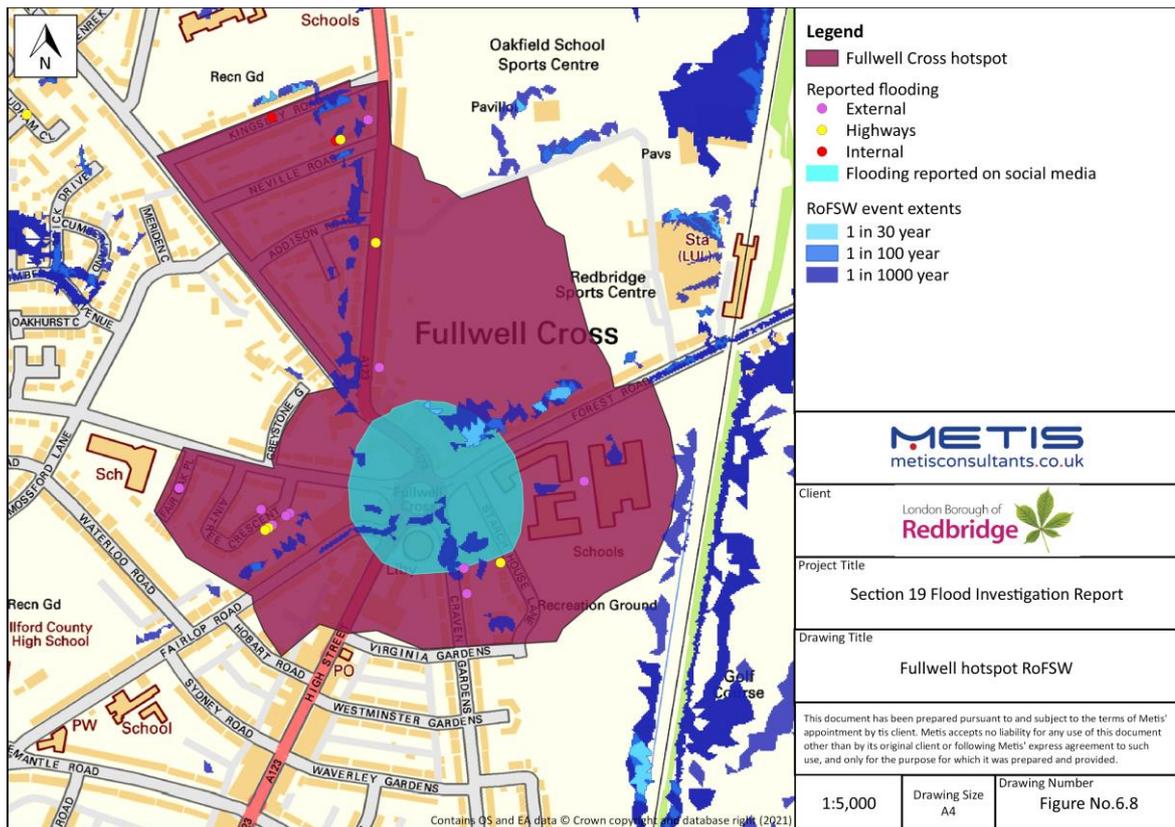
Figure 6.8: Fulwell Cross hotspot RoFSW

A review of the EA's RoFSW data (*Figure 6.8*) shows that some properties in Kingsley Road are at a predicted risk of flooding from the 1 in 30 year, the 1 in 100 year and the 1 in 1000 year rainfall events, with depths ranging between 0.15m and 0.60m. The properties that reported flooding in Neville Road and Craven Gardens are at risk of flooding from the 1 in 1000 year rainfall event and the predicted depths ranging between 0.15m and 0.30m. The hotspot is at high risk of flooding from surface water.
