Consultancy Report

Pitch relocation and improvement feasibility report – London Borough of Redbridge

January 2017

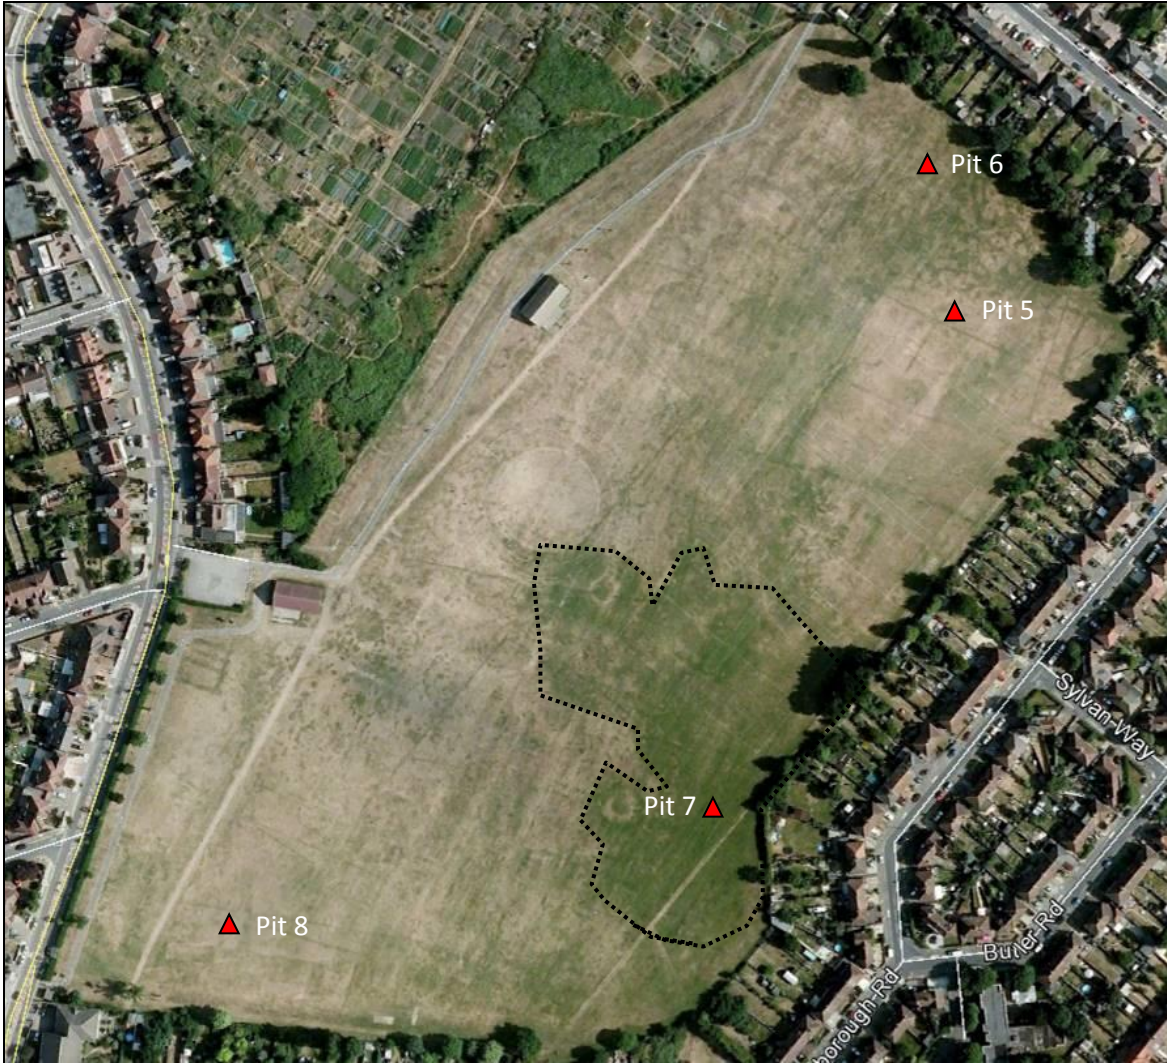
Figure 1. Goodmayes Park Extension and location of trial pits 5-8 (image taken June 2010). Approximate boundary between deeper and shallower soils marked by hashed line with the greener grass denoting the deeper soils.

The differences in soil type are clearly apparent on Figure 1 with the more speckled soils around Pit 6 reflecting small variations in surface levels where shallow depressions hold more water than the higher areas around them. Though the differences in height are small (no more than 200 – 300 mm) this is enough to catch and hold more water relative to the surroundings, thus producing a greener sward in dry periods.

The distinct linear feature running alongside the footpath that flows the western edge of the park is a culverted watercourse that flows from the lakes in Goodmayes Parks to the north, under this part of the site and off to the south. The reinstatement works over the culvert have been poorly carried out with this strip still visible over 16 years after the works were completed. This is due to the soil over the culvert being too shallow and sitting too wet in winter and too dry in summer. Ideally this should be improved if the culvert is to be reinstated properly. Currently the main car park is located off Goodmayes Lane and though sufficient for the current use of the site would need to be expanded significantly if the site is to be redeveloped.

No previous drainage was evident on the site, though the aerial photograph in Figure 1 does show a number of linear features running both east to west over the site and north to south. A pit was dug over one of these features but no evidence of a land drain was encountered. It is possible that some drains have been installed with ad-hoc additional drains linked to these main drains to relieve water from difficult areas. These may simply have been stone filled trenches linking to the gravel or may have been piped. Aerial photograph evidence suggests that any such drains are likely to be old and may no longer be functioning effectively.

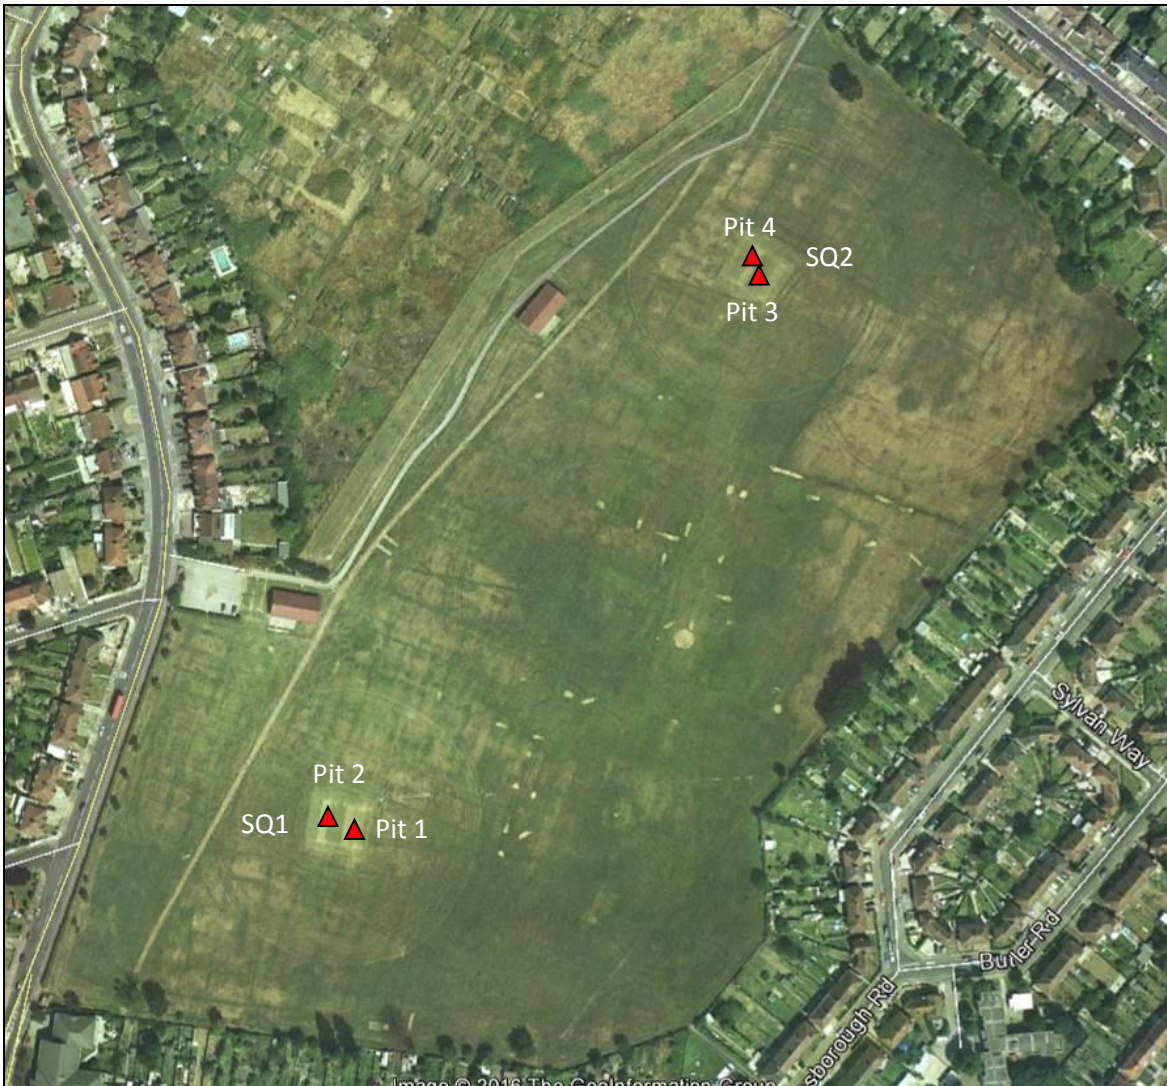
Figure 2. Goodmayes Park Extension and location of the two old cricket squares since abandoned and the shallow trial pits excavated in each square (image taken 2005).

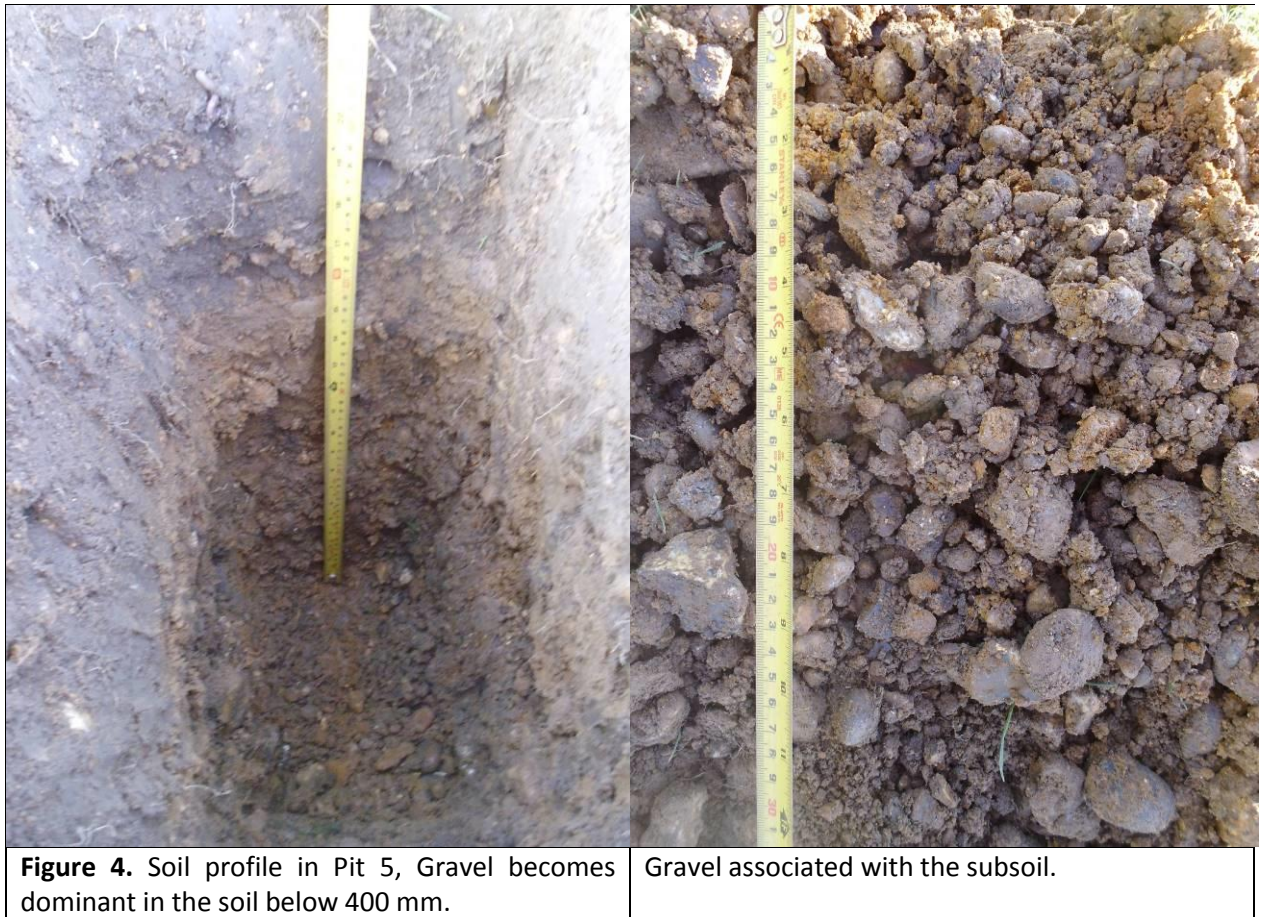
Pit 5 was located to the north east of the site (Figure 4) and was located in an area indicated by the aerial photograph to be drought prone and thus likely to be more influenced by gravel. The upper 100 mm of soil was relatively stone-free. At the surface there was a 40 mm deep layer of thatch, a layer of organic matter formed from the gradual decay of roots and leaf matter and forms in grasslands over time. Normally in sportsturf situations thatch is managed by regular removal operations such as scarification, verticutting, harrowing and by top-dressing. As thatch builds up it makes surfaces softer and holds water at the surface which can lead to cancellations even if the underlying soil is dry. It can also produce surfaces which cut up and wear quickly under play creating bare patches of soil which allow weed ingress further reducing soil quality. Between 100 and 250 mm depth the soil was moderately stony, with Flint and Chert stones to 60 mm and a moderate gravel content of around 20% at 250 mm. The topsoil was wet at the surface but became drier by 80 mm but remained friable. The soil had a SANDY LOAM texture.

Between 250 and 400 the soil was very stony with a gravel content of between 40 and 50% with stones to 100mm diameter. The soil became wetter with depth, becoming plastic at around 400 mm and had a SILT LOAM texture.

Between 400 mm and the base of the pit at 660 mm the soil was gravel dominated with around 70% of the soil mass comprised of gravels of a range of sizes. The gravel was not cemented however and there was no evidence of groundwater despite the soil remaining wet and plastic. The soil was, however, slightly mottled at this depth suggesting that the soil is anaerobic due to waterlogging at some points in a year and this may be due to proximity to a water table. The subsoil was a SANDY SILT LOAM.

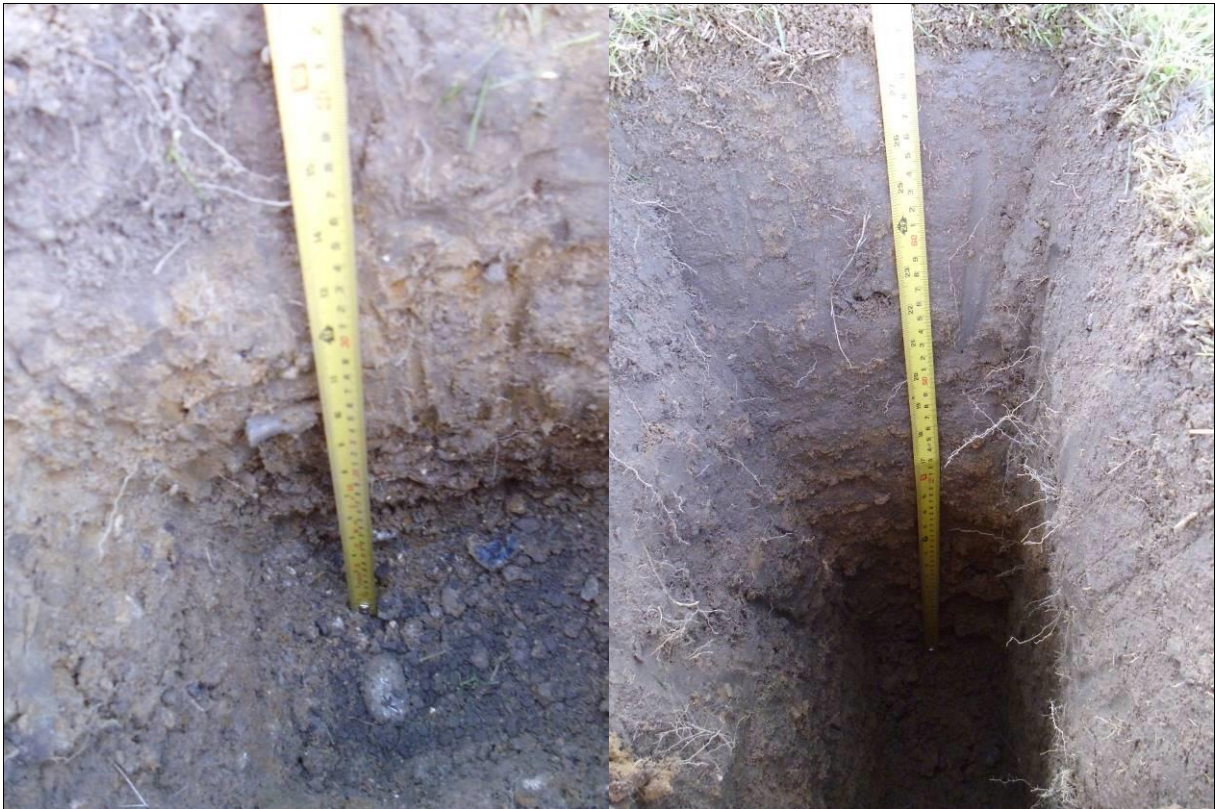
Pit 6 (Figure 5) was located towards the north eastern boundary of the site in an area where the aerial photograph revealed a mixed pattern of droughty areas and less droughty areas. The pit was dug in the base of a wide, shallow channel (approximately 100 mm lower than the surrounding area over a 3m width).

The topsoil was some 200 mm deep, being largely stone free in the upper 130 – 140 mm of the profile but with gravel increasing with depth. The soil was a SANDY LOAM texture, was dry below the upper 60 mm and was friable. The surface once again had a distinct organic thatchy layer of around 40 mm. As the topsoil in this pit was shallower than in Pit 5, the difference in droughtiness shown in the aerial photograph was most likely due to elevation with lower lying areas receiving more water from the surrounding higher areas and thus being less droughty.

The lower topsoil, between 200 and 330 mm was stonier but remained a SANDY LOAM texture. Stones to 50 mm diameter were present with a total stone content of around 20%. The soil was slightly mottled at 330 mm but not wet, and remained friable.

Between 330 mm and 570 mm when the pit was finished, the soil become much stonier with a stone content of around 70% within a SANDY SILT LOAM matrix. The soil was wetter towards the base of the pit and plastic, but was not saturated. There was no sign of groundwater entering the pit at any point.

Pit 7 (Figure 6) was located close to the southern boundary of the site in an area which was distinctly greener on the aerial photograph indicating much less droughty conditions. In contrast to the previous pits, the topsoil extended to a depth of 300 mm and remained largely stone free through this depth, with a stone content of less than 5%, though some stones were up to 75 mm

in diameter. The topsoil was a SANDY SILT LOAM in texture, was dry and friable with no signs of mottling. A 40 mm thatch layer was again evident on the surface.

Figure 5. Soil profile in Pit 6.

Figure 6. Soil profile in Pit 7.

The lower topsoil extended to a depth of 550 mm and was a SANDY LOAM, again with very few stones. Though becoming slightly wetter with depth the soil remained friable to a depth of 550 mm. Between 550 mm and 750 mm the subsoil became clearly mottled suggesting this layer is occasionally waterlogged at times in winter. Though damper than the layers above, the soil remained friable. Stone content was again less than 5% but increased at around 725 mm with more gravel becoming apparent. At 750 mm the gravel was encountered with stone content increasing to over 70% by a depth of 780 mm when the pit was finished. The difference in grass droughtiness in this area as indicated by the aerial photograph is due to the much greater depth of stone-free topsoil in this location with the soil having a great available water capacity and roots being able to penetrate freely to depth in the soil.

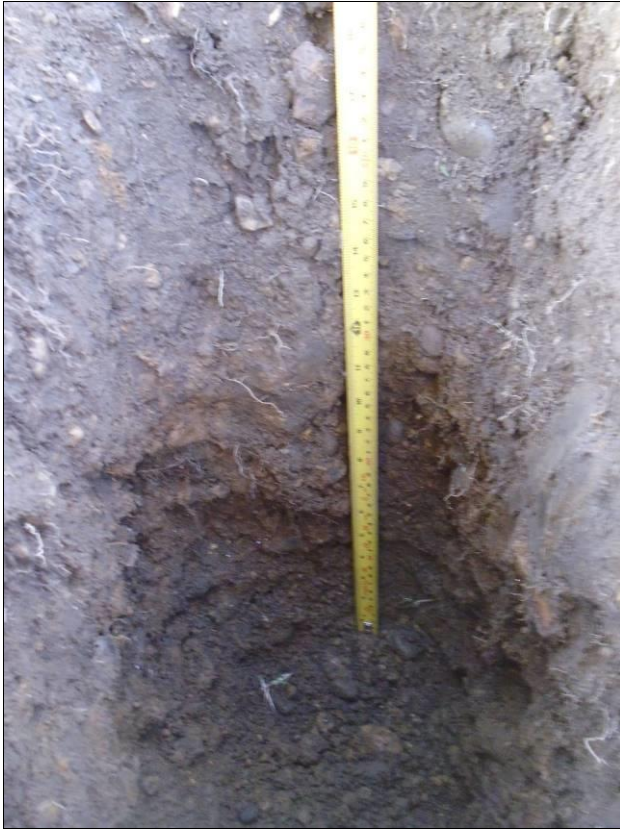
Pit 8 (Figure 7) was excavated towards the south western corner of the site in a very droughty area as indicated by the aerial photograph. As expected, this soil had a shallower topsoil with the gravel being encountered closer to the surface as was the case with Pits 5 and 6. The upper 60 mm of the soil was relatively stone free but between 60 and 110 mm depth gravel was encountered. The topsoil was a SANDY LOAM and in this location the organic thatchy layer was a little thicker at around 50 mm.

The lower topsoil between 110 and 360 mm was much stonier with a stone content estimated to be around 40 – 50%. The soil was friable and not mottled.

Between 360 mm and the base of the pit at 600 mm the soil was very stony with a stone content of around 70%. The soil was damp but not saturated and was slightly mottled at 600 mm.

Figure 7. Soil profile in Pit 8.

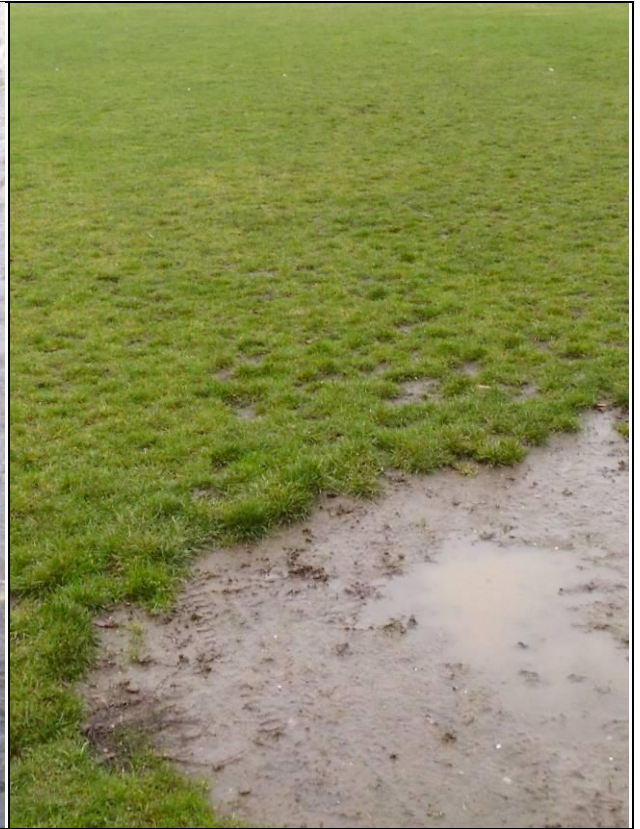
Figure 8. Water holding in a worn depression.

Where the gravel is close to the surface the soil drainage rates will be moderate or good, but this will be highly dependent on compaction management and maintaining a grassed surface. Where such management does not take place, water can gather in depressions as was seen in a worn area of the site during the visit (Figure 8). This underlines the need for good ongoing management should pitches be re-located to this site and is something that must be considered as part of the sustainability plan for this site. When managed well, new pitches should be able to support at least 4 hours use per week as long as they are maintained effectively. Where the topsoil is deeper not only should turf quality be better but drainage should also remain good as long as pitches are well managed. If very high quality pitches are required then some drainage may be needed.

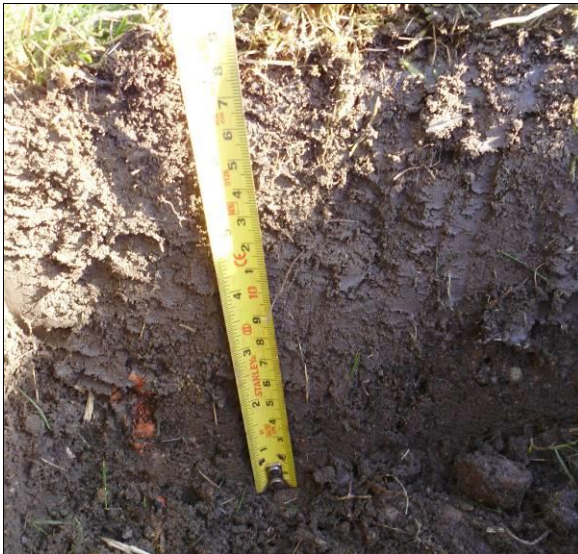
Figure 9. Pit 1.

Pits 1 and 2 were taken from the old square located in the south west of the site. Both pits were shallow, extending only through the topsoil (Figures 9 and 10). Both pits revealed a thatch layer varying between 40 and 50 mm which has developed over time. The underlying soil was stone free to a depth of between 120 and 125 mm when gravel was encountered. It is most likely that this gravel is the same as that occurring over the majority of the playing field rather than being a specific stone base as it was very similar in size, shape and composition to the gravel noted elsewhere. The sward on the cricket squares had long since reverted to the general amenity sward and was a mix of Annual Meadow Grass, Perennial Ryegrass, Daisy, Plantain, Clover and other broad-leafed weeds.

The soil texture results indicate that the soils were SANDY CLAY LOAMS on this square which is not ideal for cricket (Table 4). To reinstate good quality pitches on this area a minimum of the upper 100 mm of grass and soil would need to be stripped, the sub-base levelled and firmed and the surface made up with proprietary cricket loam for re-seeding and establishment. Once re-constructed the square would require 12 months of ongoing management prior to use.
