# Appendix A: Local Heritage List Buildings and Structures

London Borough of  
Redbridge

August 2023

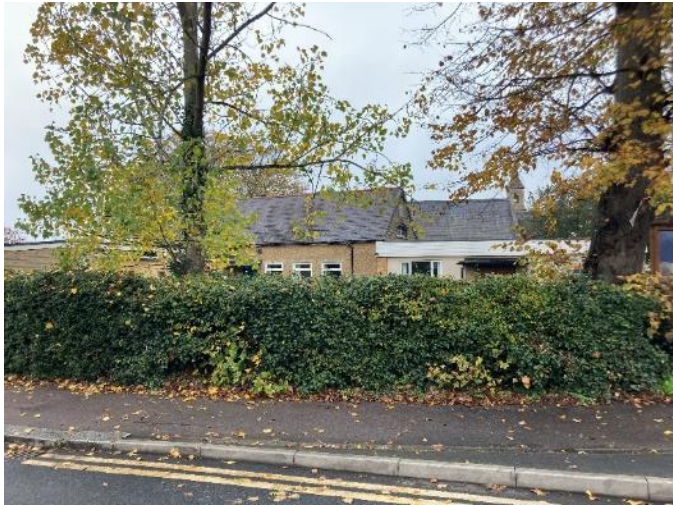
7. Description				
<p>Originally constructed in the mid-nineteenth century, single storey in scale constructed from stock brick. The property has large, single-storey flat roof extensions to the north, east and west elevations which date from the mid-late twentieth century. These extensions have severely compromised the architectural interest of the building and seriously harmed its significance. Only the west gable end and part of the east gable of the historic building can now be seen.</p>

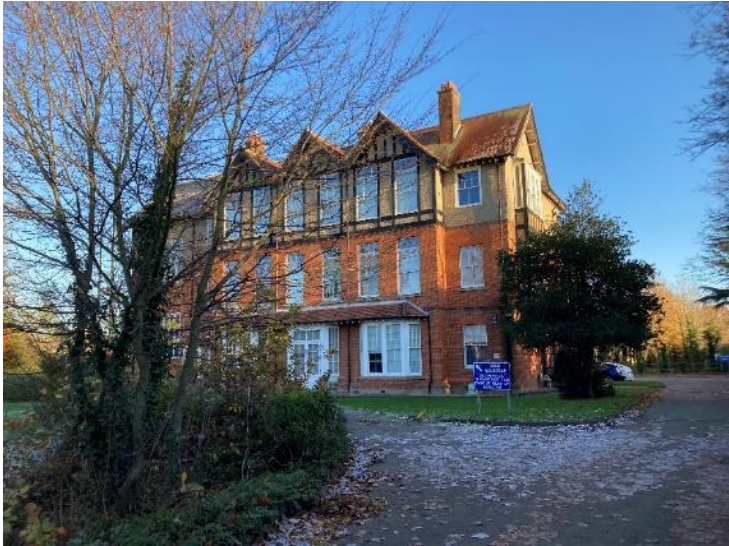
7. Description
1903 three storey building, Pevsner states that the building was the 'entrance house' to the Barnado's Girls' Village. Arts and Craft style. Constructed of red brick with pebble dash render at second floor. Six bays. Three central bays have bay windows at ground floor level with hipped, clay tiled roof above, and at first and second floor level there are 6 over 2 sash windows (six on each floor) with small casement windows above. Three gables sit above the sash windows with decorative timber framed patterns. Clay tiled roof with three chimney stacks.

15. Archaeological Value							
Intrinsic though limited archaeological value due to its surviving fabric.							
16. Overall Condition							
Good	x	Fair		Poor		Very Poor	
Unknown		Notes:	Interior not inspected

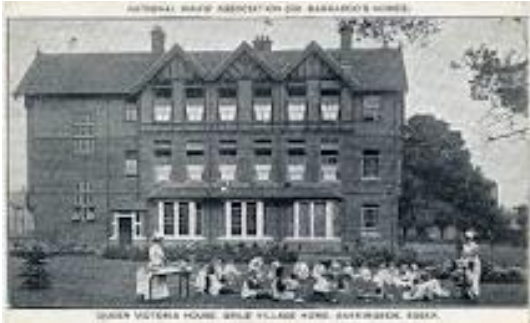
Queen Victoria House 1903

8. Age (X)							
Pre-1840		1840-1913	x	1914-1947		Post 1947	
Exact date (if known):							1903
9. Authenticity (X)							
X	A single significant phase and which is largely intact						
	A single significant phase with some alterations and/or extensions						
	A single significant phase with significant alterations and/or extensions						
	The asset is of multiple significant phases						
10. Aesthetic / Architectural Value							
An attractive Arts and Craft building, Queen Victoria House has retained its original form, with a small, single storey extension at the back being the only addition. It is an impressive building, carefully arranged and consistently detailed which once would have formed a unified group with the rest of Barnado's Girl's Village. It retains architectural value of a regional interest.

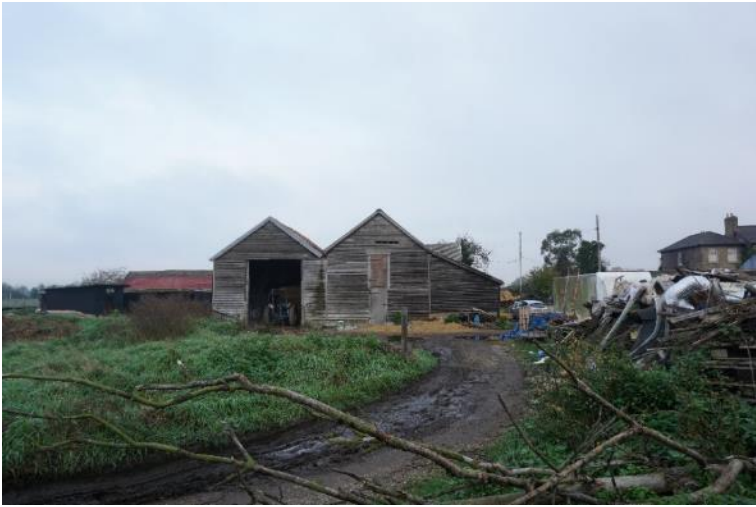
7. Description				
Large timber frame barn, possibly of eighteenth-century origins. Gable end roof form with long catslide and midstep to southern elevation. The external elevation is weatherboarded with corrugated asbestos cement roof. Outbuilding with pantile roof to east. Interior not inspected.

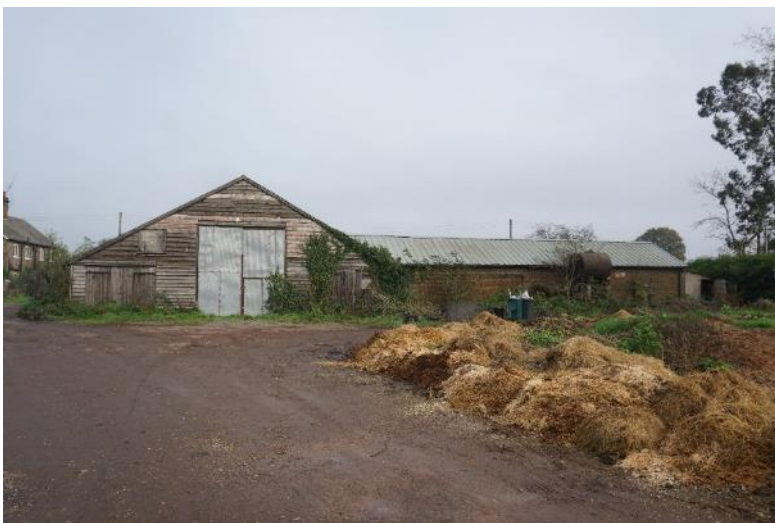
7. Description				
Built during the mid-nineteenth century. Range of barns with a U-shaped platform. Range on the east-west axis of a low gable form with wide footprint, weatherboarded. Ranges on north-south axis single storey in stock brick. Interior not inspected.

10. Aesthetic / Architectural Value							
It is notable for its appearance and detailing typical of mid-nineteenth century agricultural buildings, contributing positively to local style. The roofs have been replaced with modern materials but its character is unaffected.

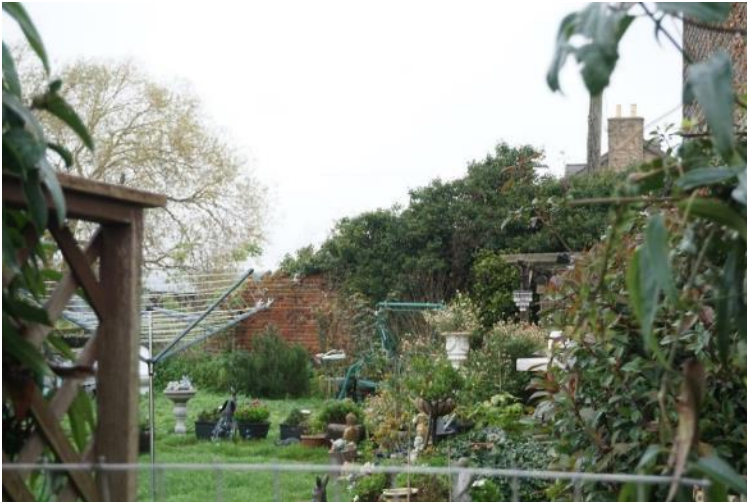
7. Description				
The garden walls at the rear of the cottages, part of Aldborough Hatch Farm formerly associated Aldborough Hall (now demolished). The walls are of red brick and approximately 2m in height.

15. Archaeological Value							
Indicative of eighteenth century building techniques and use of materials.							
16. Overall Condition							
Good		Fair		Poor	X	Very Poor	
Unknown		Notes:	The wall was recently damaged by a fallen tree and remains in a poor state of repair.				
17. Recommended for inclusion				Yes	X	No	
18. Date of assessment				20/12/22

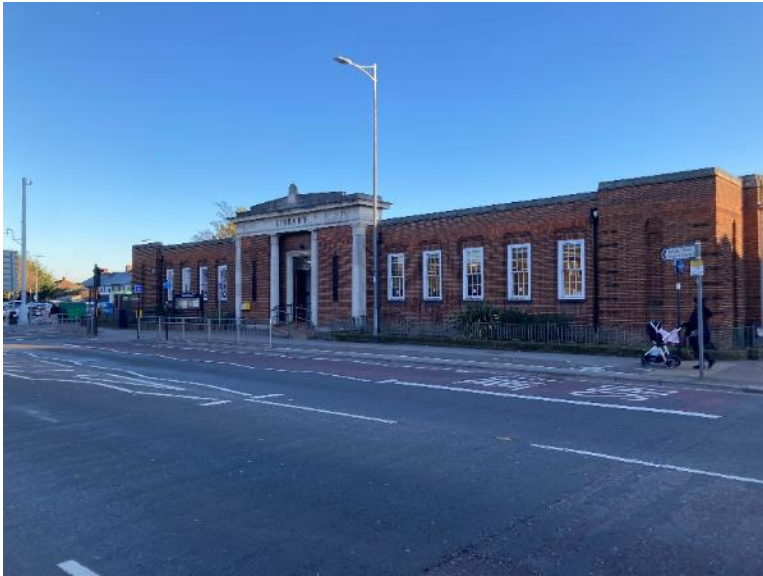
7. Description
1938 designed by L.E.J Reynolds, Borough Surveyor. Library. Single storey building, steel frame with red brick façade. At the centre of the front elevation is the entrance with Corinthian type columns either side, constructed of Bath stone, with architrave above and pediment a top. Five six over six sash windows either side. Impressive side entrance on west side

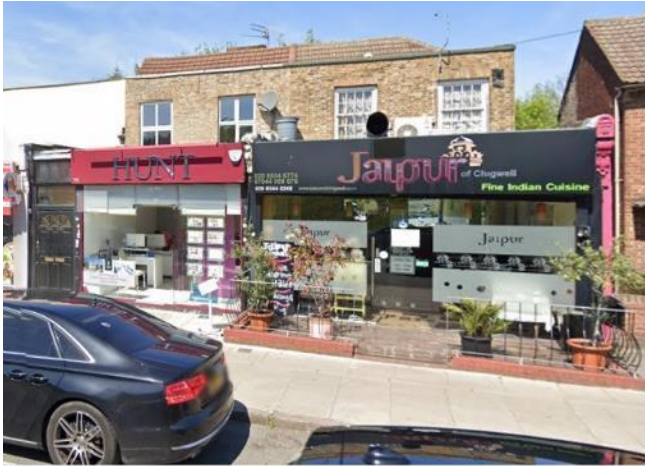
7. Description
Late eighteenth century. Two storeys at front in buff stocks. Double hung sash windows with glazing bars. Three storeys at rear. Both concealed by bungalow shop additions at the front.

16. Overall Condition							
Good		Fair		Poor	X	Very Poor	
Unknown		Notes:	Interior inspection not possible. This would be required to assess whether much historic fabric survives				
17. Recommended for inclusion				Yes	X	No	
18. Date of assessment				09/12/2022

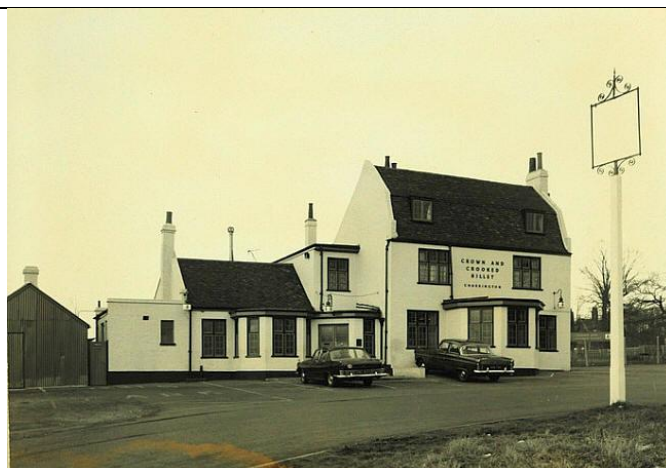
Crown and Crooked Billet Public House 1965

8. Age (X)							
Pre-1840	X	1840-1913		1914-1947		Post 1947	
							Exact date (if known):
9. Authenticity (X)							
	A single significant phase and which is largely intact						
X	A single significant phase with some alterations and/or extensions						
	A single significant phase with significant alterations and/or extensions						
	The asset is of multiple significant phases						
10. Aesthetic / Architectural Value							
An attractive, eighteenth century public house. The design presents a strong eighteenth century character, indicative of local style. The property retains its original character and most of its original features and is a good example of a once rural pub that is now within a suburban area.

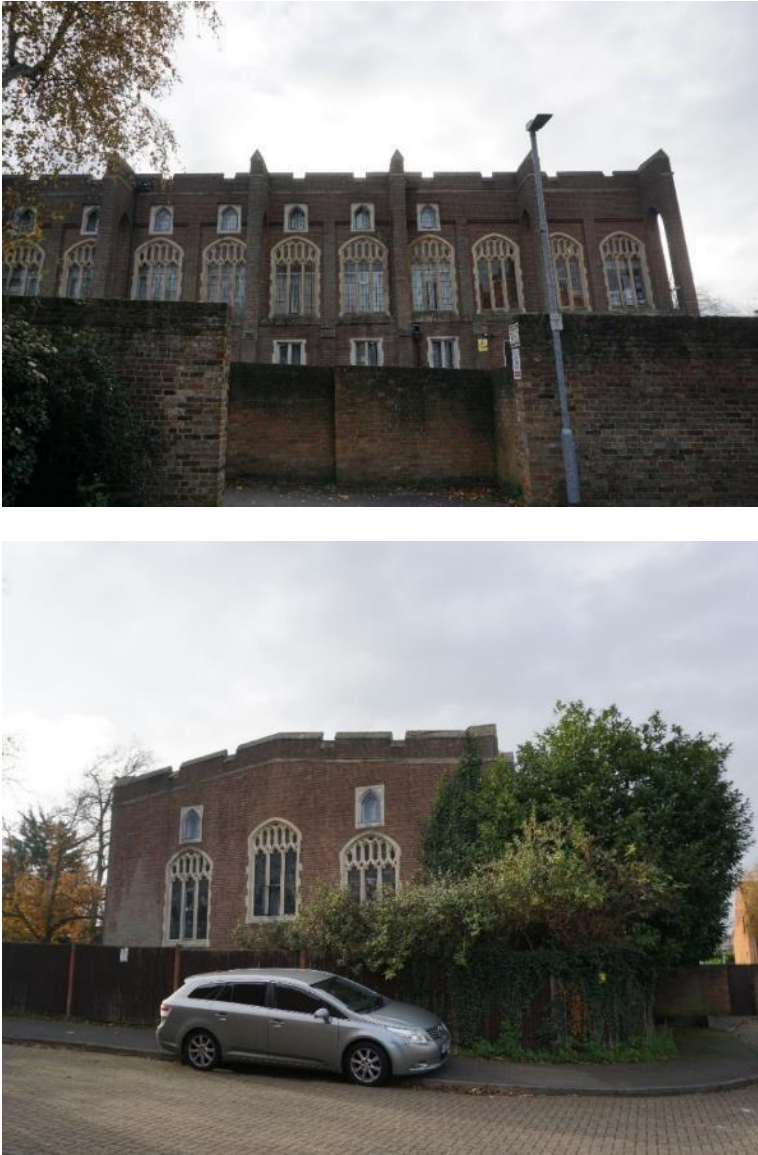
7. Description				
Former chapel, constructed in 1932 and designed by W. H. Godfrey. Constructed from red/brown brick with a simple rectangular plan. Features include stone dressing, windows with perpendicular tracery and prominent flying buttresses.

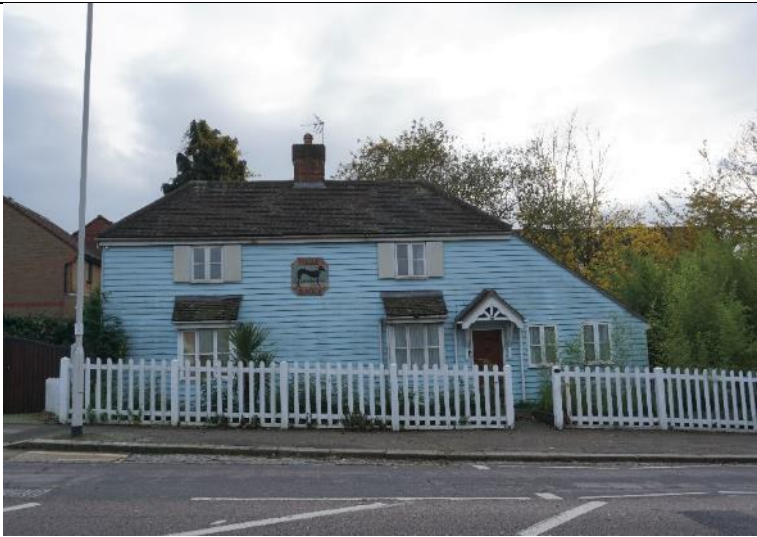
7. Description
Eighteenth century cottage, formerly a semi-detached pair now a single dwelling. Timber framed and weather boarded under a hipped tiled roof and catslide to the west. The front elevation has two small bay windows to ground floor and small casement windows to first floor. Sign centrally located reading 'The Cottages' with an image of a greyhound.

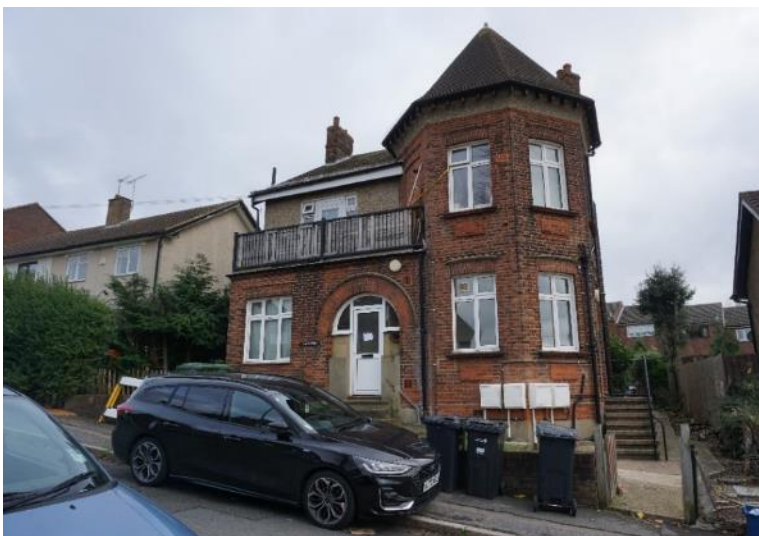
7. Description
Large Edwardian house built around 1903, constructed from redbrick. The property is two-storeys in height under a plain tiled gabled ended roof which is flanked by red brick chimneys. First floor has pebble dashed render with half timbering effect. Style displays a distinct turret element round arched entrance door, exposed rafters and balcony with metal balustrade. All of which were refinements of earlier Victorian decorative features.

10. Aesthetic / Architectural Value							
The property is typical Edwardian dwelling with attractive features such as the turret, terracotta tiles, prominent chimneys and exposed rafters. The property has been altered including replacement uPVC windows and doors, infill porch, pebble dash render and replacement roof. All of which erodes the original character of the property.

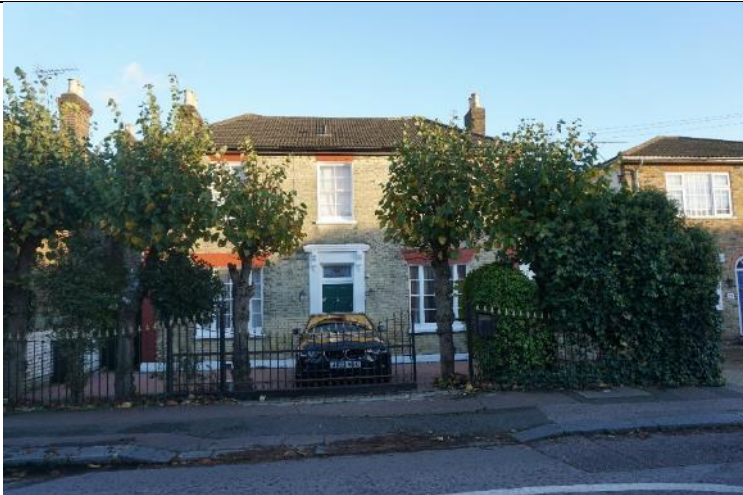
<p>Number 23 West Grove</p>

11. Historic Value							
N/A							
12. Social / Communal Value							
N/A							
13. Group Value							
A row of three detached dwellings with clear design relationship and strong group value. Numbers 23 and 27 have replacement roof coverings dilute the uniformity of the row.

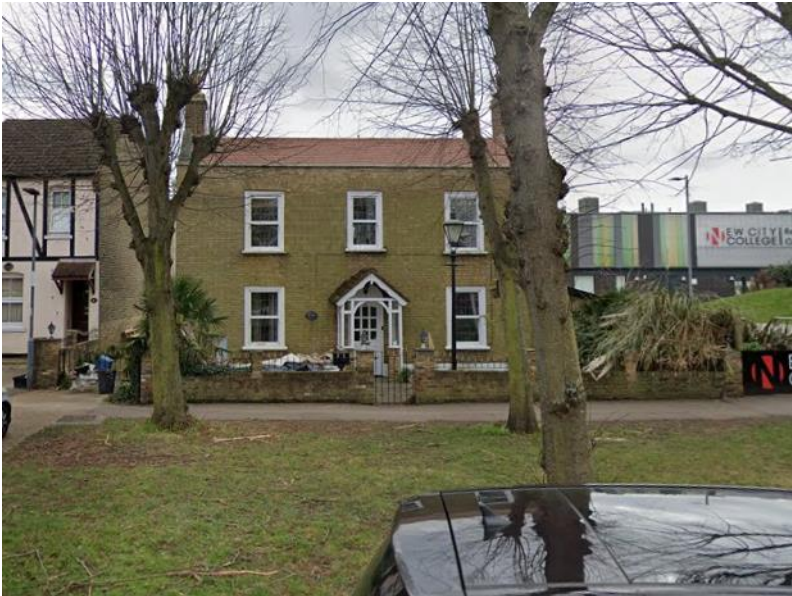
7. Description
Detached dwelling constructed from buff stock brick in the late eighteenth century. The property is set over two storeys with a central entrance with a block semi-circular fanlight. The property sits under a gabled roof with catslide to the rear. The roof is covered in machine made clay tiles and is flanked by two chimneys. A single storey lean-to extension on the west elevation and an ancillary range extends from the southwest corner of the property. Both are constructed from stock brick with slate roof covering.

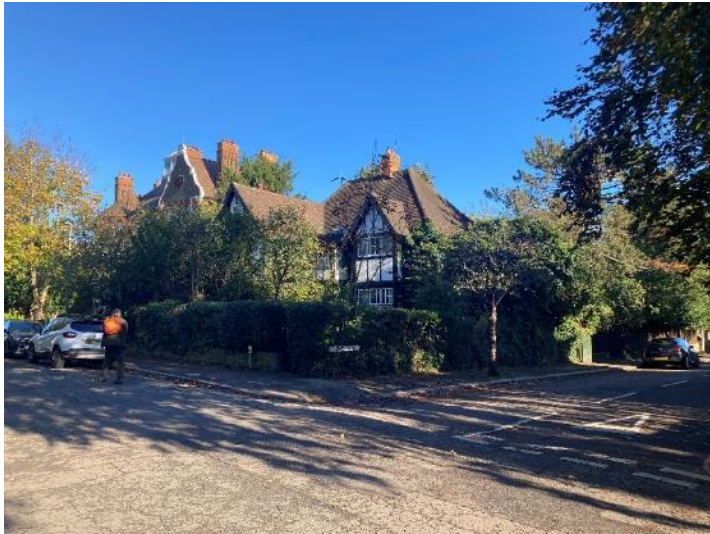
7. Description
Built circa 1882. The property is set over two storeys and is constructed in dark red brick with black and white half-timbered to front elevation gables and rear under catslide roof. Hipped roof covered in clay tiles with red brick corbelled chimney. Two gables to front elevation with decorative barge boards and casement windows with glazing bars.

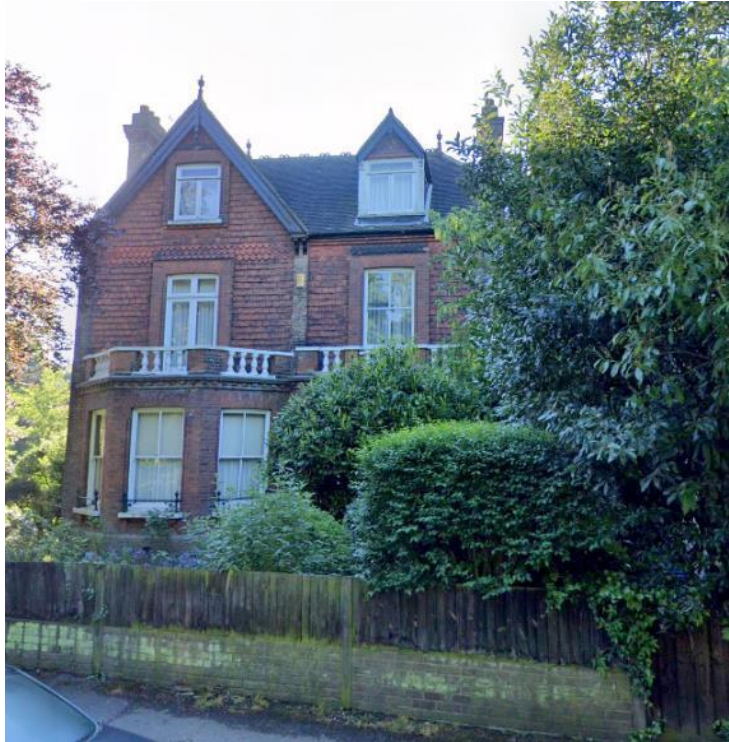
7. Description
Built circa 1883. The property is detached and set over two storeys with attic. Constructed from buff stock brick with red brick to window surrounds and bay windows. Timber sash and casement windows, ground floor bay windows have cast iron window boxes. Scalloped and straight tile hanging to first floor. The bays to the front elevation have stone balustrading. Hipped roof with projecting gable elements and dormers which have finials, the roof is covered in clay tiles with crested ridges and flanked by chimneys. Entrance off Higham Road with a canopy supported by timber brackets.

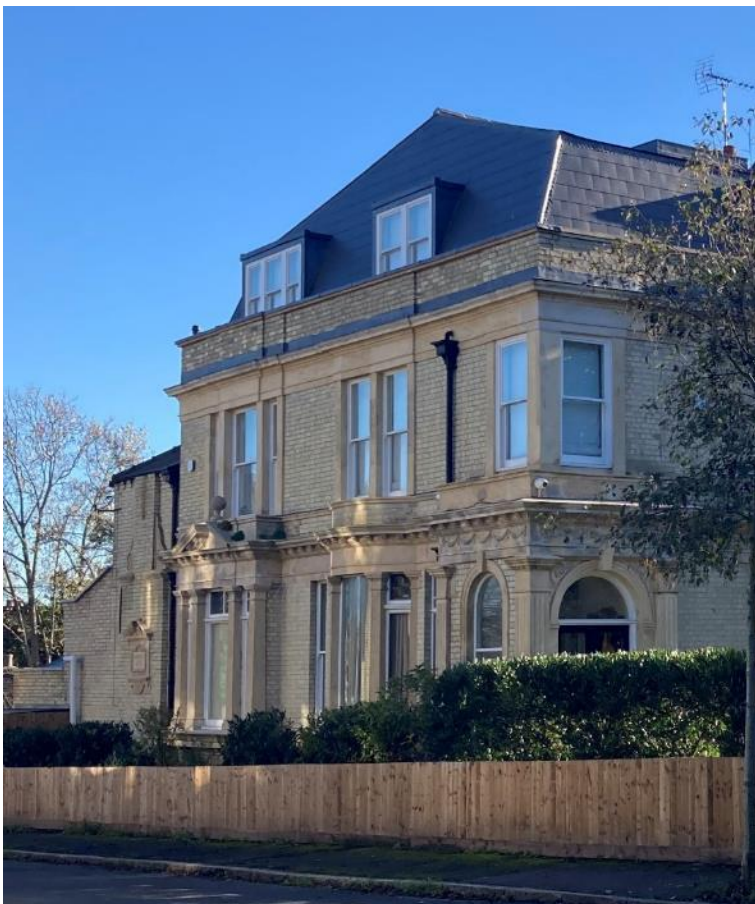
7. Description
Built 1890. The semi-detached property is two storey and a half storey in height. Constructed from stock buff brick with stone window dressings, string course with dentil detail and festoon to entrance. Full height bay window to front elevation with stone pediment to ground floor and balustrading to upper floor. Slate mansard roof with dormers behind parapet. Ground floor bow window and square bay with pediment. Ground floor bay windows have leaded top lights. Smaller hipped roof extension to rear of similar detailing with plaque inscribed 'Broomhills 1890'. Windows are timber sashes without glazing bars. Cast iron rainwater goods with decorated hoppers.

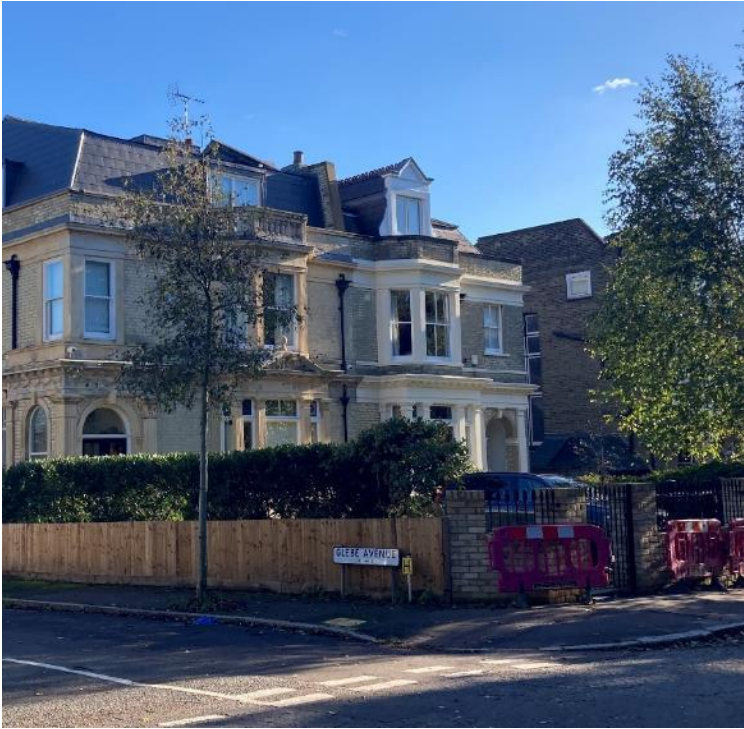
7. Description
Built circa 1895, the semi-detached property is two and a half storeys in height, constructed from buff stock brick. Stone window and entrance dressing, string course with dentil detail. Full height bay window to front elevation (square at ground floor and canted at first floor). Mansard to hipped roof in slate behind a parapet. Large, pedimented dormer window. Timber sash windows with central mullion. Cast iron rainwater goods with decorated hopped. Entrance set to the right accessed by steps and recessed behind storm porch with round arch flanked by pilasters.

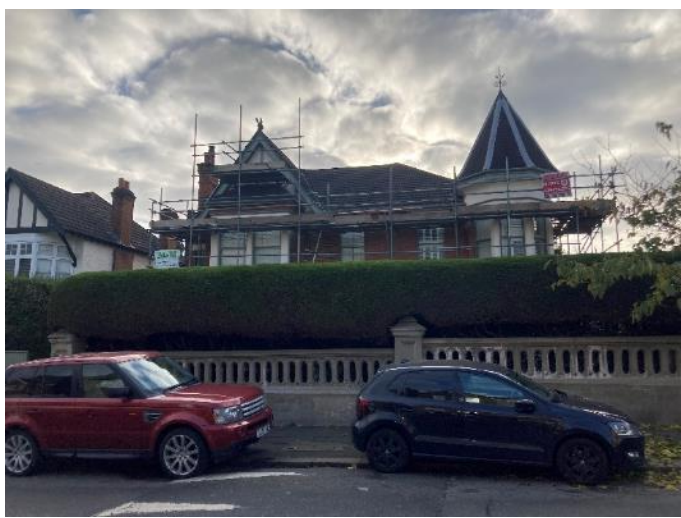
7. Description
<p>A mid-late nineteenth century former chapel now residential dwelling. The property is a single storey, with attic level with dormers. White render with pantiles to roof.</p> <p>The property is not widely visible from the public highways so cannot confirm the surviving (if any) historic fabric.</p>

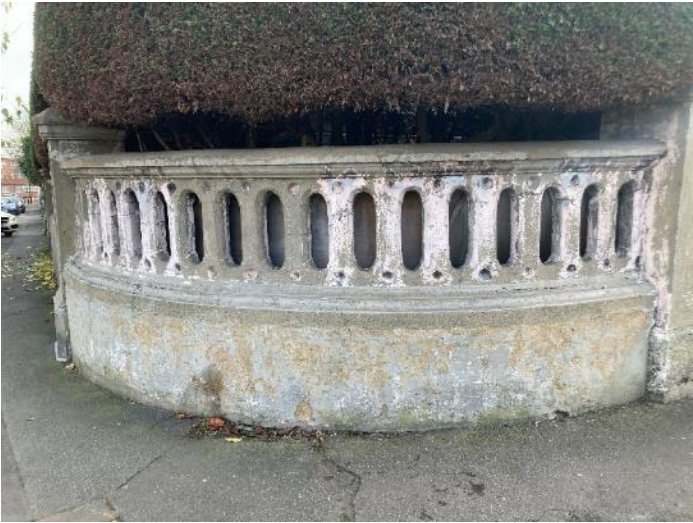
7. Description				
Built between 1863 and 1897 from brick with ashlar rendering. The wall sits at 1.8m high, taller piers that are capped. It comprises a plinth, balustrade with moulded posts and elongated oval openings and saddleback coping.

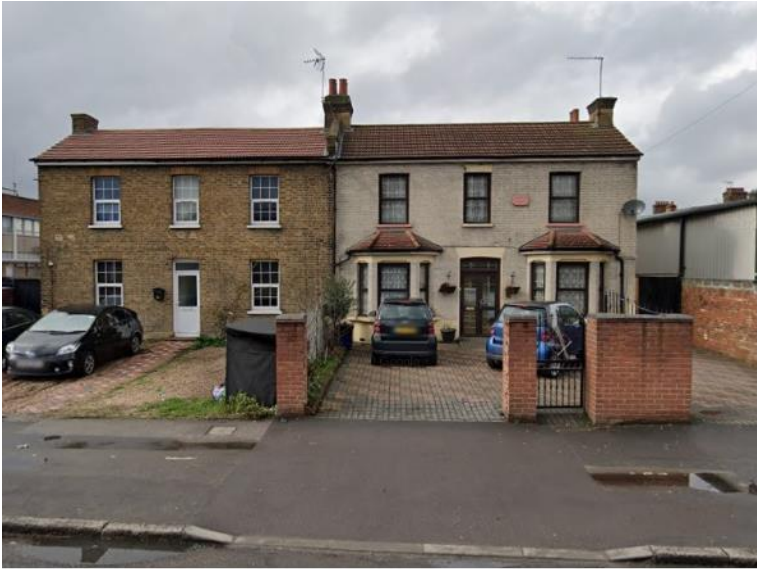
7. Description
<p>Site formerly Alexanders Building Yard and includes two houses nos.160 &amp; 162 Chigwell Road, one bearing a plaque saying 'Oakdale 1902'. Pair of houses clearly seen on map of 1896 along with workshops. Pair were built as farmhouses earlier than this date or indeed the date on the plaque - probably around 1870. Attractive double fronted classic brick and tile houses with timber sashes of 12 panes, both have been modernised with right hand house having the addition of bow fronts to the ground floor, replacement of original windows by plain sashes, and a large rear extension to the rear; and the left hand house also having a large rear extension. Elegant well proportioned notable example of farm cottages. Original outbuildings and stables have been demolished.</p>

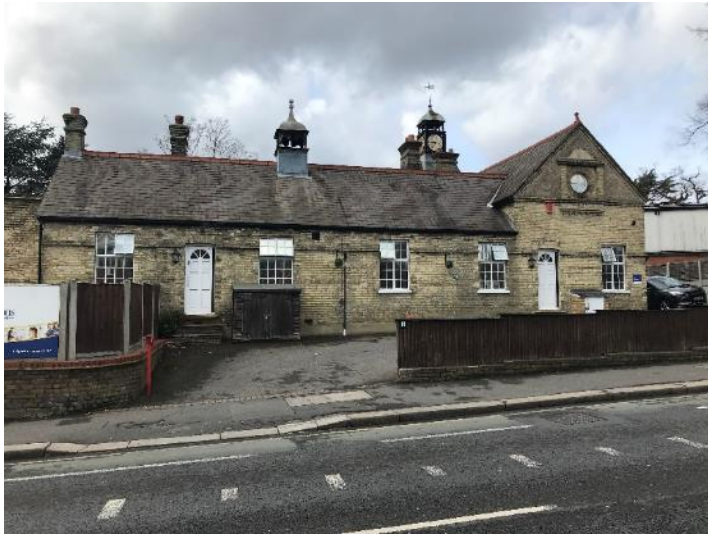
7. Description
Constructed 1890 as the former stable block to Pymont House (see St. Aubyns School, Bunces Lane). Single storey, gault brick elevations under a slate roof with cupola. Distinctive ornamental clock turret over arched entrance to courtyard on northern elevation. Brickwork detailing and decorative plasterwork to gable end. Replacement windows and doors.

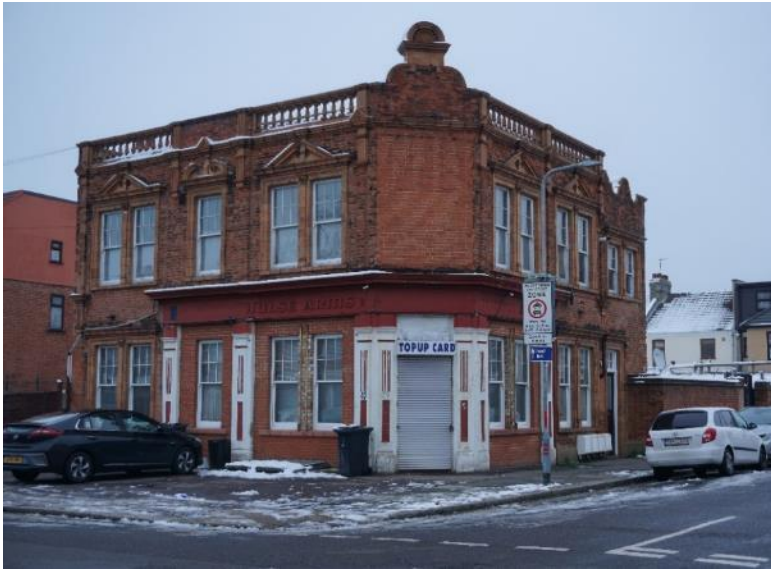
7. Description
Built in 1905 and designed by C. Foulsham & H. Ridnes. Two storey red brick building entrance on splayed corner. Surrounded by two storey Victorian terraced housing. Entrance and shop windows are flanked by pilasters with a simple fascia board and cornice above. Four sash windows on the ground floor and eleven sash windows the first floor. All sash windows have glazing bars to the upper sash, architrave surrounds and Ionic pilasters. First floor windows have closed and curved pediments and bracketed cornice above. Roof concealed behind part brick and part balustraded parapet and Dutch gable to splayed corner.

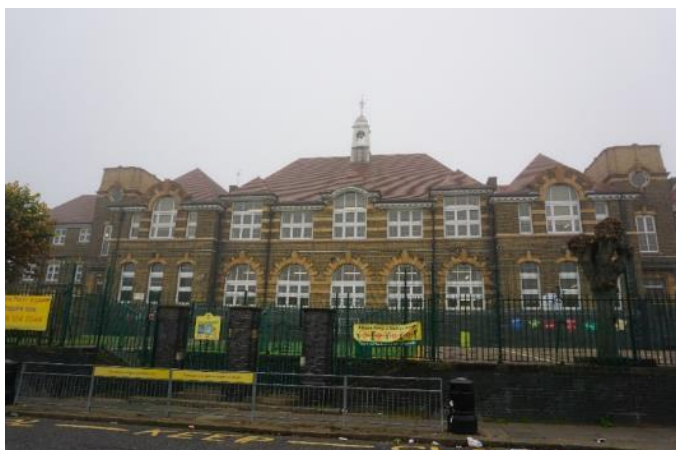
7. Description				
<p>Early twentieth century, large two-storey structure of yellow stock, with base of blue Staffordshire brick, and a clay tiled roof which is hipped with dentil eaves. Segmental, round and flat-headed window openings with uPVC windows. Faux keystone, voussoir, and horizontal band detailing of terracotta around windows and doors. Cast iron rainwater goods.</p> <p>Nursery structure is located to the northeast and was formerly detached. It is a single storey range constructed in the same design with Arts and Crafts details. The building sits under a gable ended clay tiled roof with sprocketed eaves. The boundary is marked by cast iron railings mounted on a blue Staffordshire brick plinth with brick gate piers.</p> <p>Highlands Primary School was constructed on the land of a form eighteenth-century estate of the same name.</p>

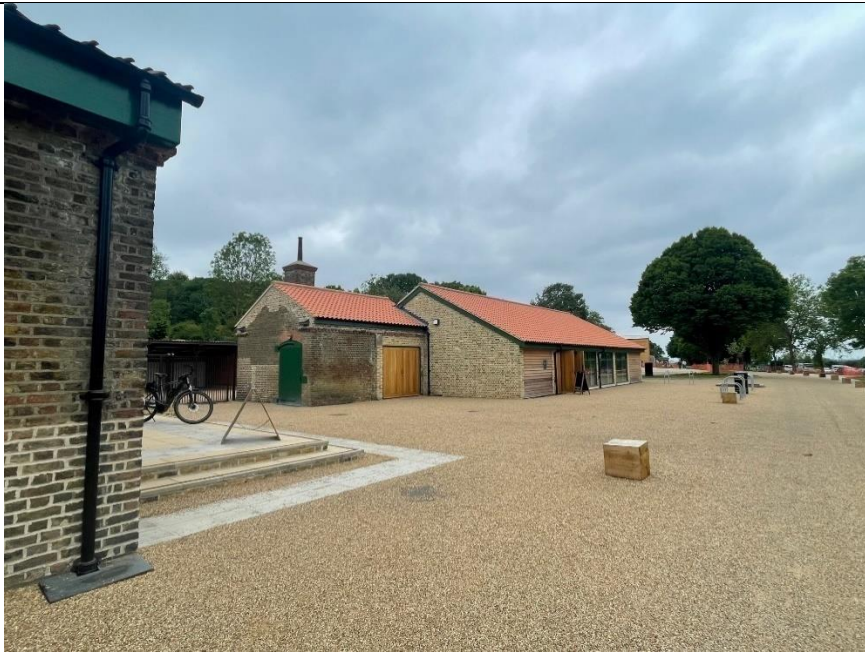
<b>7. Description</b>		
A small group of mid-nineteenth century barns. They are constructed from stock brick with -pantile roofs. The barns have red brick semi-circular arched window openings some with timber louvres and dog toothed corbelled eaves.

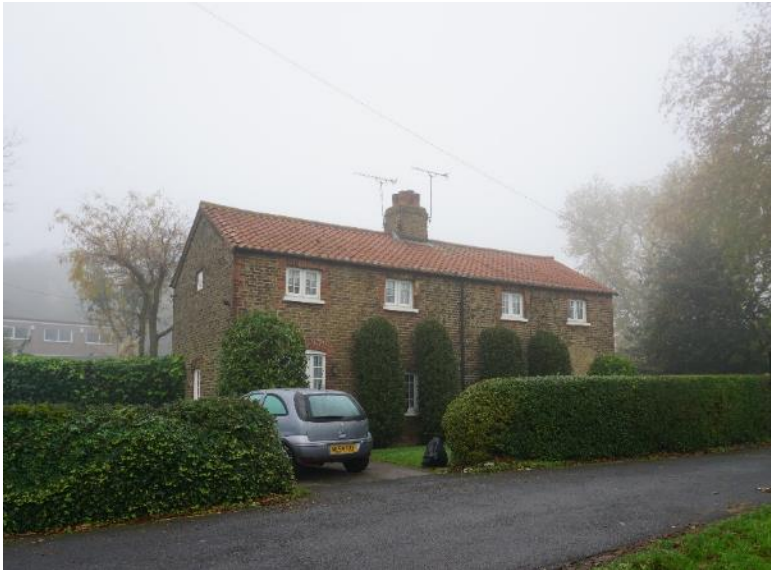
7. Description			
A pair of semi-detached cottages built in 1857. The property is constructed from brown stocks with red brick window dressing and quoining under a gabled pantile roof.

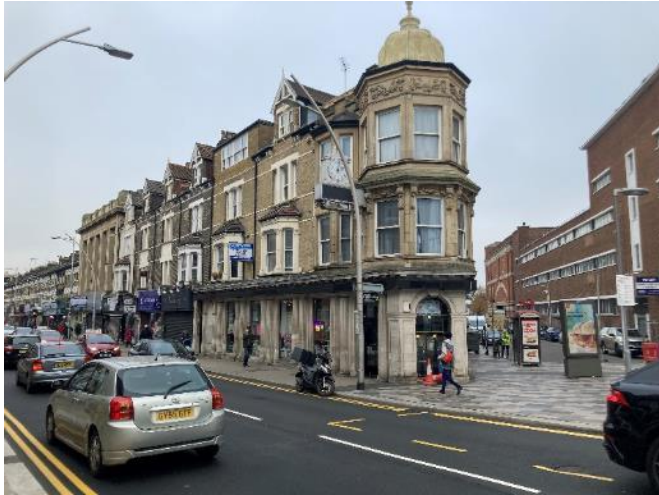
7. Description				
Circa 1900. Three storeys with attic. Stone ground floor with engaged fluted Doric columns. Yellow stock brick upper floors. Slate roof with dormers. The main feature is a full height octagonal bay window with ogee copper cupola on the corner of the site.

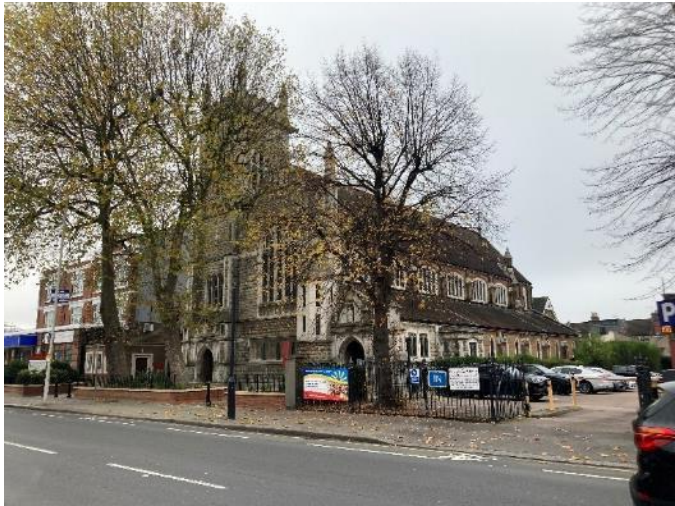
7. Description				
<p>Constructed in 1898 by builders Messrs Gregar &amp; Son and designed by Robert Leabon Curtis in a Perpendicular Gothic style. Front elevation built in Portland stone dressed with Kentish ragstone from the Medway Valley with prominent tower at north side of west front added 1906-7. The rest of the building constructed from stock brick with red brick banding and dressings laid in Flemish bond. High nave with five-sided splayed apse at east end. Low lean-to north and south aisles added 1904-12. The roof is covered in clay plain tiles. The tower has corner buttresses, false gargoyles and small stepped buttresses to aisles. Aisle windows are narrow lancets with trefoil heads and stained glass. Clerestory windows have four similar lancets under segmental arches. Large perpendicular window with stained glass to west front.</p>

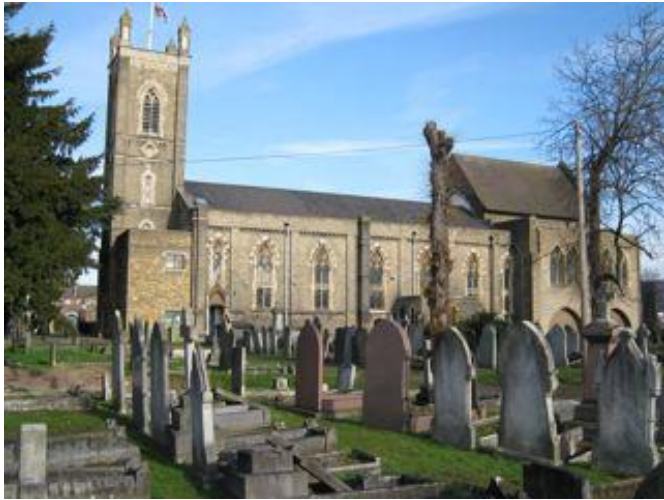
7. Description				
Built 1831 by James Savage. Commissioners Gothic in style. Grey/white brick. Low pitch slate roof and plain parapet. Tall, thin tower at west end (constructed 1865 by Arthur Ashpitel) with prominent pinnacles, flanked by modern flat roofed two storey wings in yellow stocks. High chancel with steep pitch tiled roof (constructed 1920 by Edwin Dunn). Windows with fanciful tracery.

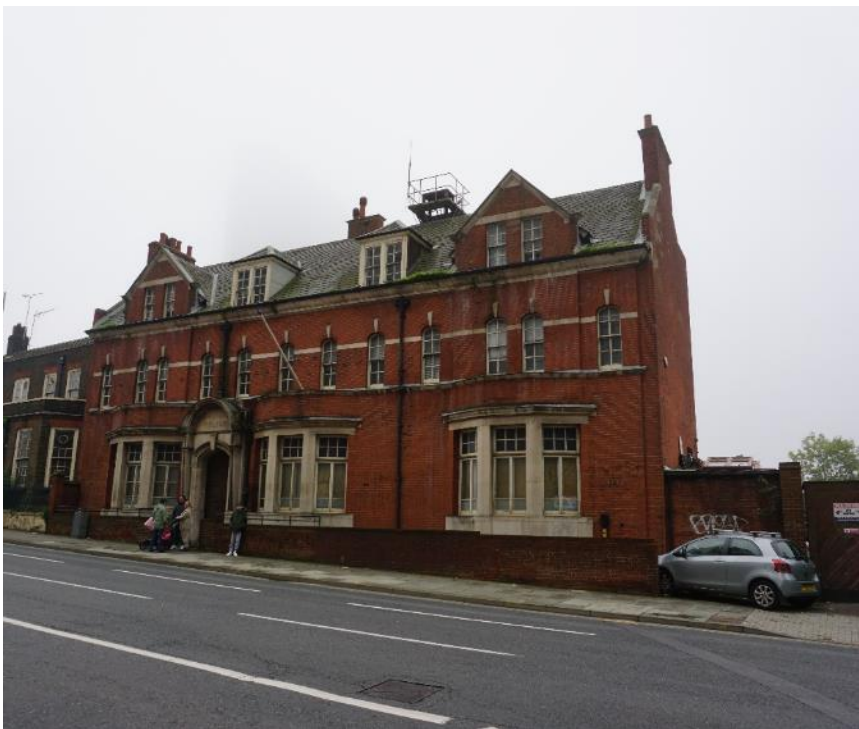
7. Description
Constructed in 1906 and designed by John Dixon Butler. Neo-Georgian two storey building with attic. Red brick with stone dressings. Medium pitch graded slate gabled roof with four dormers, two gabled and two hipped. First floor has twelve narrow windows under segmental arches and stone keystones. Entrance with semi-circular arched hood on tall Art Nouveau consoles. Flanking canted bay windows on ground floor. Third bay on right hand. Windows double hung sashes with glazing bars.

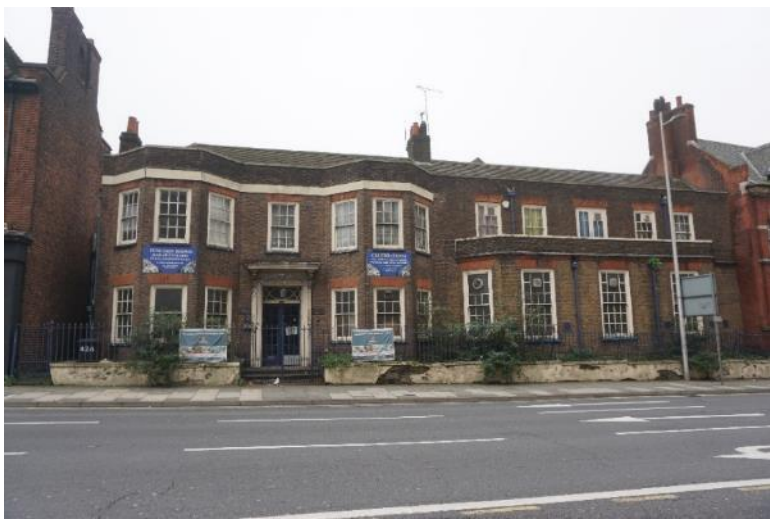
7. Description
The property is set over two storeys in a red brown brick. It has a plain tile roof with high parapet. Details include a band across the first-floor window heads and red brick flat gauged lintels. The entrance has a decorative fanlight and a projecting flat moulded hood on decorative brackets flanked by full height canted bays. Wing extension to the on right consisting of five bays with ground floor projection with parapet. Windows are predominantly six over six double hung sashes and twelve over twelve sash windows to single storey front projection. The property's front boundary consists of metal railings on a rendered brick plinth, entrance gates have lamp supported on arched iron railing.

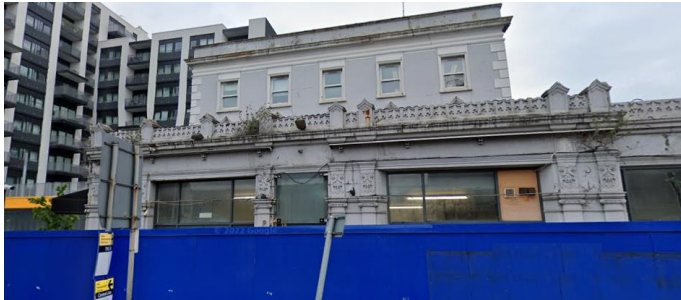
7. Description				
C18 late/C19 early. Three storeys. White stucco with parapet concealing hipped slate roofs. Five windows wide. one and two storey rear extensions and c20 bungalow front. Projecting quoins and moulded architraves to windows, including steep pediments to first floor front windows. Double hung sashes, no glazing bars. Originally a building of some distinction.

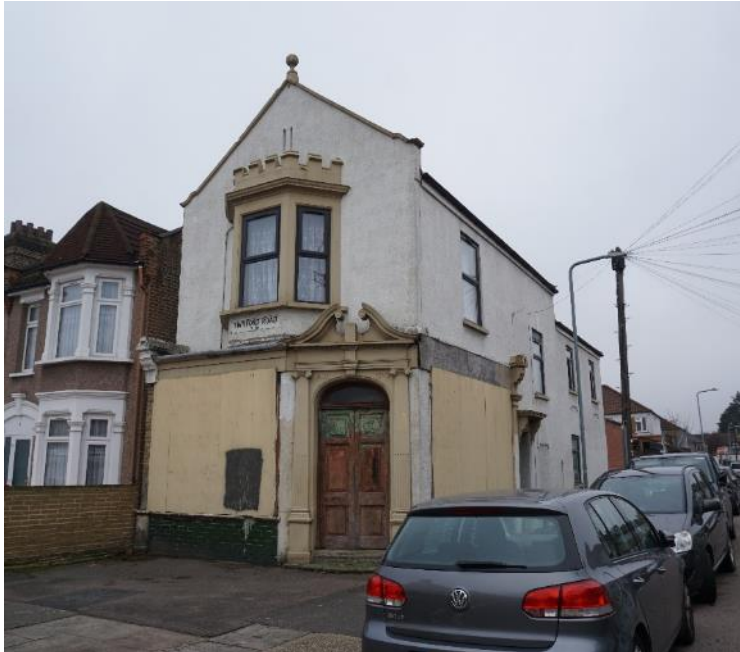
7. Description
Corner shop built in 1905. Two storeys, one bay wide. Rendered elevations under slate roof. Gabled roof form with parapet to front elevation topped with decorative stone finial. Entrance on splayed corner flanked by Ionic pilasters and striped brick and stonework with elliptical arch beneath broken curved pediment. Green glazed brick stallrisers (shopfront not visible). Oriel window at first floor level with crenellated parapet.

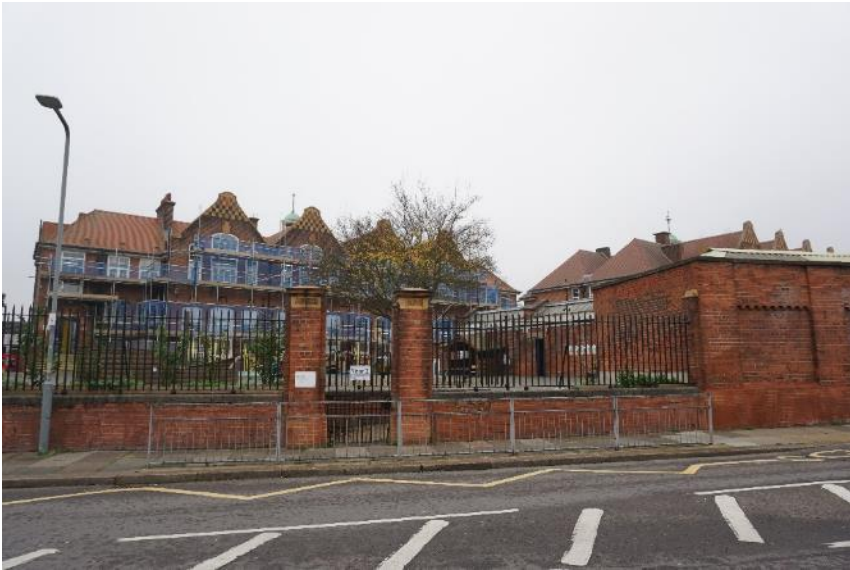
7. Description
Built in 1913, the purpose-built school comprises of two formerly detached blocks. Both are set over two and three storeys in red brick under hipped plain tile roofs with a domed copper cupola bell tower. The building has Dutch gables with terracotta chequer pattern and terracotta dressings. Large double hung sash windows with glazing bars. Original boundary railings with new gates. School keeper's house located to the west of the school constructed of red brick with gabled roof, catslide over entrance door and prominent chimneys.

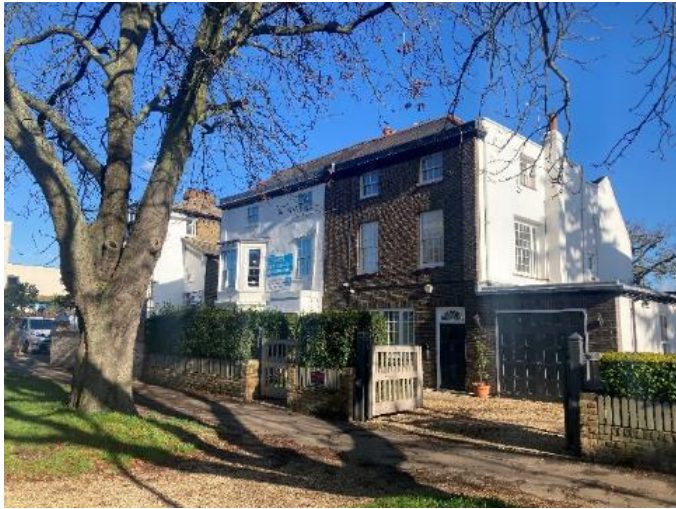
7. Description
Late eighteenth century. Pair of houses. Three storeys, two windows wide. No.488 front rebuilt inaccurately in red facing brick with modern windows. Hipped tile (Marley) roof. No.490 white render. Dentilled cornice and hipped slate roof. Projecting flat roof entrance porch on Doric columns flanked by projecting canted bay to ground and first floor. Both altered and modernised.

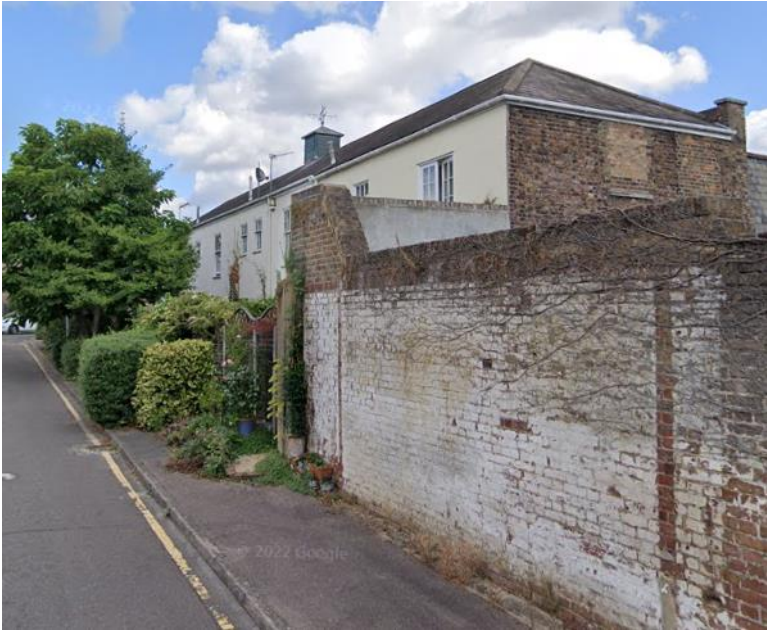
7. Description				
<p>Early nineteenth century, former stable block constructed in light brick with a C-shaped planform. Now converted to residential units. The main block set on a north south axis is two storeys in height under a hipped slate roof; first floor windows are set in recessed semi-circular panels. The wing extensions (east west axis) are one and a half storeys under a mansard roof with sash windows. To the ground floor are seven entrance doors to residential units under small canopies.</p>

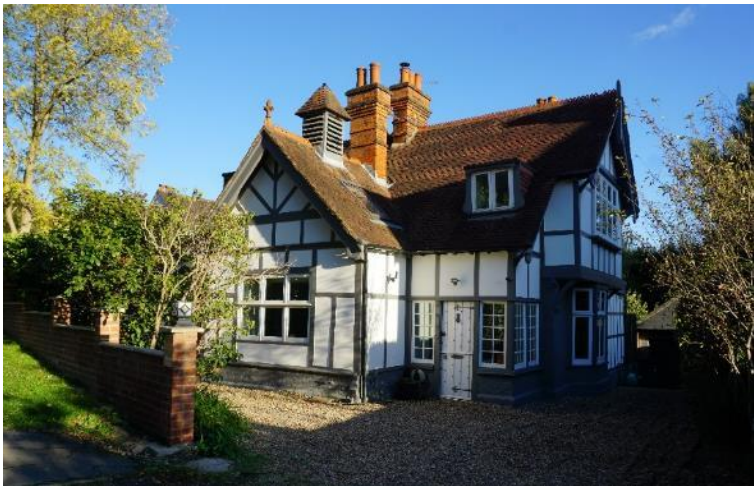
7. Description				
Constructed circa 1870-90. The property is a model estate cottage. Set over two-storeys, rendered with half timbering. The roof is of a gabled form covered in decorative scalloped and straight clay tiles with small flat roof dormers. Corbelled red brick chimneys and louvered cupola. Decorative barge boards and timber casement windows.

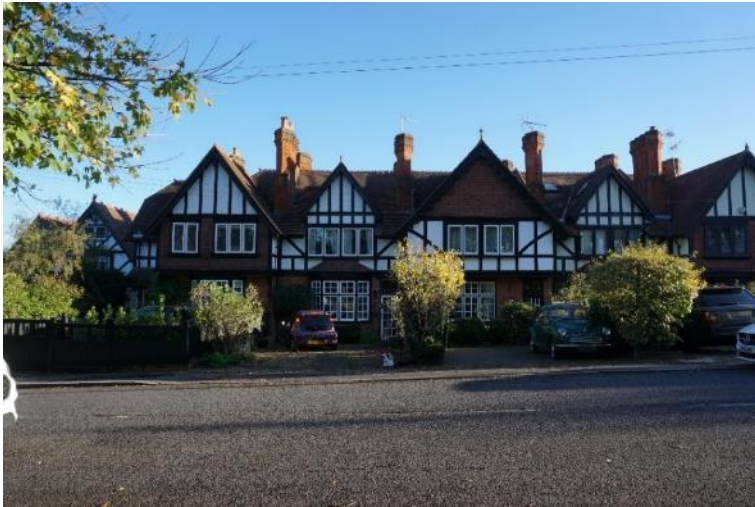
7. Description				
<p>Built circa 1870-90, a terrace of five model cottages with a detached dwelling each end. Set over two-storeys, ground floor is of red brick and upper floors with half timbering effect as well as scalloped and straight hanging tiles with decorative bargeboards. Terrace has half hipped ends with gabled front and rear projections, detached dwellings are of a gable form; all with plain clay tiles. All properties have tall, angled chimneys. Some with original timber casements with diamond leaded lights and some replaced by plain glazing.</p>

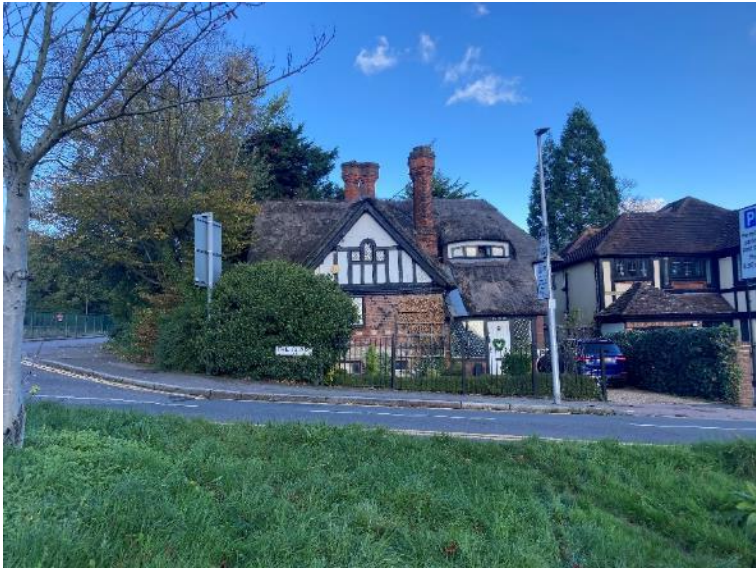
7. Description			
Circa 1880 old English Revival. Part one storey and part two storey. Red brick with half timbered gable. Thatch roof. Angled chimneys. Latticed casements. Formerly an entrance lodge to Knighton House.
