# Appendix A: Local Heritage List Buildings and Structures

London Borough of  
Redbridge

August 2023

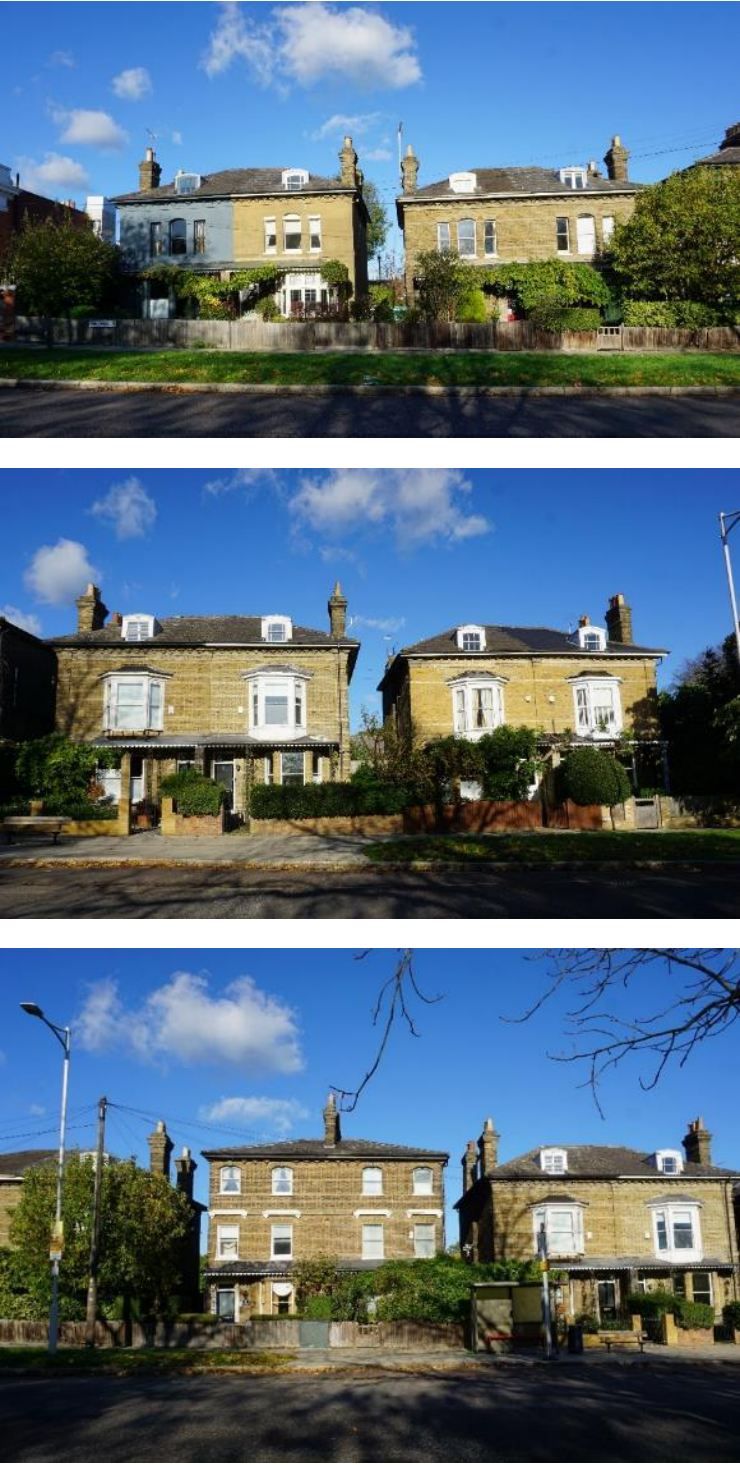
7. Description				
A row of five mid-nineteenth century, semi-detached villas. The central property (Numbers 6-7) is set over three storeys, the flanking properties (Number 2-4 and 8-11) are set over two storeys with attic level. They are constructed from yellow stock brick and sit under hipped slate roofs with brick dentils at the eaves. Numbers 2-3 have been rendered. Each pair have large and prominent chimney stacks. Canted bay windows to ground

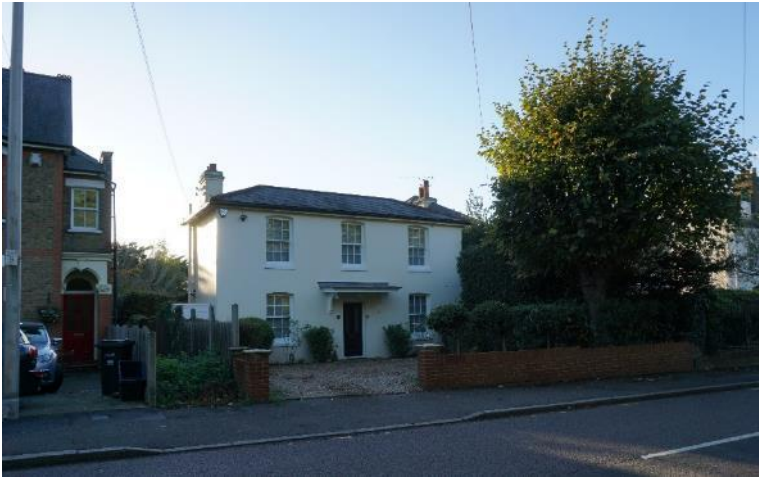
7. Description
Built circa 1830-40. The early nineteenth century property is detached, two-stores, 3 bays wide with a central entrance and stuccoed elevations. It sits under a low-pitched, hipped roof covered in slate flanked by chimneys. The central entrance has a projecting flat canopy on decorative timber brackets which appear to be mid-nineteenth in derivation. Windows are double hung six over six sashes with horns.

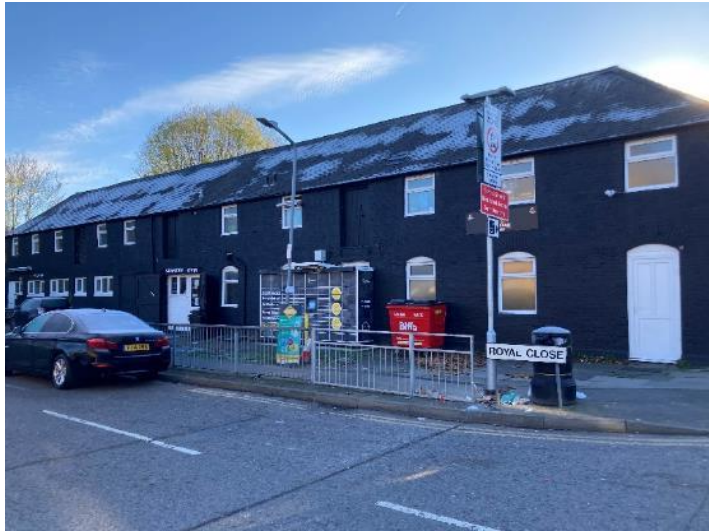
7. Description
Mid nineteenth century. Two storey, 13 bay stable block. Yellow stocks with red brick segmental window arches and dressing courses, now painted black. Blue brick window surrounds. Medium pitch hipped slate roof. First floor has three hoist openings and ground floor has various double doors. Most doors and windows are now UPVC. Formerly associated with Downshall Farm.

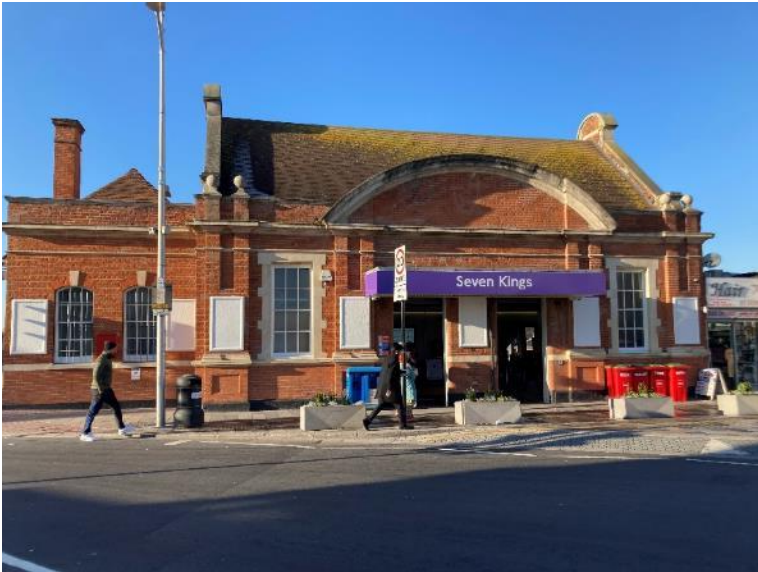
7. Description			
Built 1899. One storey. Red brick with stone dressings. Tile roof with pedimented gables. Shallow segmental pediment over the entrance.

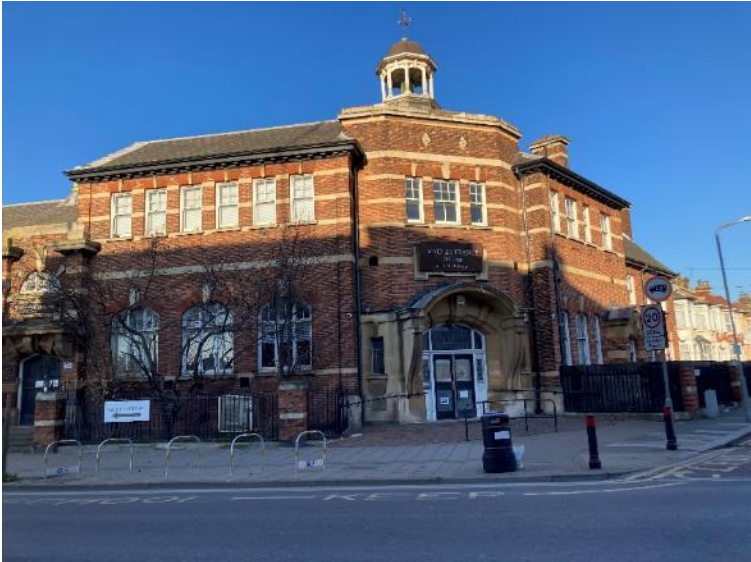
7. Description
Built 1908 by Henry Shaw. A Carnegie Library. Altered 1968. Library is two storeys. Public Hall one storey and basement. Red brick with cream stone dressings. Slate roof with dentils at eaves. Cantled corner entrance with moulded stone canopy on large projecting curved stone brackets. Plaque over inscribed 'Carnegie Public Library'. Crowning parapet and cupola. Recessed arched entrance with flat moulded stone canopy to Public Hall. Library interior has numerous freestanding Corinthian columns and staircase with decorative balustrade. Public Hall interior has shallow barrel vaulted ceiling. Curved fronted rear balcony on deep decorative brackets. Interiors of both are not of special interest. Library lodge. Two storeys. Three storeys. Three windows with ground floor projecting splayed bay. Modest house of group value only.

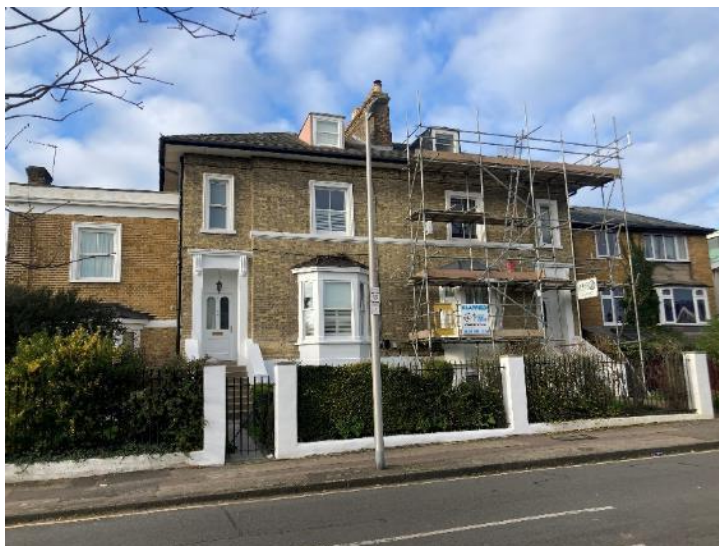
Nos 1 and 2 Grove Crescent

Circa 1840. The vestiges of a continuous terrace of linked pairs. Two storeys with semi-basement and attic. Yellow stock brick. Stucco basement and first floor sill strings. Hipped slate roof with wide eaves (console brackets at 7/8) and small dormers. Entrances with shallow moulded hoods on large console brackets. Double hung sash windows, some with glazing bars and rendered reveals. The links each side were lower two storey with ground floor spayed bays, dentils at heads, however, the link only survives at No.1.

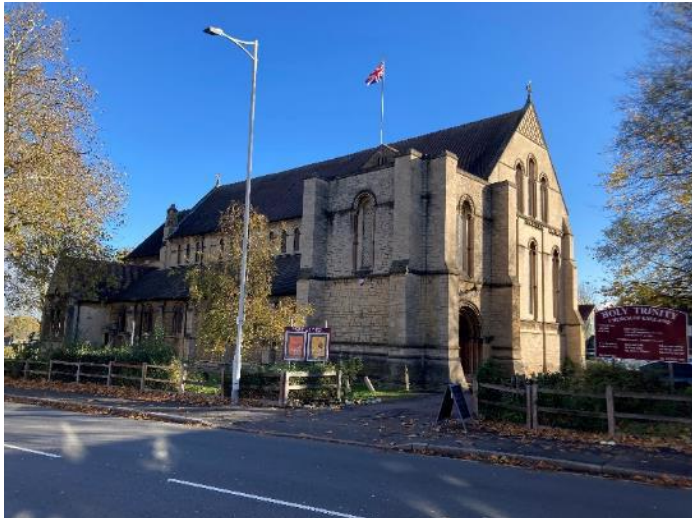
7. Description				
<p>1887/90. J.Fowler of Louth. Twelfth century transitional style nave and aisles. Semi-circular east apse and square tower at north-west corner. Tower and south aisle never completed. Yellow stone with red stone shafts. Steep pitch red tile roof. Round headed and lancet windows. West front has two tiers of three lancet windows. Round arched door with dog tooth carving to base of tower. Interior has round columns, pointed arches and a timber roof.</p>

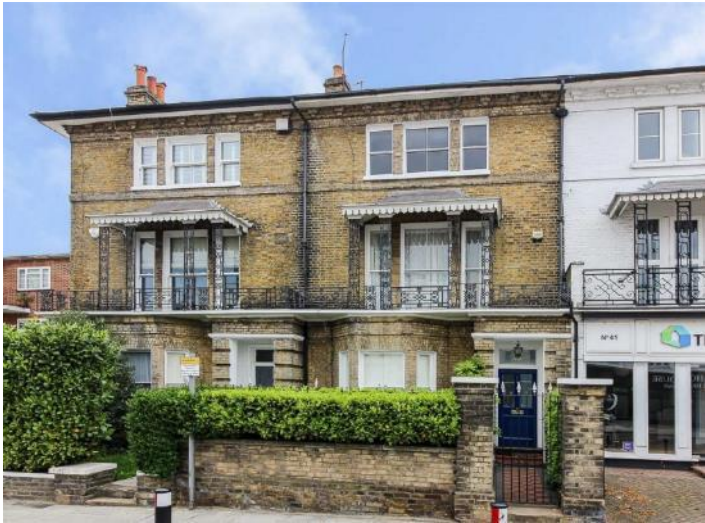
7. Description				
<p>Circa 1840/60. Terrace of three. Three storey houses. Yellow stock bricks. Low pitch hipped slate roof with wide eaves. Each house has one window with flanking narrow lights separated by brick mullions. Double hung sash windows under flat gauged brick arches some with vertical glazing bars. Ground floor windows form canted bays. Enclosed entrance porches with rusticated channelled quoins. Brick string course between first and second floors. Cast iron Trafalgar balconies on the first floor oversailing bay and porch. No.41 (now a shop) greatly altered but included for group value.</p>

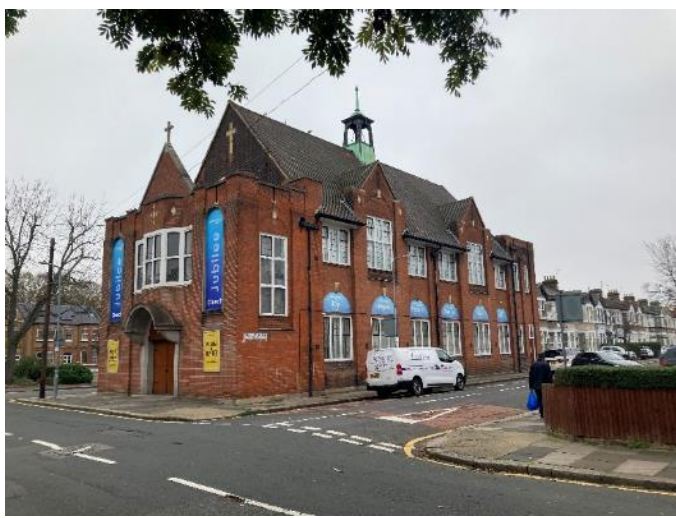
7. Description				
1907/08. C.J. Dawson. Arts and Crafts style. Two storeys. Nine windows in flank. Oriel window over main entrance. Steep pitch red tile roof. Copper clad central cupola. Red brick, stone dressings. Windows with timber mullions, some with transoms, small leaded panes. Stone hood on brackets over entrance.

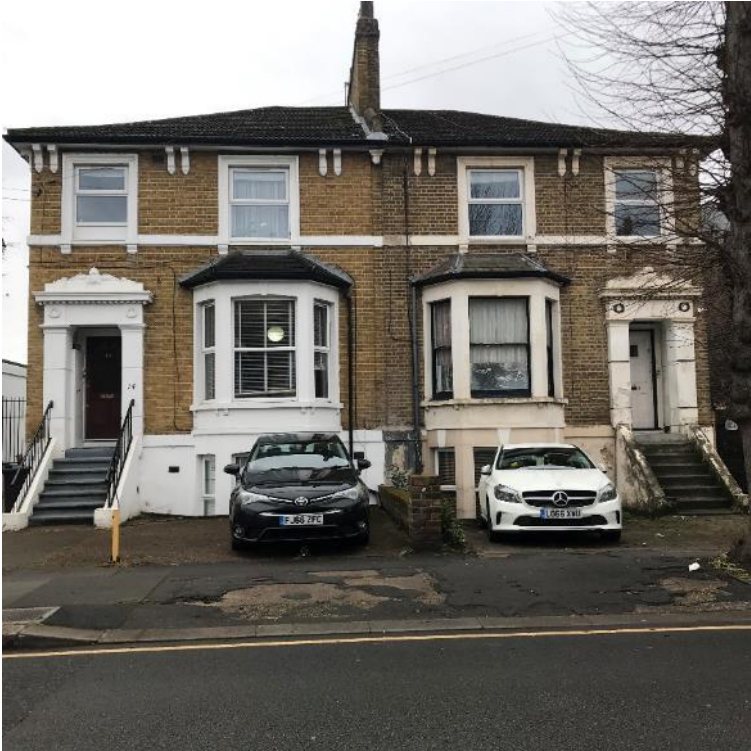
7. Description				
C19 early to mid. Pair of semi-detached villas. Two storeys over basement. Each house two windows wide. Yellow stock brick. Stucco to basement architraves. Stucco string course between first and second floors. Hipped slate roof on bracketed eaves. Cantled bay windows on ground floor. Entrances up steps with heavy Grecian surrounds. No.14 has been altered - upper windows and tiled roof.

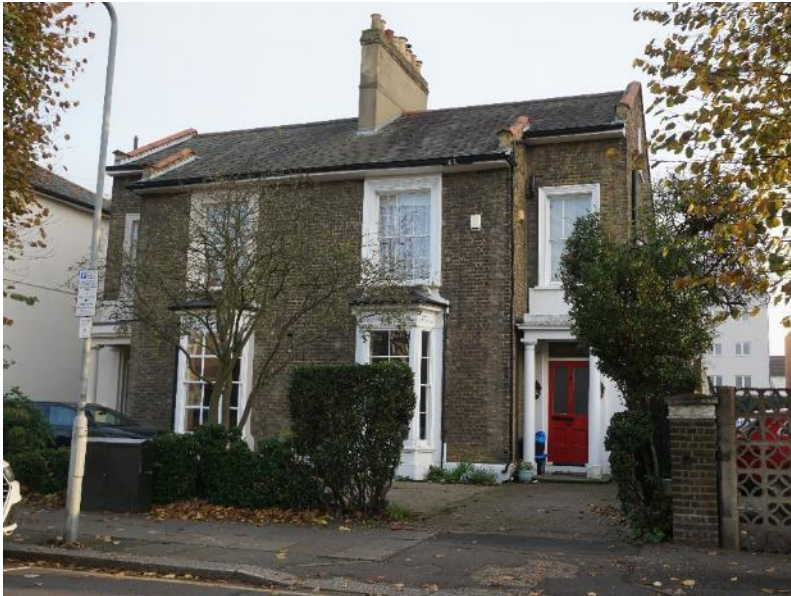
7. Description
Early to mid-nineteenth century semi-detached villas. Set over two storeys. Each two bays with entrances in recessed end bay. Constructed from yellow stock brick under a slate roof with a large central chimney. Double hung sash windows with glazing bars, arranged six-over-six with the ground floor bay window of no. 6 in a four-over-four arrangement. Narrow canted bay windows to ground floor. Projecting porches supported by thin Doric columns.

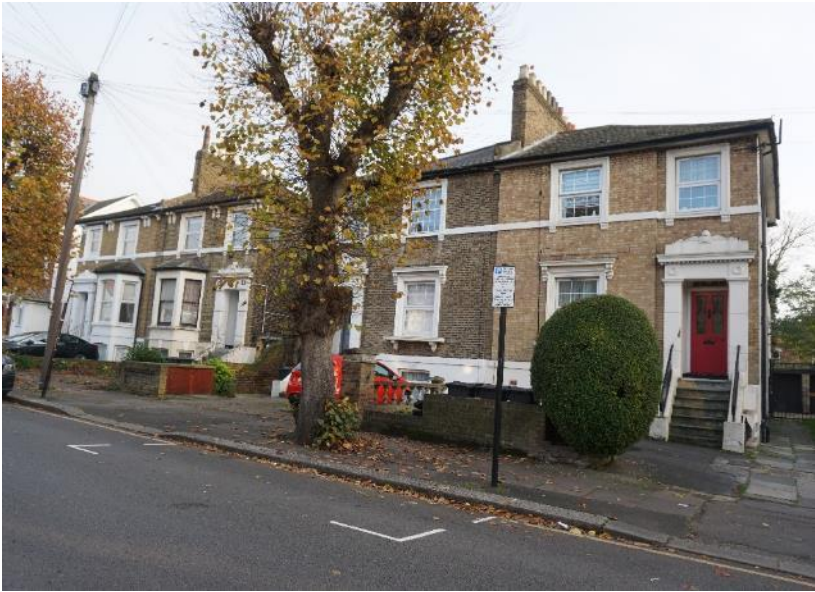
7. Description
Early to mid-nineteenth century. Pair of semi-detached villas. Two storeys over basement. Each house is two bays under a hipped slate roofs with large central chimney. Stucco entablatures to ground floor windows and string course. Entrances accessed by steps from street level. Recessed entrance doors with heavy Grecian doorcases.

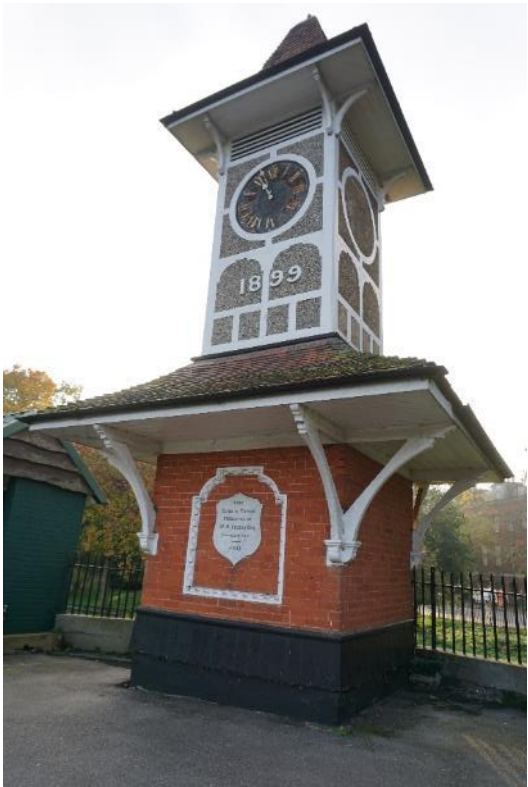
7. Description
<p>Small square tower, erected 1899. Lower part red brick above black painted plinth with tiled canopy on timber brackets. Upper part rendered with painted decorative strapwork and clock face and '1899' date on the east side. Tiled spire with overhang on timber brackets. Plaque reads; "This clock and tower presented by W.P. Griggs Esq ., Cranbrook Park 1899". The clock is thought to be eighteenth century in derivation that comes from the stables of Cranbrook Hall.</p>

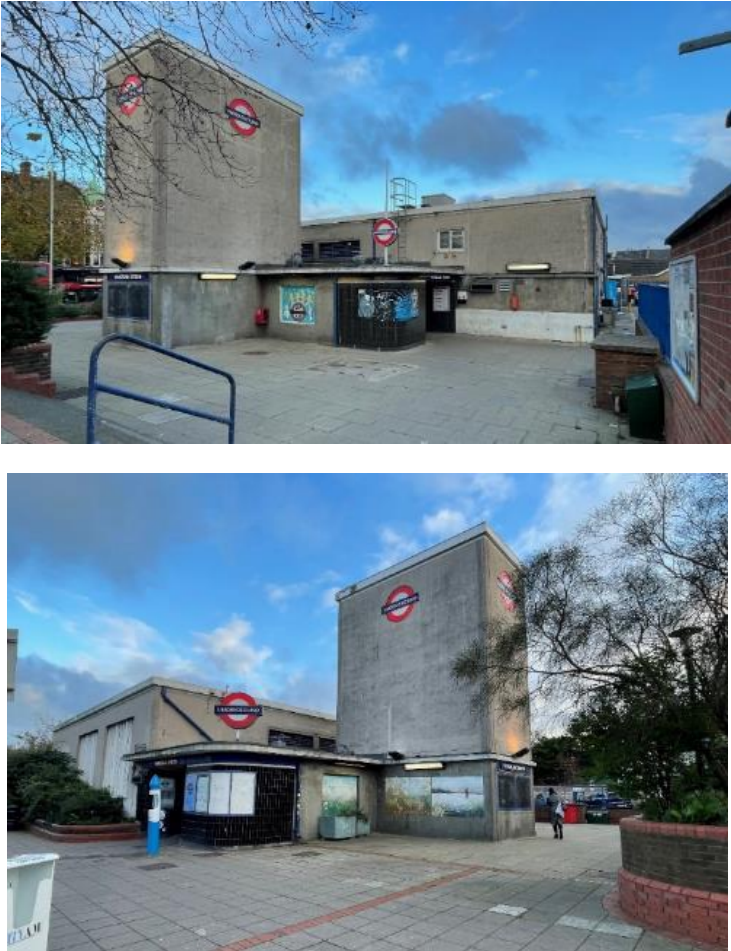
7. Description
Designed by Charles Holden 1937-38. The station is a concrete structure with a rectilinear form. The station is two-storeys with a prominent tower to the western elevation displaying the Underground roundel on each face. The north elevation has large windows with vertical emphasis and concrete mullions. The entrance is single storey with curved wall clad in glazed tiles.

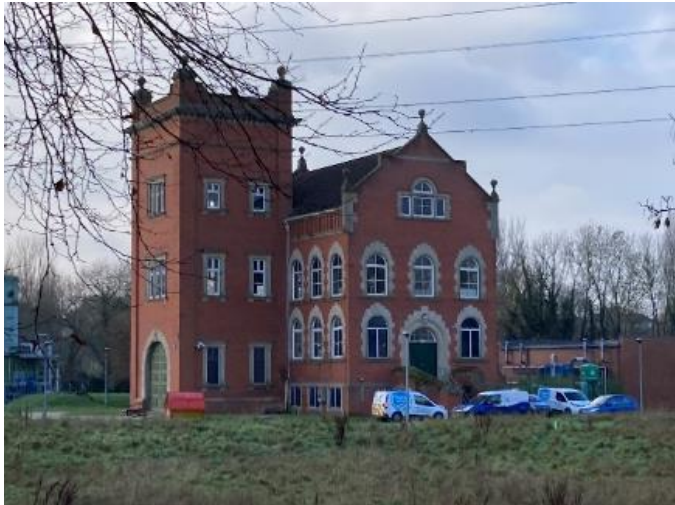
7. Description				
<p>Circa 1900. Jacobean style. Large rectangular machine hall with square tower on east. Hard red brick with stone dressings. Plain tile roof with gables, parapets and finials. Tower has parapet with raised corners, finials and large semi-circular arched ground floor entrance. North gable of machine hall has arched entrance at head of curved flight of steps. Timber windows with semi-circular heads. Two storey caretakers house in domestic Tudor style. Within extensive grounds.</p>

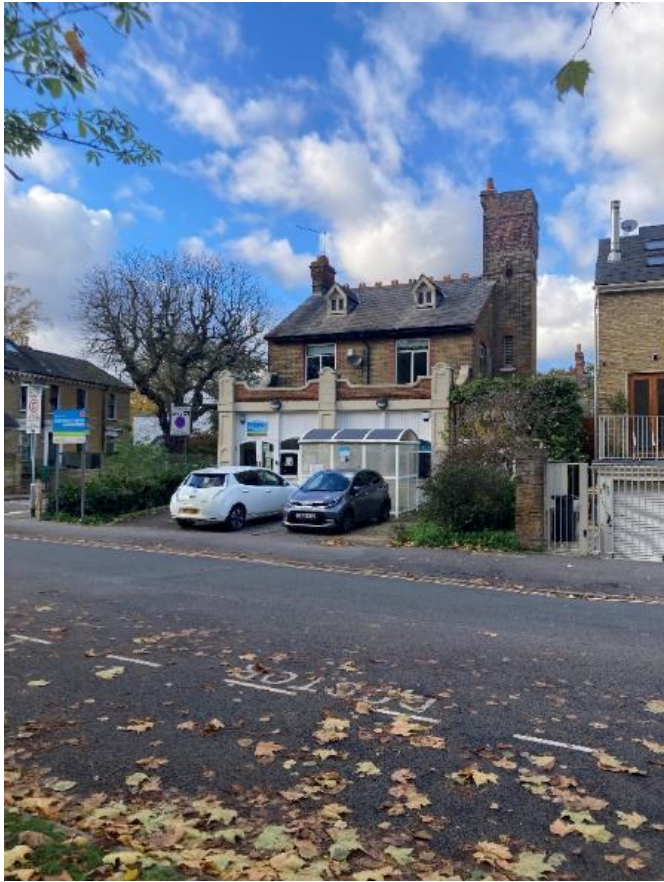
7. Description
Built 1913. Two storey with chimney flue on east side and one storey engine shed. Yellow brick construction with red brick lintels and quoins to window. Chimney flue and is marked by decorative corbelling and diapered brickwork and engine shed has pilasters constructed of limestone and parapet constructed of red brick with limestone top. Slate roof with two small dormers at front and chimney stack on west side. Engine shed doors have been replaced.

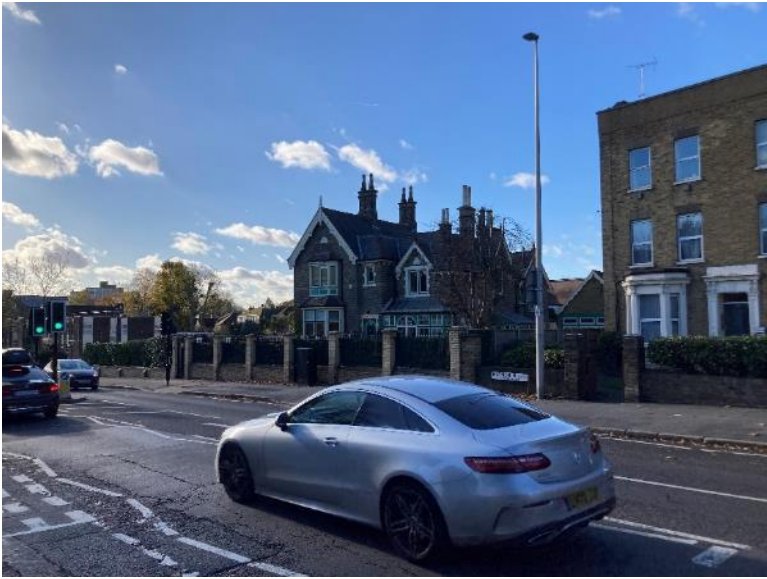
7. Description
1887 Tudor villa. Two storeys. L-plan. Steep pitch slate roof, gabled without bargeboards. Yellow stock with diamond patterns in contrast brick. Tall chimneys. Wooden mullion and transom windows with casements. Small bay window to ground floor.

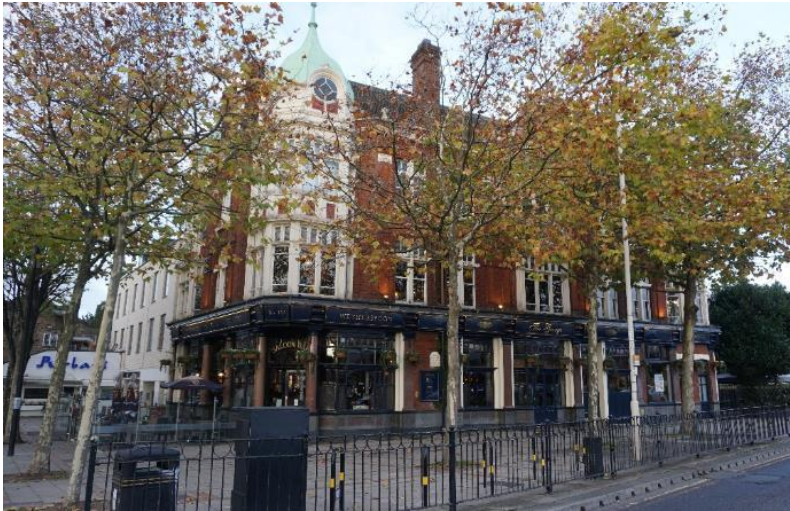
1. Name	The George Hotel			
2. UID	WV04			
3. Address	High Street (East side), 159			
4. Postcode	E11 2RL			
5. Grid Ref	E 540646 N 188298			
6a. Conservation Area	Yes	x	No	
6b. If yes, which CA	Wanstead Village

7. Description
Built in 1904 and designed by A.J Bywater, the building is set over three storeys on rectangular plan. Orange-red brick with parapet and steep pitch tile roof. On each of the three visible corners is a five-sided turret bay rising through all three storeys, culminating in a copper ogee cupola. Each elevation includes a central shallow two storey bay with Dutch gable pediment and two storey brick pilasters with stone Ionic capitals. Ground floor has engaged columns and extensive glazing.

15. Archaeological Value							
The building is reflective of early twentieth century building techniques and is demonstrative of how materials and architectural features were used within public house architecture.							
16. Overall Condition							
Good	X	Fair		Poor		Very Poor	
Unknown		Notes:					
17. Recommended for inclusion				Yes	X	No	
18. Date of assessment				22/12/22

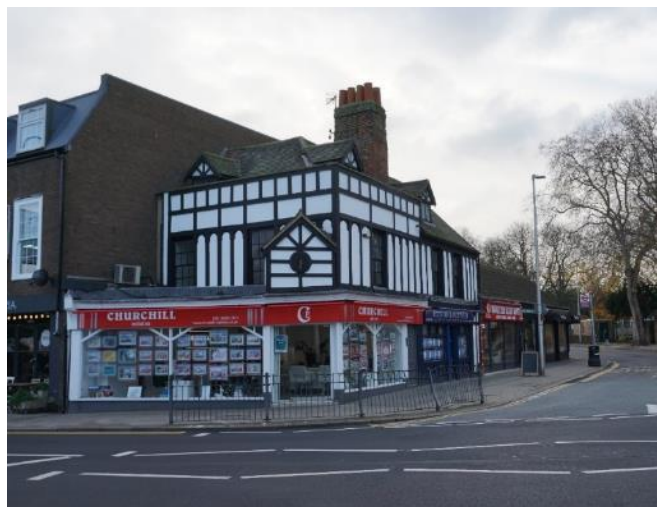
1. Name	31 High Street (west side) and 11-15 Woodbine Place			
2. UID	WV05			
3. Address	High Street (west side), 32 and Woodbine Place, 11-15			
4. Postcode	E11 2RH			
5. Grid Ref	E 540555 N 188382			
6a. Conservation Area	Yes	x	No	
6b. If yes, which CA	Wanstead Village

Exact date of construction unknown. However, it is present on the Tithe Map (1840) with possibly earlier origins. The ground floor comprises of shops which appear to derive from the twentieth century. The first-floor elevation is in a mock Tudor style with half timbering. The building has a hipped roof covered in clay tiles and small pitched dormers with half timbering effect to gable fronts. The roof has a substantial chimney.

To the rear 11-15 Woodbine Place is a single storey linear range occupied by shops. Roof is hipped with pantiles.

16. Overall Condition							
Good	X	Fair		Poor		Very Poor	
Unknown		Notes:					
17. Recommended for inclusion				Yes	X	No	
18. Date of assessment				22/12/22

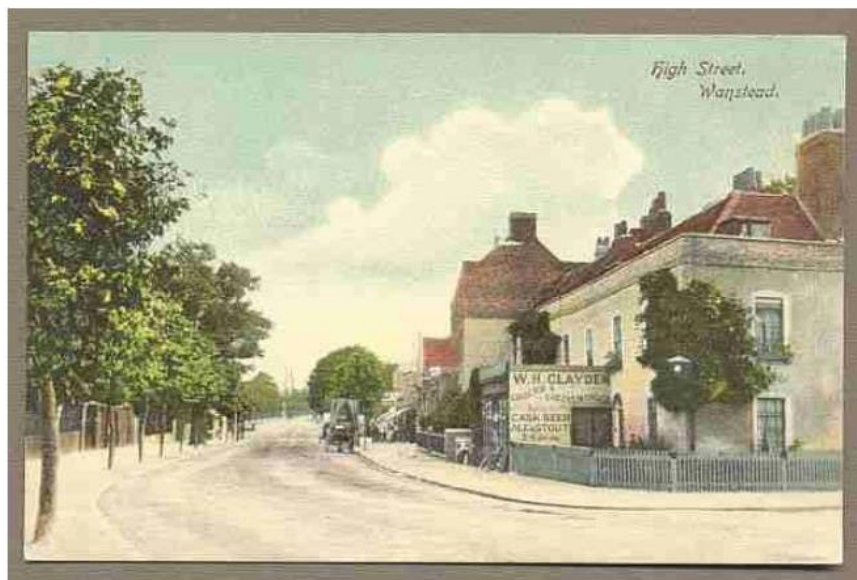
The above image is a view looking south down Wanstead High Street with Woodbine Place to the right. It is believed the building on the corner is Number 31 with the prominent chimney stack. At present, the date of the image is unknown but possibly nineteenth century prior to the alterations. Found online via <https://pubshistory.com/EssexPubs/Wanstead/index.shtml>. Image is owned by Redbridge Museum.

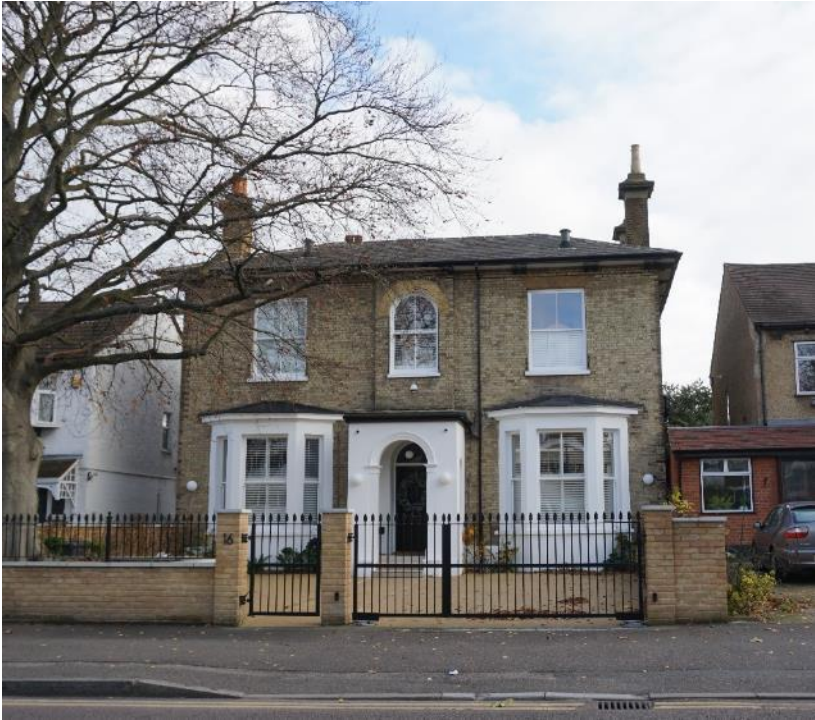
1. Name	16 New Wanstead			
2. UID	WV06			
3. Address	16 New Wanstead			
4. Postcode	E11 2SN			
5. Grid Ref	E 540160 N 188487			
6a. Conservation Area	Yes		No	x
6b. If yes, which CA

7. Description
A mid-nineteenth century dwelling of two storeys with basement and three bays. Constructed from stock brick under a low pitch hipped slate roof with wide eaves on console brackets. Tall slender chimneys; two to the southern roof slope and one to the northern. The property has a central entrance flanked by shallow canted bay windows in stucco with lead roofs. Enclosed porch with round arched stucco architrave. Timber sash windows with central glazing bars. Cast iron rainwater goods and Frets to first floor sills.

12. Social / Communal Value							
N/A							
13. Group Value							
N/A							
14. Landmark / Townscape Value							
Has some townscape value as a large mid-nineteenth century dwelling surrounded by twentieth century development.							
15. Archaeological Value							
Some archaeological value as an example of mid-nineteenth century construction methods and use of materials.							
16. Overall Condition							
Good	X	Fair		Poor		Very Poor	
Unknown		Notes:					
17. Recommended for inclusion				Yes	X	No	
18. Date of assessment				22/12/22

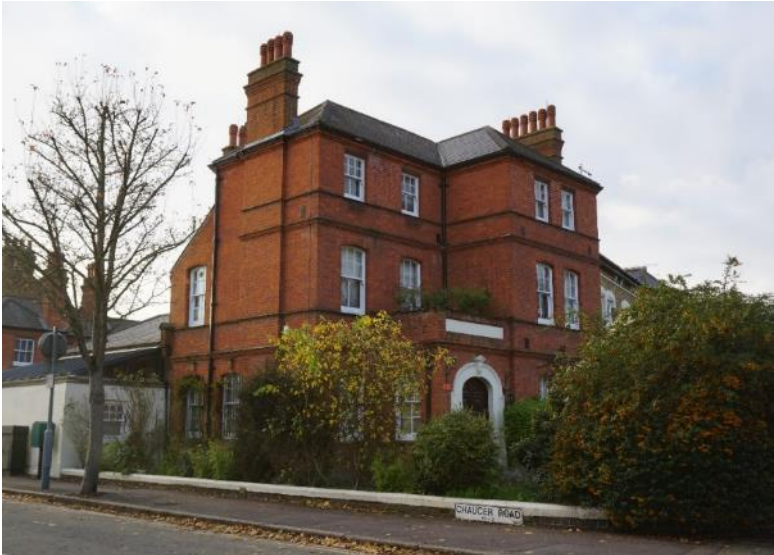
1. Name	Spratt Hall Police Station			
2. UID	WV08			
3. Address	Spratt Hall Road, 42			
4. Postcode	E11 2RQ			
5. Grid Ref	E 540258 N 188382			
6a. Conservation Area	Yes	x	No	
6b. If yes, which CA	Wanstead Village

7. Description
<p>Built in 1886, designed by John Butler. The purpose-built police station with an L-shape planform is constructed from red brick under a hipped slate roof with large, corbelled chimneys. Set over three storeys with string course moulded brick detail. Timber sash windows with segmental arched lintels to ground and first floor, some with key stones and flat gauged arched lintels to second floor. Metal guttering with decorative brackets to downpipes. The entrance is in a single storey porch with parapet in the return of the "L" plan; it has a painted stone surround, and the keystone bears the date 1886.</p> <p>To the rear of the site is a two-storey dwelling with attached stables. Both are constructed in the same style as the station. The house was used for married constables.</p>

15. Archaeological Value							
Some archaeological value as evidence of late nineteenth century building techniques and use of materials.							
16. Overall Condition							
Good	X	Fair		Poor		Very Poor	
Unknown		Notes:					
17. Recommended for inclusion				Yes	X	No	
18. Date of assessment				13/01/23

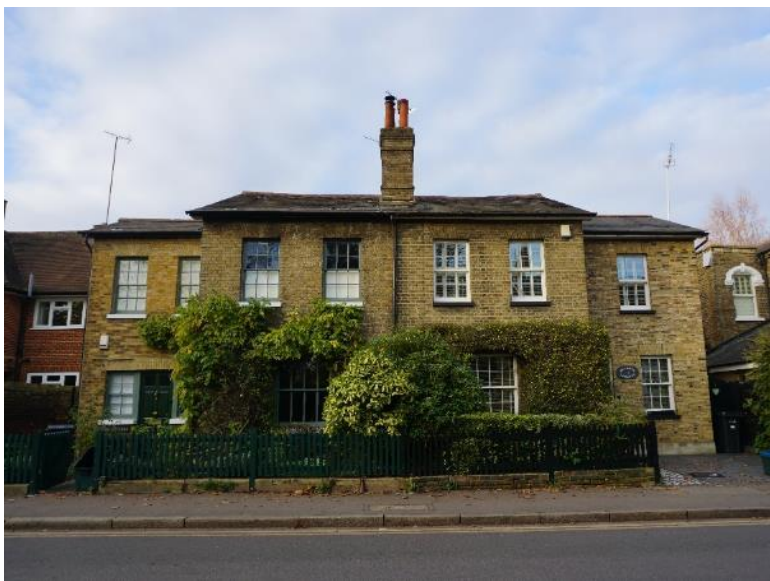
1. Name	39-41 Wanstead Place			
2. UID	WV10			
3. Address	Wanstead Place, 39-41			
4. Postcode	E11 2SW			
5. Grid Ref	E 540377 N 188548			
6a. Conservation Area	Yes	x	No	
6b. If yes, which CA	Wanstead Village

7. Description
A semi-detached pair of dwellings constructed c.1840 in yellow stock brick. The pair is set over two-storeys under a gable ended slate roof and a central chimney. To the principal elevation each pair has a large, eight over eight sash window to ground floor and two six over six sash windows to the first floor; windows sit under flat gauged arches. Two storey, set back side extensions to both flanks.

15. Archaeological Value							
Some archaeological value in the pair as provide evidence of early-mid nineteenth century building techniques and use of materials.							
16. Overall Condition							
Good	X	Fair		Poor		Very Poor	
Unknown		Notes:					
17. Recommended for inclusion				Yes	X	No	
18. Date of assessment				13/01/23

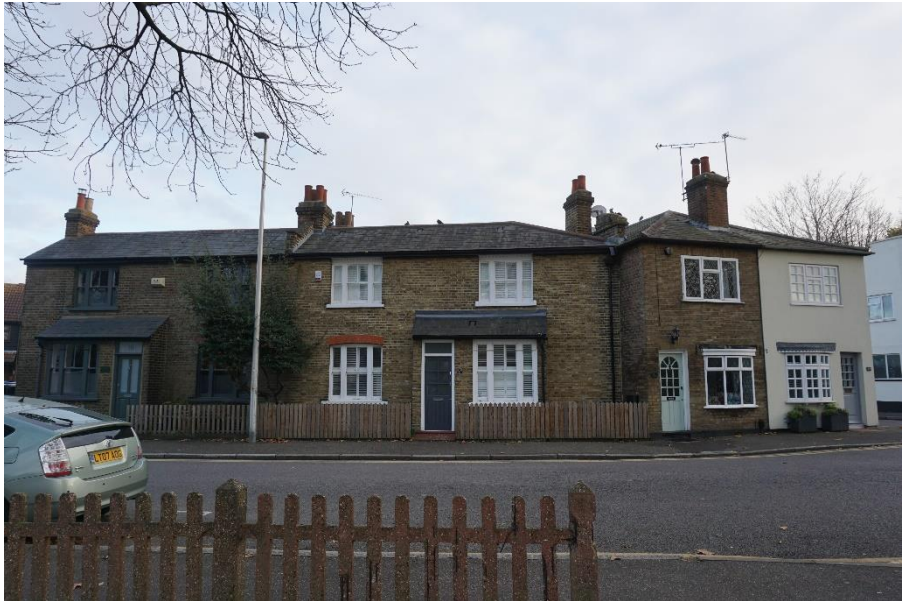
1. Name	16 -19 Woodbine Place			
2. UID	WV11			
3. Address	Woodbine Place, 16			
4. Postcode	E11 2RH			
5. Grid Ref	E 540507 N 188328			
6a. Conservation Area	Yes	x	No	
6b. If yes, which CA	Wanstead Village

7. Description
Early to mid-nineteenth century terrace of cottages. The row are two storeys in height, constructed from brown stocks under a low pitch hipped slate roof with chimneys. Numbers 16 and 17 have sash windows with red brick arched lintels. Numbers 18 and 19 project at an angle.

14. Landmark / Townscape Value							
The cottages are notable in the streetscene due to their positioning opposite Wanstead Park and the road layout result in them being detached from the surrounding built form.							
15. Archaeological Value							
Some archaeological value as evidence of nineteenth century construction techniques and use of materials.							
16. Overall Condition							
Good	X	Fair		Poor		Very Poor	
Unknown		Notes:					
17. Recommended for inclusion				Yes	X	No	
18. Date of assessment				13/01/23
