SECTION 19 FLOOD RISK INVESTIGATION
FLOOD RISK INVESTIGATION REPORT

PREPARED FOR LONDON BOROUGH OF REDBRIDGE

Authored by: Michael McCarthy
Reviewed by: Tom Whitworth
Approved by: Nicholas Metcalfe
Date: September 2022
Version: 2.1

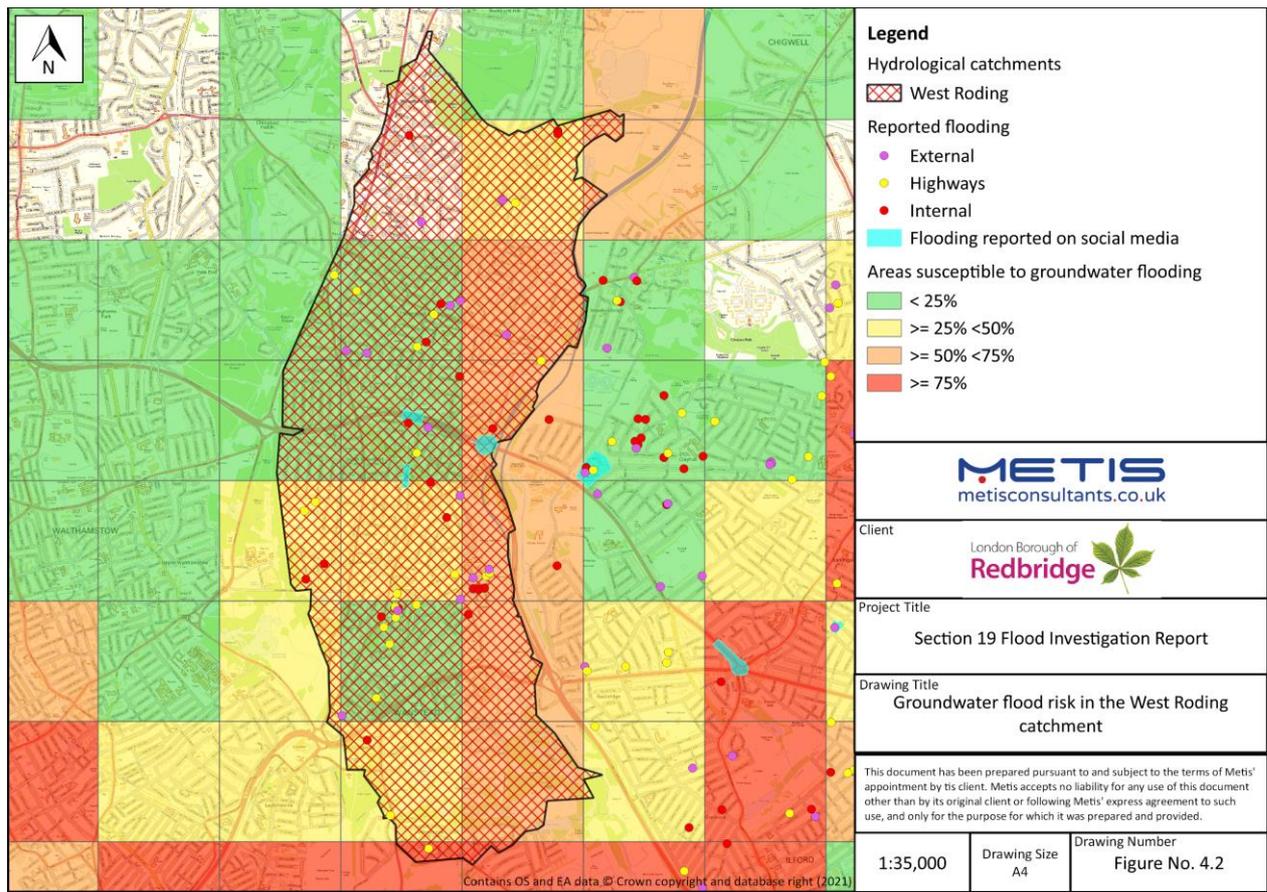
Figure 4.2: Groundwater flood risk in the West Roding catchment

The Rivenhall Gardens hotspot lies within the '>=25% <50%' risk class of the EA's Areas Susceptible to Groundwater Flooding data (see Figure 4.2). The flooding reports do not mention groundwater as the source of flooding but there is water seepage on the site coming from the west of the Rivenhall Gardens from what could be a burst pipe or groundwater.

The Roding Valley hotspot lies within the ‘>=50% <75%’ risk classes of the EA’s Areas Susceptible to Groundwater Flooding data (see Figure 4.2). The flooding reports do not mention groundwater as the source of flooding and there are no known reports of groundwater flooding elsewhere in the hotspot. Therefore, it is believed that this flood incident cannot be attributed to groundwater flood sources.

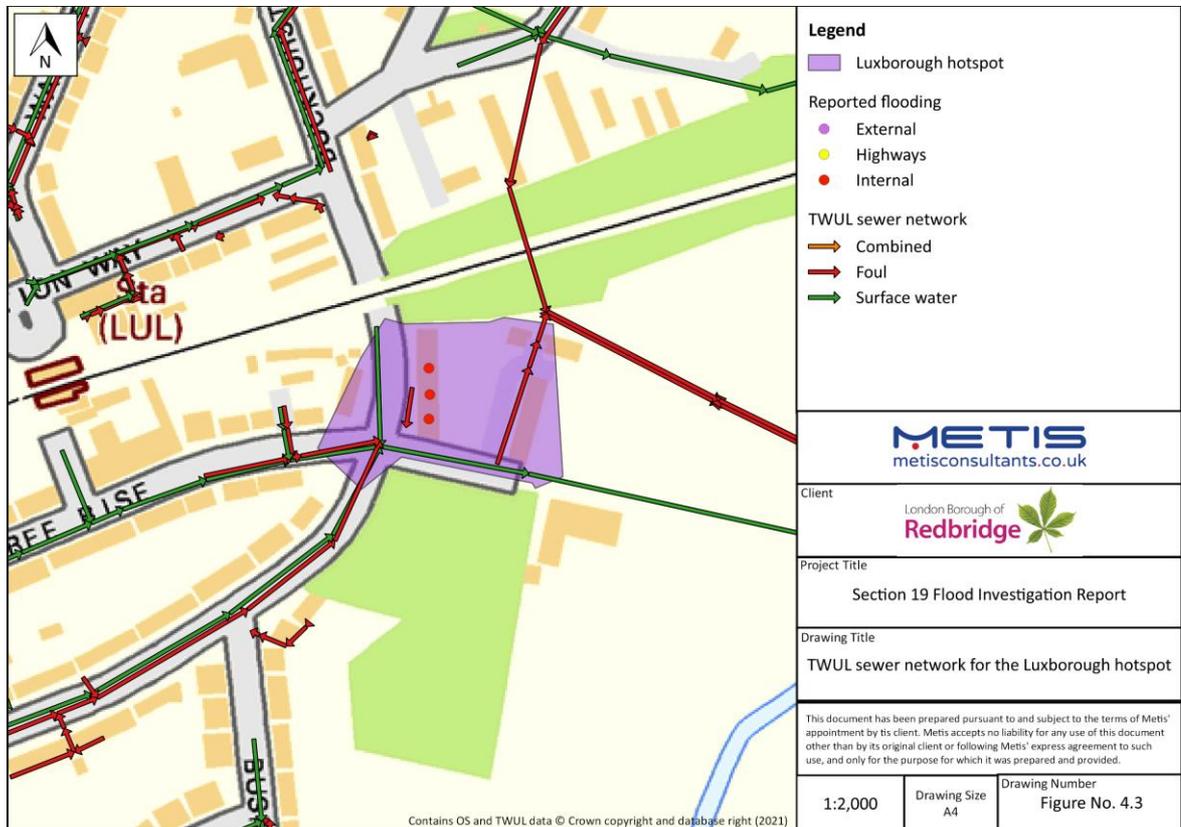
Figure 4.3: TWUL sewer network for the Luxborough hotspot

Figure 4.3 shows the TWUL sewer network within the local area. The intersection between Buckhurst Way and Cherry Tree Rise is a connection point of three separate surface water sewers. A surface water sewer with a diameter of 225mm flows in a southerly direction from Buckhurst Way, starting near the railway line. A second surface water sewer with interchanging diameters of 150mm and 225mm flows in an easterly direction along Cherry Tree Rise and a third surface water sewer with interchanging diameters of 150mm, 225mm and 300mm flows in a southerly direction along the west section of Cherry Tree Rise and is redirected in a north-easterly direction along Buckhurst Way. All three sewers connect at the intersection between Buckhurst Way and Cherry Tree Rise and discharge to a 300mm surface water sewer that flows in an easterly direction for approximately 260m before discharging into the River Roding. There is also a separate foul water

sewer network that follows a similar layout, with the addition of a sewer connecting from Bush Road, and the sewers discharging to the 825mm combined sewer that broadly follows the River Roding.

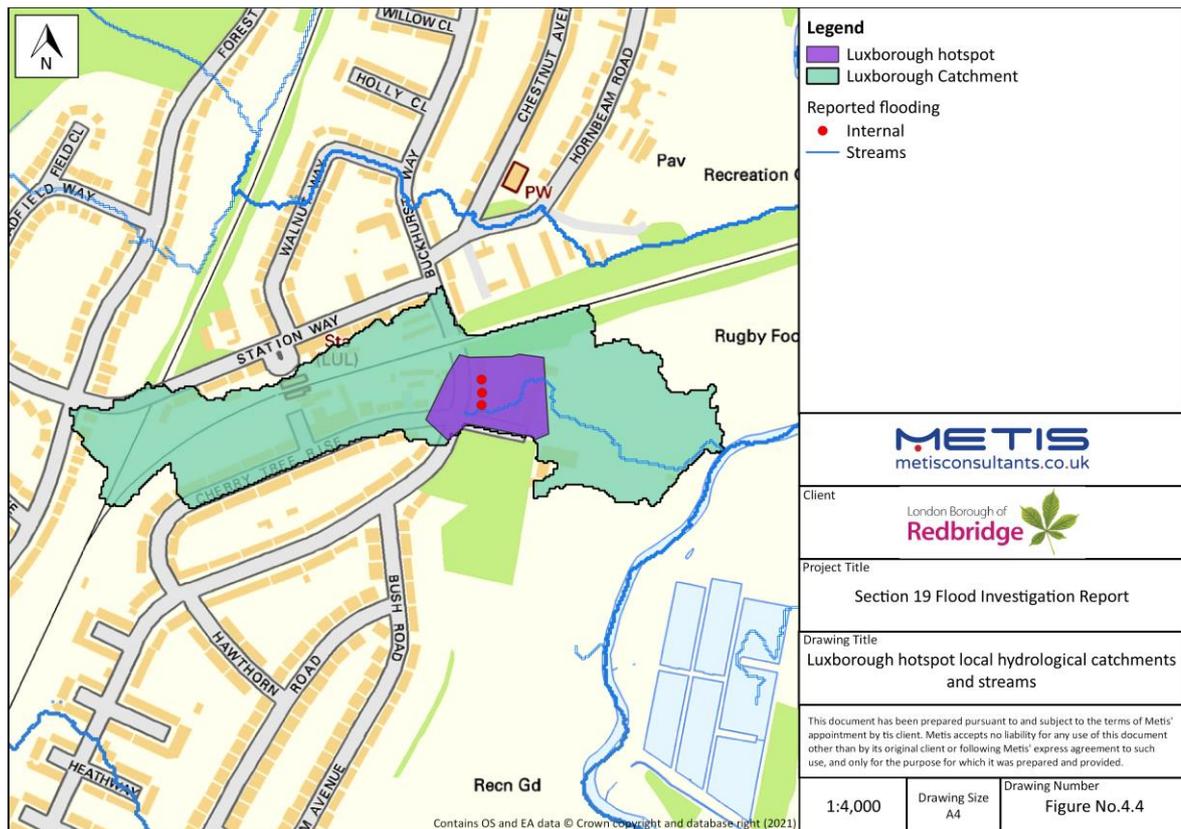
Figure 4.4: Luxborough hotspot local hydrological catchments and streams

A watershed analysis of the area using Geographic Information System (GIS) provided small hydrological sub-catchments along with the primary flow paths (referred to as 'Streams' in Figure 4.4). LiDAR data shows that the flooded properties in Buckhurst Way lie on a topographical low point within the hydrological catchment. This means that surface water within the defined catchment will naturally flow towards the area and pond near the intersection with Cherry Tree Rise and behind the properties.

The primary flow paths are the main overland flow routes for surface water in the defined catchment. For this specific catchment, the primary flow path generally flows in an easterly direction towards River Roding.

The properties on the east side of the intersection are known to be slightly lower than the road, with the driveways dipping towards the front of the properties.

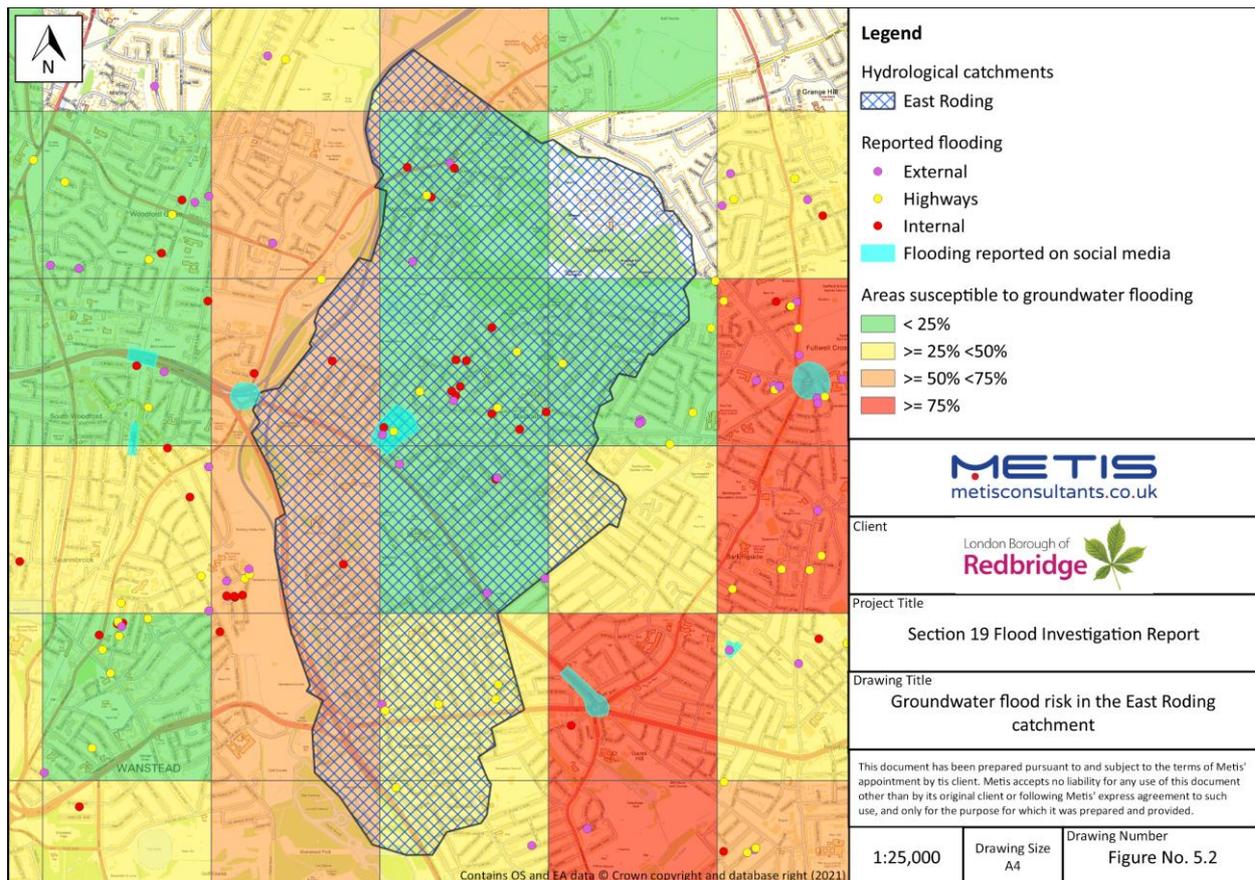
Figure 5.2: Groundwater flood risk in the East Roding catchment

The Clayhall hotspot lies within the '<25%' risk class of the EA's Areas Susceptible to Groundwater Flooding data (see Figure 5.2). The flooding reports do not mention groundwater as the source of flooding and there are no known reports of groundwater flooding elsewhere in the hotspot. Therefore, it is believed that this flood incident cannot be attributed to groundwater flood sources.

The Woodford Bridge hotspot lies within the '<25%' risk class of the EA's Areas Susceptible to Groundwater Flooding data (see Figure 5.2). The flooding reports do not mention groundwater as the source of flooding and there are no known reports of groundwater flooding elsewhere in the hotspot. Therefore, it is believed that this flood incident cannot be attributed to groundwater flood sources.

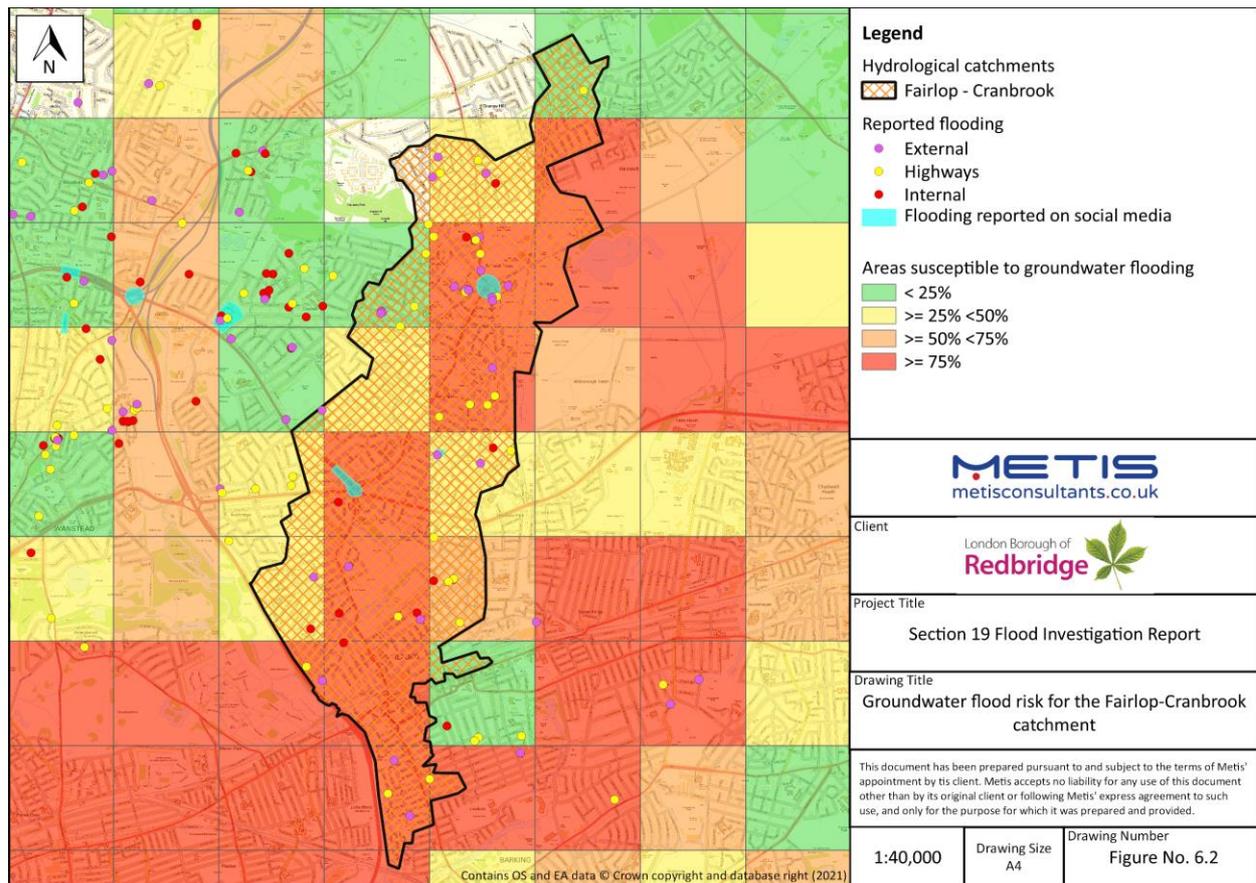
Figure 6.2: Groundwater flood risk in the Fairlop-Cranbrook catchment

The Fullwell Cross hotspot lies within the '>=75%' risk class of the EA's Areas Susceptible to Groundwater Flooding data (see Figure 6.2). The flooding reports do not mention groundwater as the source of flooding and there are no known reports of groundwater flooding elsewhere in the hotspot. Therefore, it is believed that this flood incident cannot be attributed to groundwater flood sources.

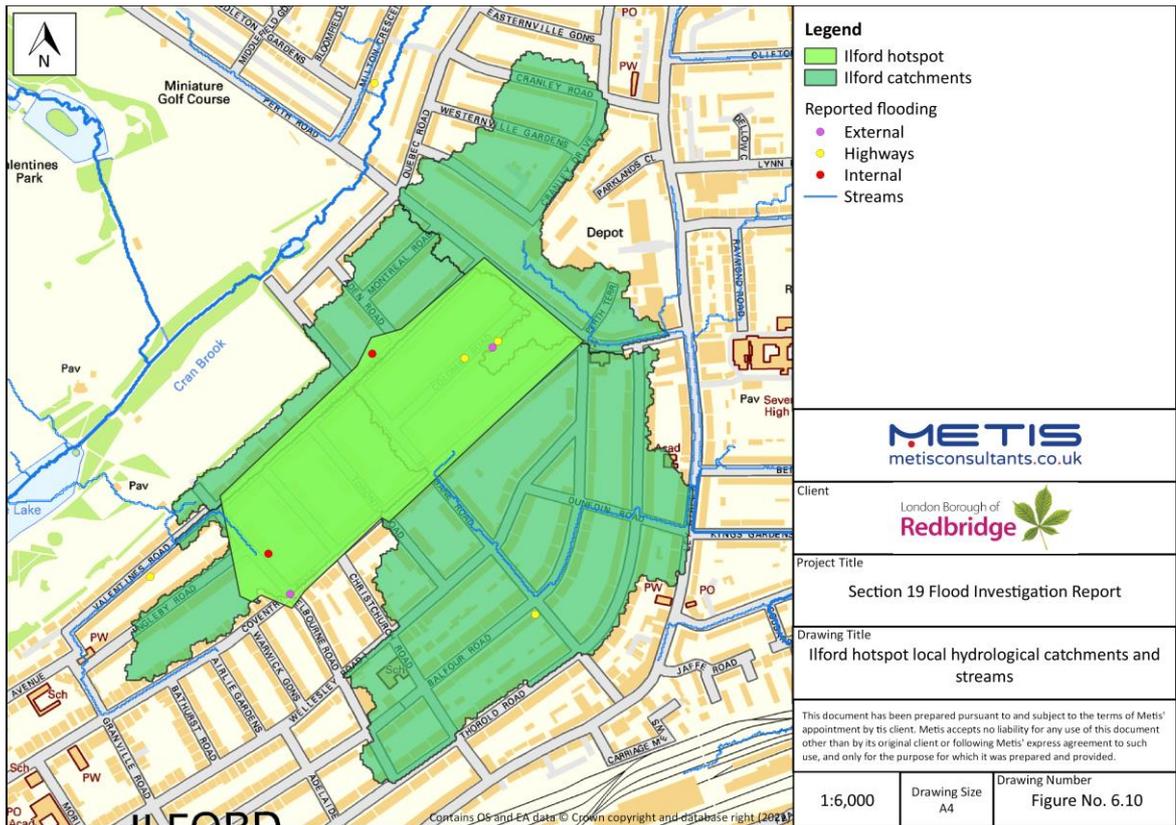
Figure 6.10: Ilford hotspot local hydrological catchment and stream

A watershed analysis of the area using a GIS provided small hydrological sub-catchments along with the primary flow paths (referred to as 'Streams' in Figure 6.10). LiDAR data does not show that the any of the flooded properties lies in a local topographical low point.

The primary flow paths are the main overland flow routes for surface water in the defined catchment. For this specific catchment, the overland flow route flows towards Fulwell Cross before merging and flowing in a southerly direction. The property in Melbourne is located in close proximity to the overland flow paths of the local sub-catchments. The other properties having reported flooding are not on or near flow paths.

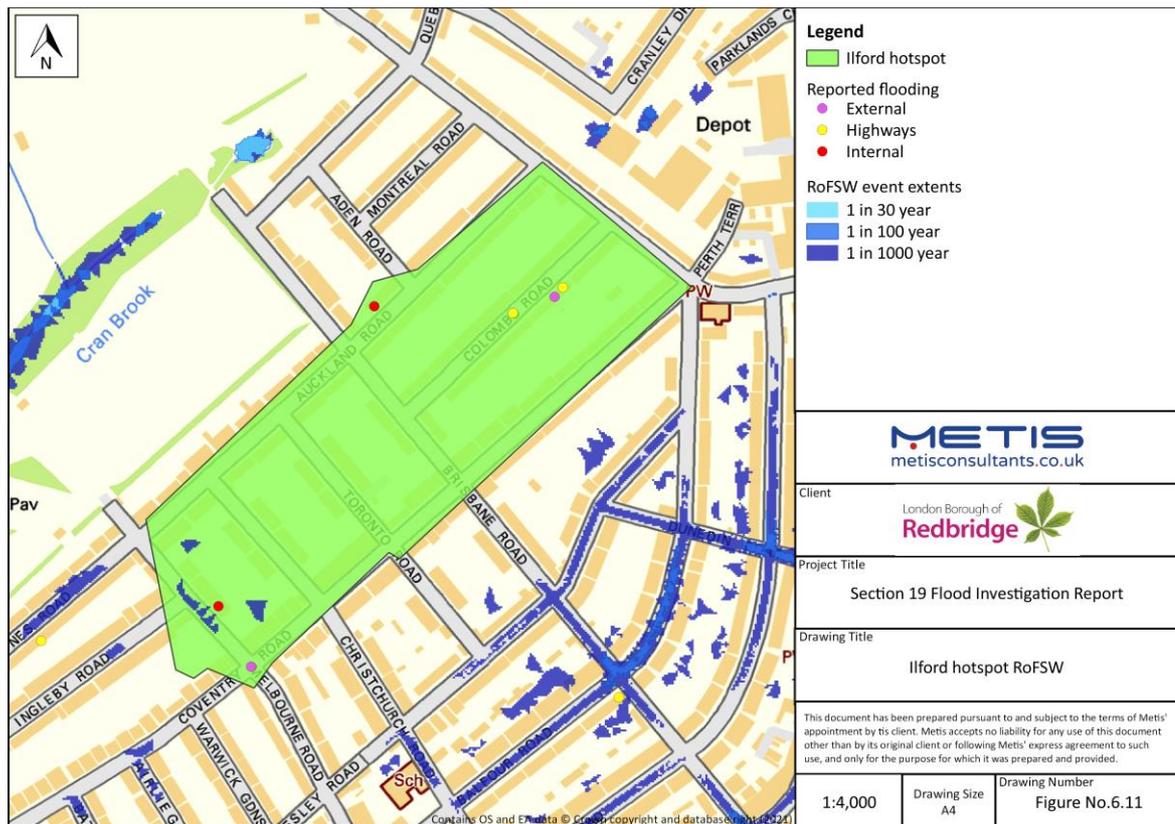
Figure 6.11: Ilford hotspot RoFSW

A review of the EA's RoFSW data (*Figure 6.11*) shows that the flooded property in Melbourne Road sits just outside of the extent of flooding in the 1 in 1000 year rainfall event, with predicted depths ranging between 0.15m and 0.30m. Based on this information, the Ilford hotspot is at low risk of surface water flooding.

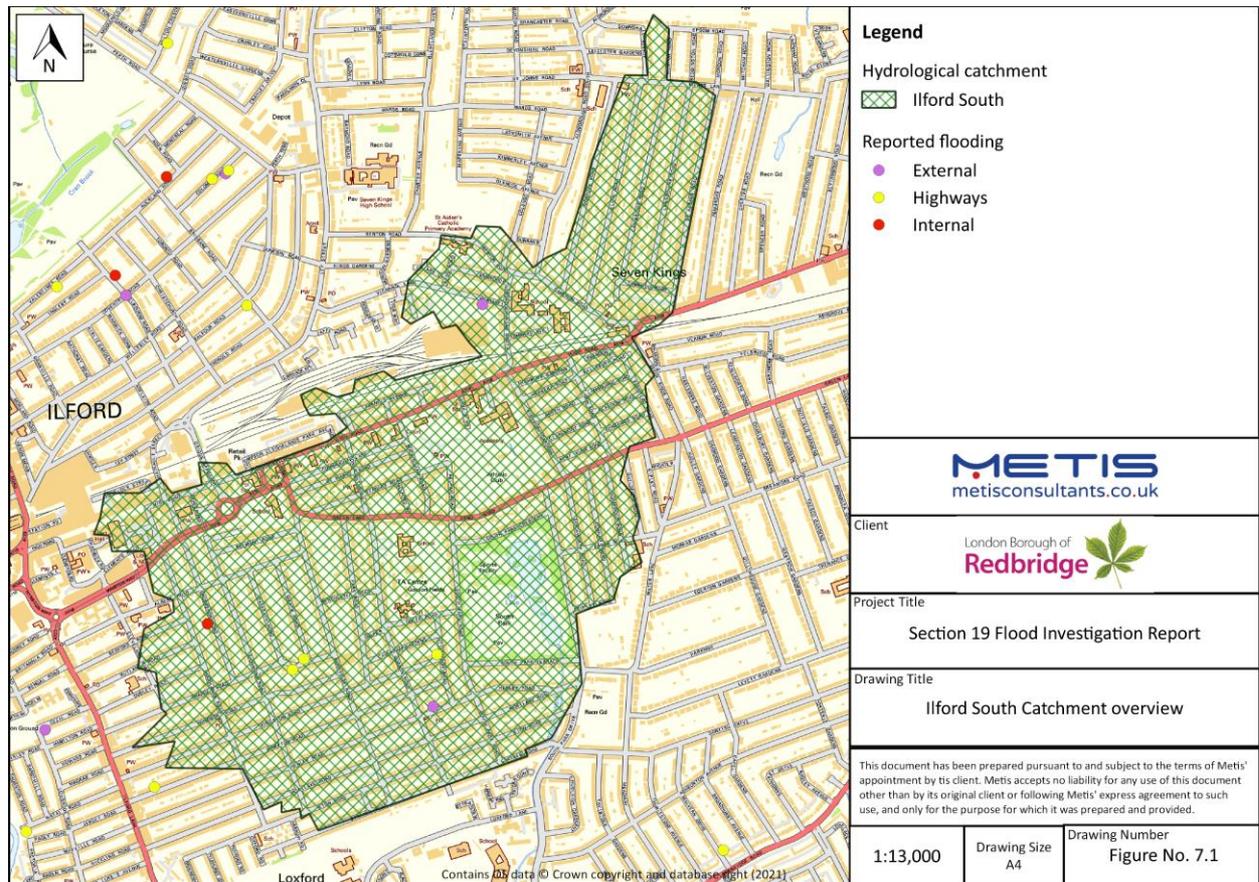
Figure 7.1: Ilford South catchment overview

The Ilford South hydrological catchment spans from the edge of Loxford Park and Seven Kings (Figure 7.1). Residents in this catchment reported two internally flooded properties (one of which was not described specifically enough to be mapped), four externally flooded properties (two of which were not described specifically enough to be mapped), and four cases of flooding to the highway, totalling at ten reports. Because the locations of the reported flooding are spread across the entire catchment, arbitrarily grouping properties would not be logical. Instead, this section mostly focuses on the internal flooding reported in Grosvenor Road.

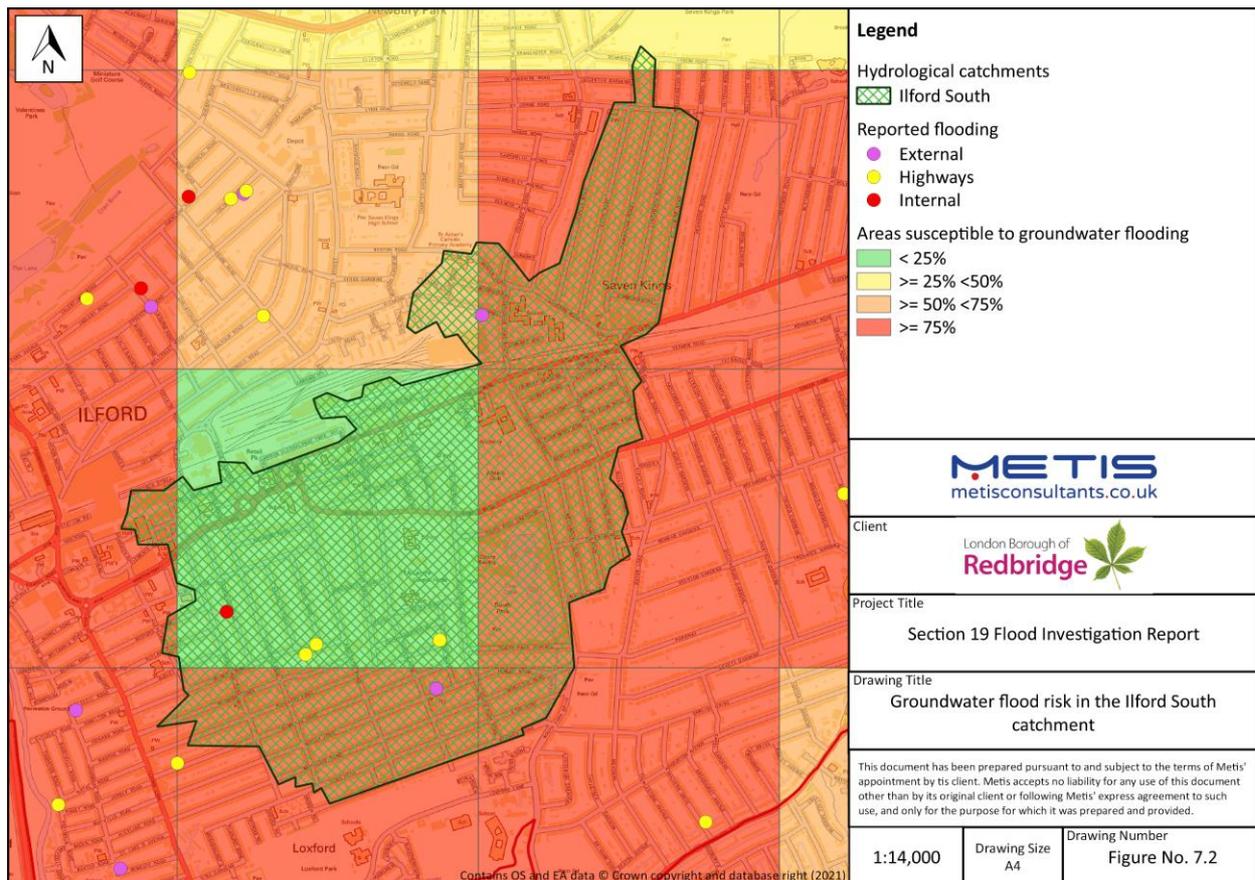
Figure 7.2: Groundwater flood risk in the Ilford South catchment

Grosvenor Road lies within the '<25%' risk class of the EA's Areas Susceptible to Groundwater Flooding data (Figure 7.2). An incident of a flooded basement has however been reported, so groundwater flooding cannot be discounted with further information.

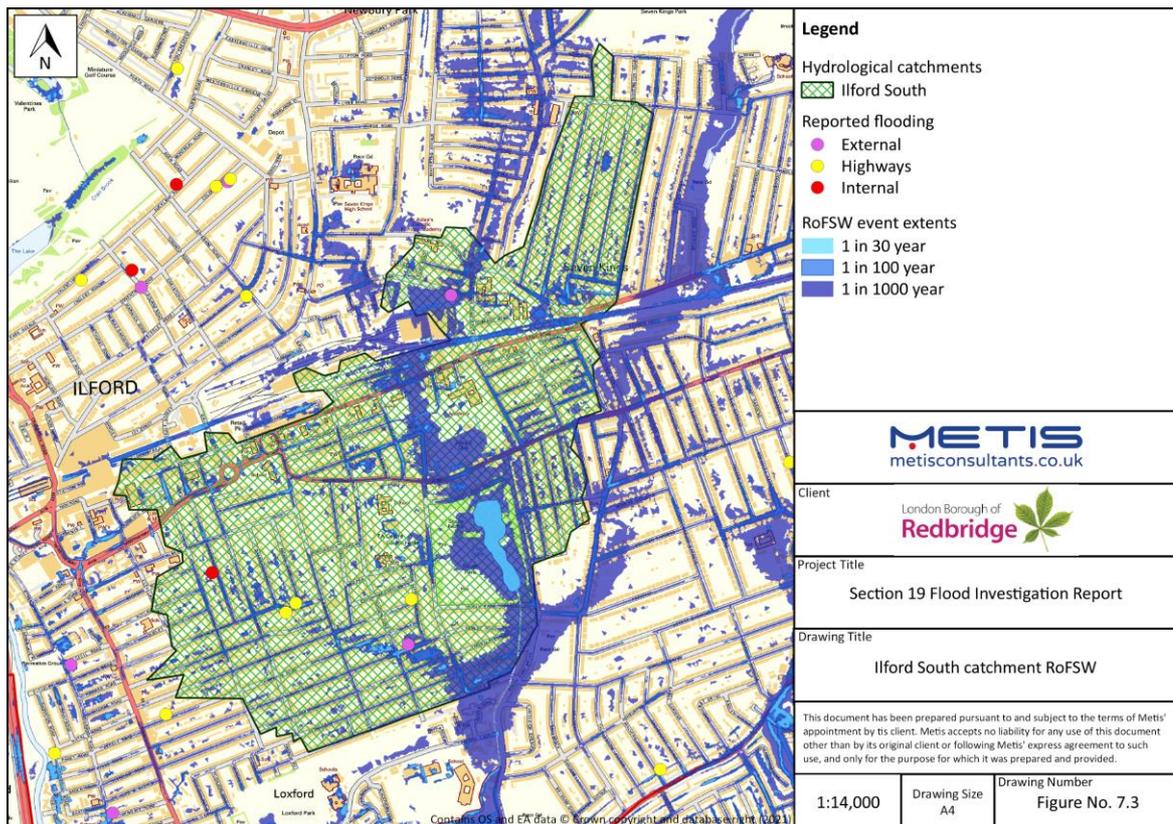
Figure 7.3: Ilford South catchment RoFSW

A review of the EA's RoFSW data (Figure 7.3) shows that the flooded property in Melbourne Road sits just outside of the extent of flooding in the 1 in 1000 year rainfall event, with predicted depths ranging between 0.15m and 0.30m. Based on this information, Grosvenor Road is at low risk of surface water flooding.
