Fire Risk Assessment:

1 - 42 Buckthorne House Yellowpine Way Chigwell IG7 4AZ

1 FIRE RISK ASSESSMENT,1 - 42 BUCKTHORNE HOUSE

Completed by: Mitie Compliance

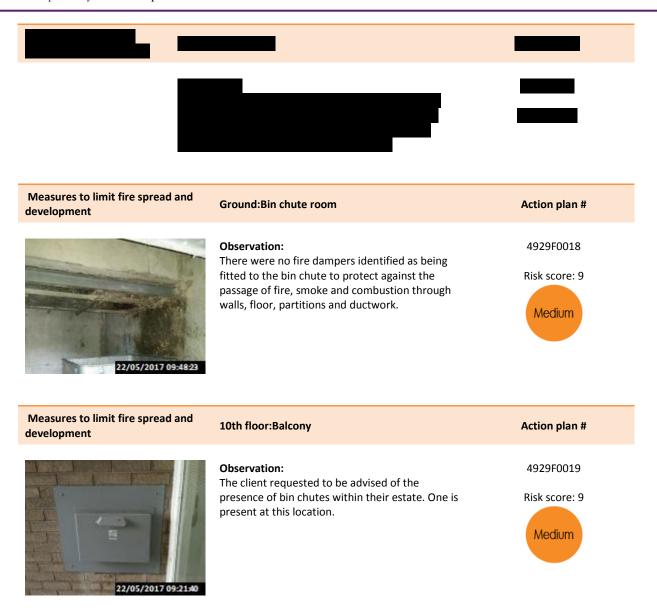
No. of issues
Measures to limit fire spread and development	3

Action plan #	Category	Description	Priority	Allocated to	Completed by	Current status
-		and eliminate the cause of the damage.				
4929F0016		Disused laundry room	Risk score: 9			
		Observation Combustible materials are not separated from ignition sources	Medium			
		Recommendation It is recommended that combustible materials are kept separate from ignition sources.				
4929F0017	¥ 	Flat lobby Observation Residents individual flats were outside of the scope of this assessment which covered communal areas only. From external inspection it would appear that some may not be or have had ad hoc adaptations.	Risk score: 9 Medium			
		Recommendation An assessment of all residents flat entrance doors is recommended to establish fire resistance in line with the building stay put evacuation strategy.				
4929F0018	<u>8</u>	Bin chute roomObservationThere were no fire dampers identified as being fitted to the bin chute to protect against the passage of fire, smoke and combustion through walls, floor, partitions and ductwork.	Risk score: 9 Medium

Recommendation Investigate whether dampers need to be fitted to protect against passage of fire, smoke and combustion through walls,
